**City of**  
**Summit**

**City Wide**

**Drainage**

**Assessment**

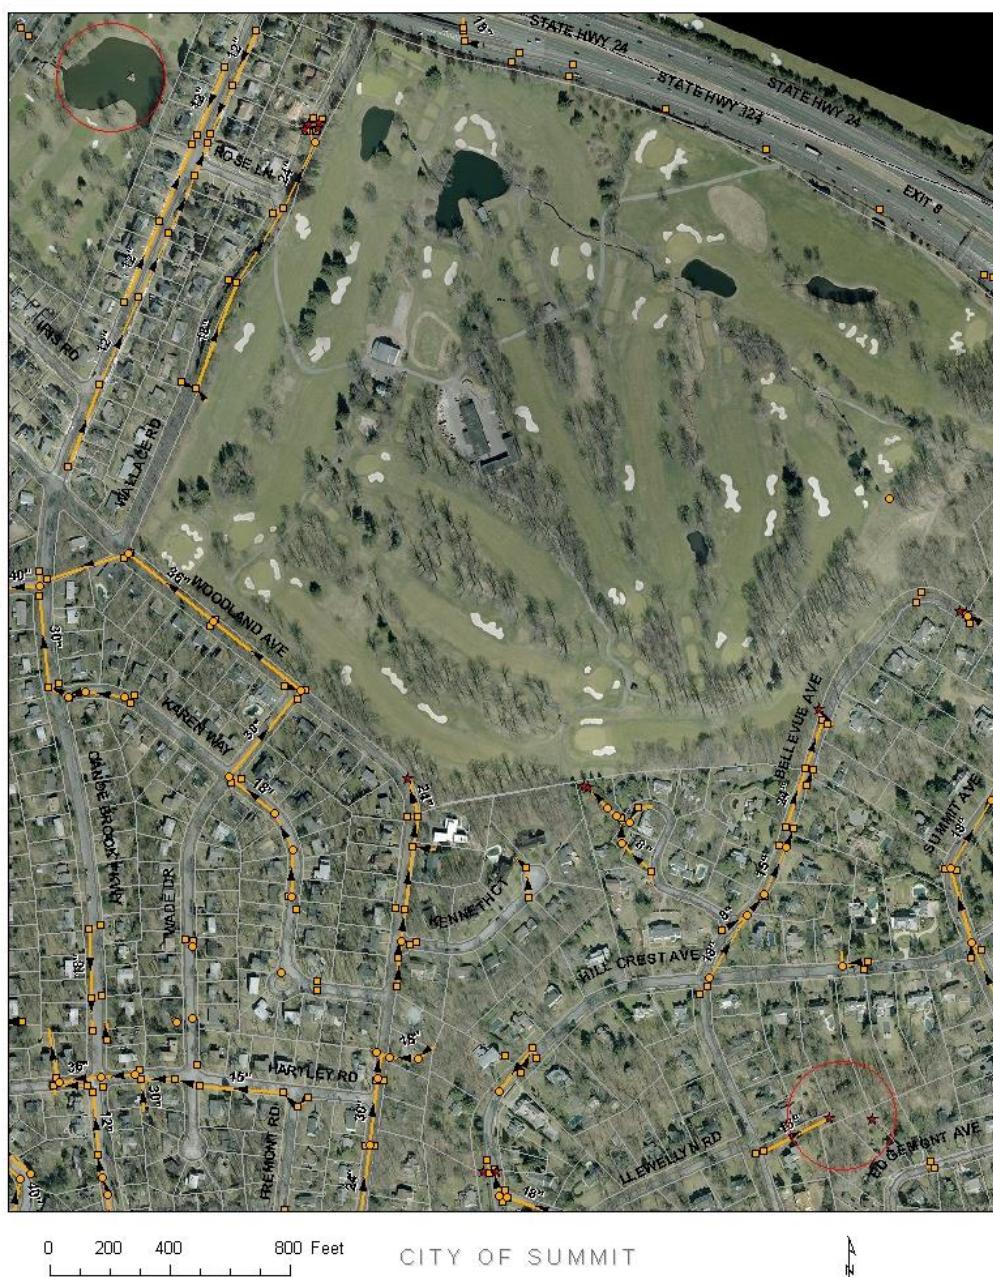
55 BELLEVUE & GOLF COURSE POND

Residents that live along the stream on Canoe Brook Parkway and Wallace Road experience flooding during very intense rain events. In order to reduce the occurrence of flooding in this area, the spillway for Golf Course Pond at the Municipal Golf Course must be redesigned. By increasing the size of the weir and raising the low chord of the pedestrian bridge at the Golf Course pond there will be an increase in flow capacity that can alleviate upstream flooding. Both contribute to flow restrictions. Permitting is currently at NJDEP to proceed with this project.

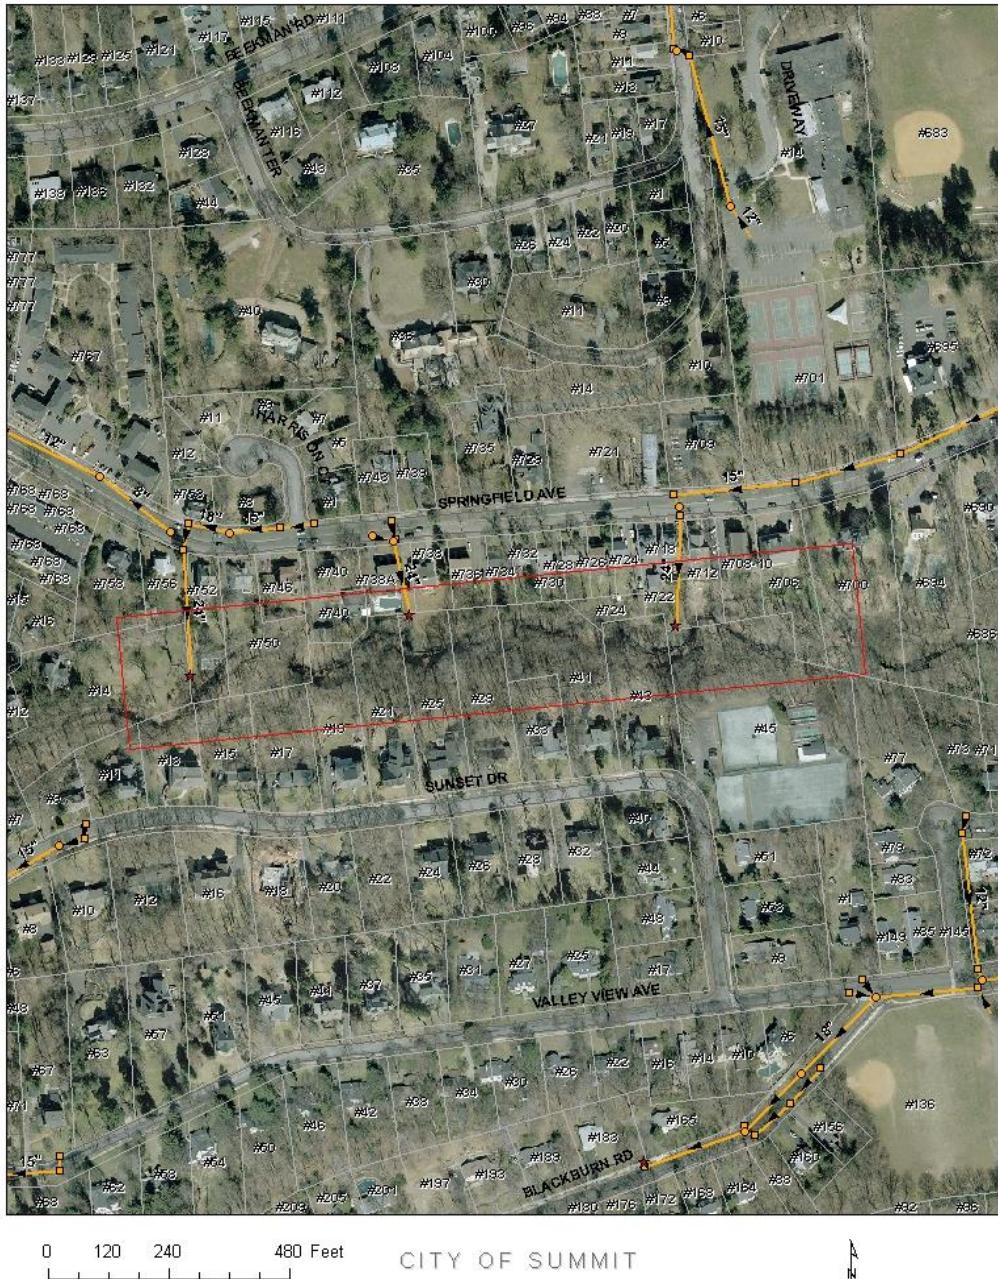
SALT BROOK EROSION

Erosion is evident along the banks of the Salt Brook and private properties flood during heavy storms. The Division has begun discussions with the most affected residents and a consulting Engineer was hired by a private resident for private improvements. The City oversaw and project managed a grant obtained by the Consulting Engineer for the Private resident from the NRCS. City staff continues to monitor the area.

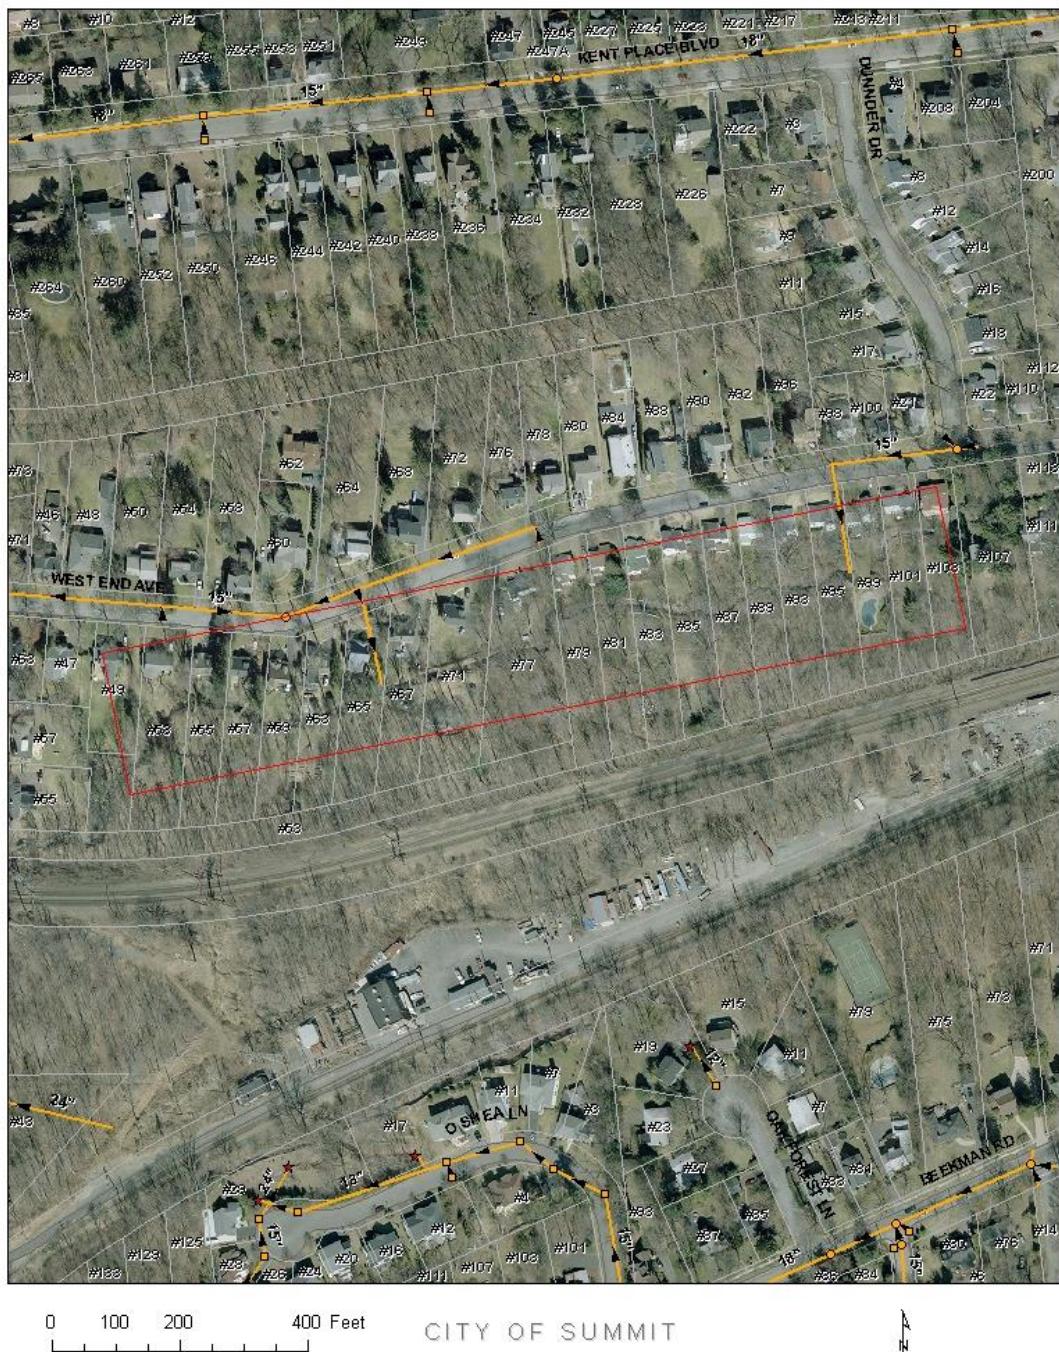
WEST END AVENUE

Erosion is evident along the banks of the brook and private properties flood during heavy storms. The brook is located entirely on private properties. Significant erosion has occurred during heavy rain events along West End Avenue and the Cul-de-Sac portions of Colonial Road. City staff continues to monitor the area

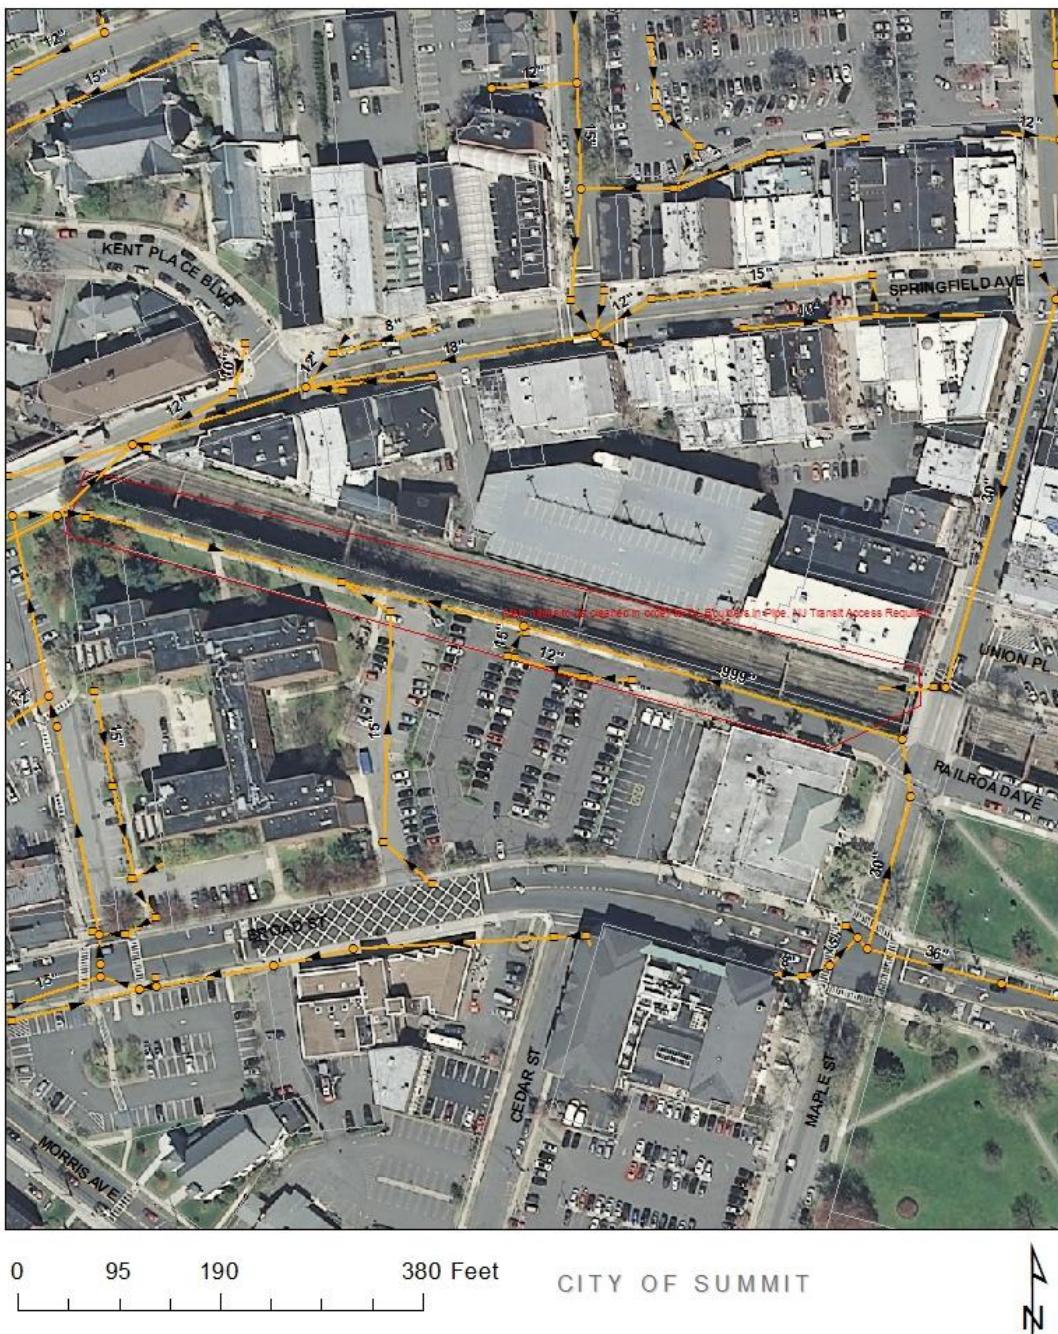
RAILROAD CULVERT

The entire downtown storm sewer system and parts surrounding the downtown drain to a large size culvert constructed into the railway retaining wall below grade. The culvert begins under the train tracks at Maple Street and discharges near Colonial Road. This Culvert is owned by NJ Transit as it lies within their jurisdiction. The Engineering division is working closely with them to confirm proper inspection, maintenance and operation. Any damage or obstructions within these culverts may result in drainage problems in the downtown area.

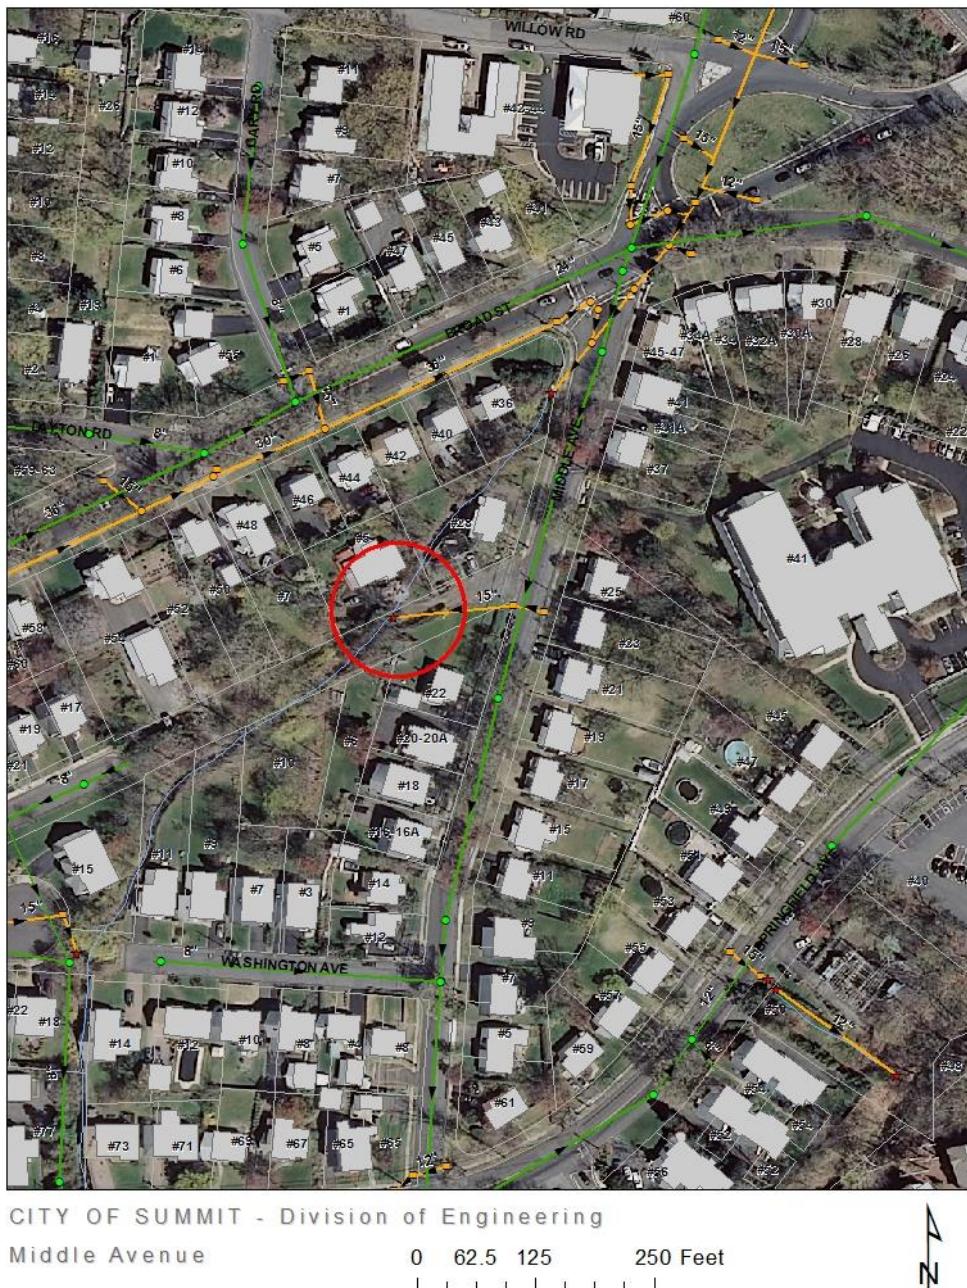
A culvert located along the rear of the properties on Middle Avenue, crossing the dead end portion of Grove Street, discharges large volumes of storm water into the Bryant Pond. An informal visual inspection of this culvert revealed some damage to the top of the culvert. Further investigation must be made as to the ownership of this culvert prior to the re-inspection, design and construction of any repairs.

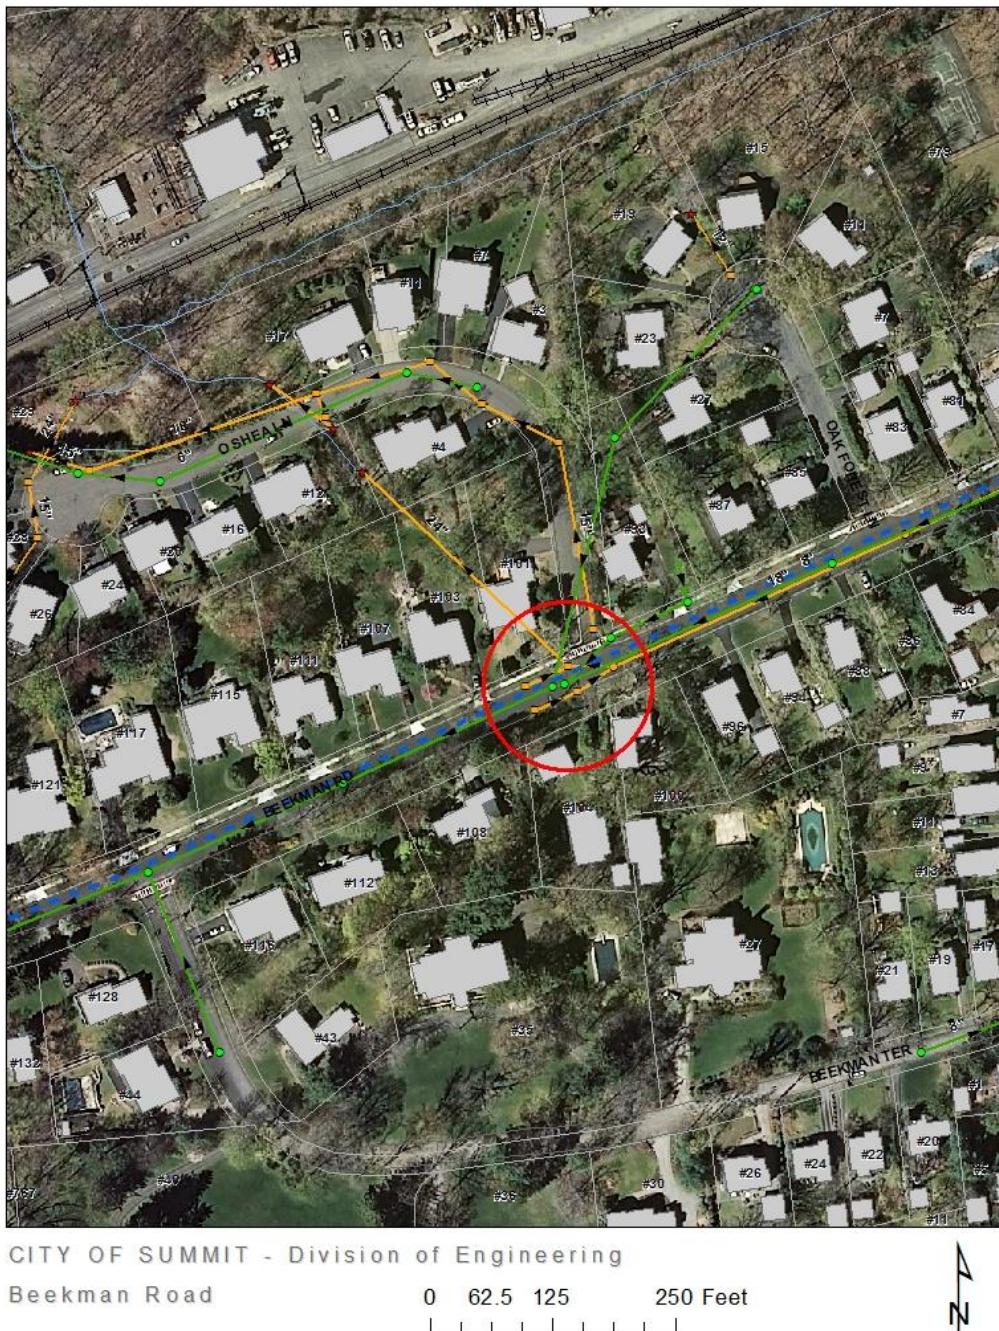
An old box culvert consisting of river stones and steel exists at the corner of Beekman Road and O'Shea Lane carrying drainage from the surrounding area to the West End Avenue Stream. The box culvert is believed to be well over a hundred years old by inspection of its construction and lack of records. The culvert is beginning to fail and portions have been repair by the City's public works department. The culvert will need to be fully replaced.

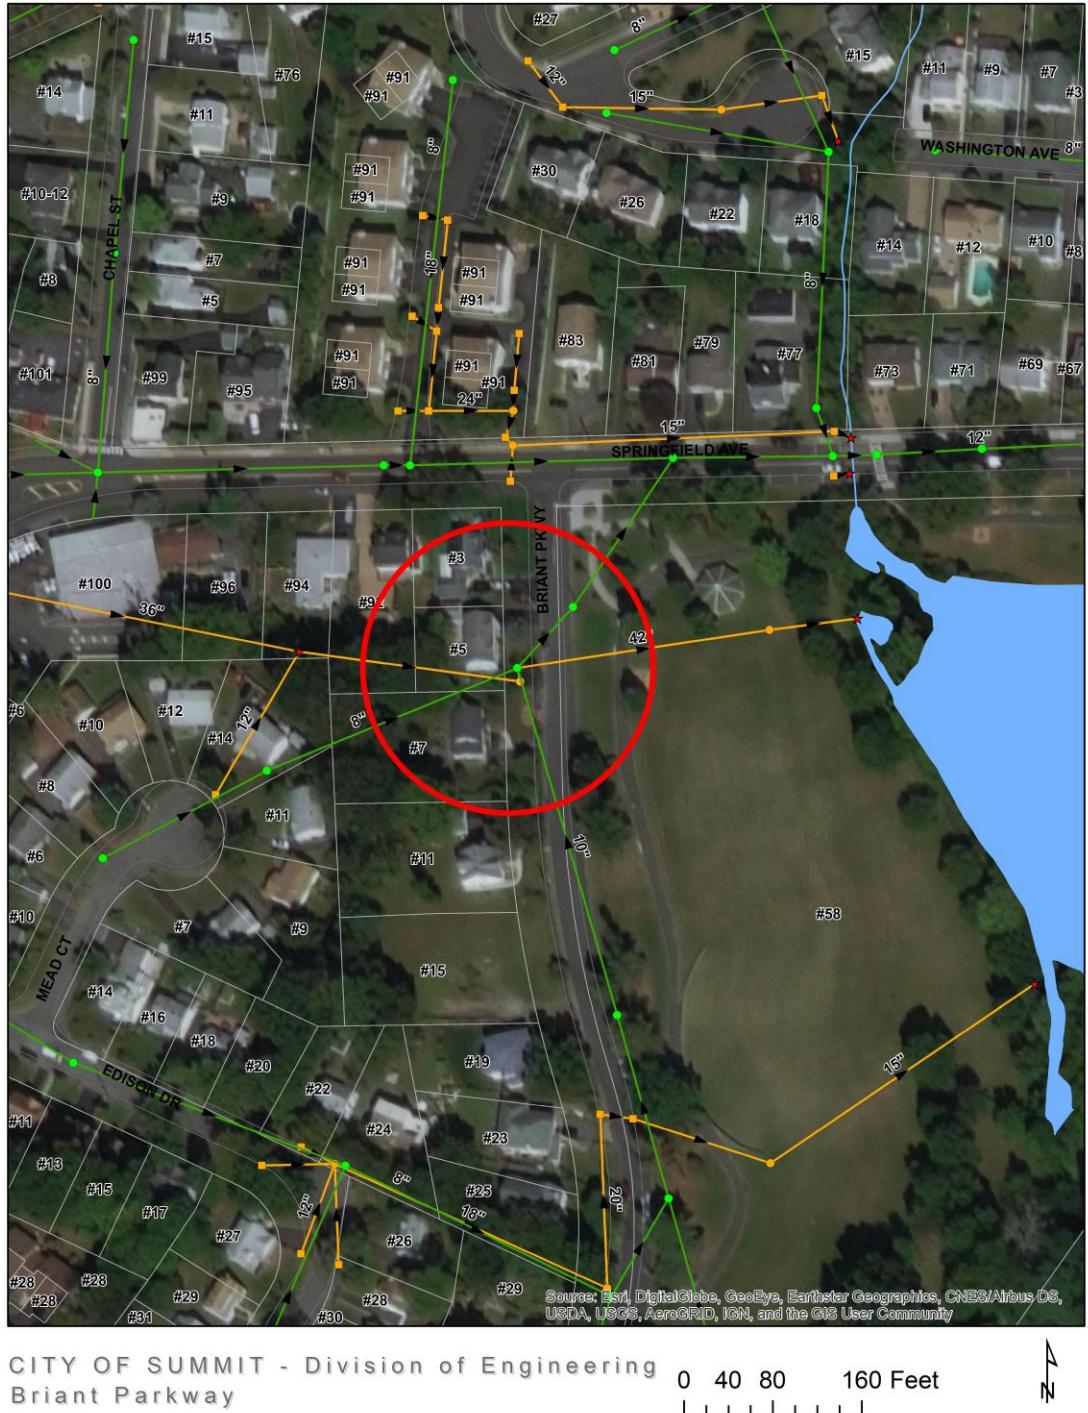
Easements on private property carry storm sewers that drain into Briant Pond. During heavy rain events the layout of the storm sewers restricts flow and causes manholes to surcharge on private property. The storm sewers and surrounding area need to be investigated to determine if a new configuration is possible.

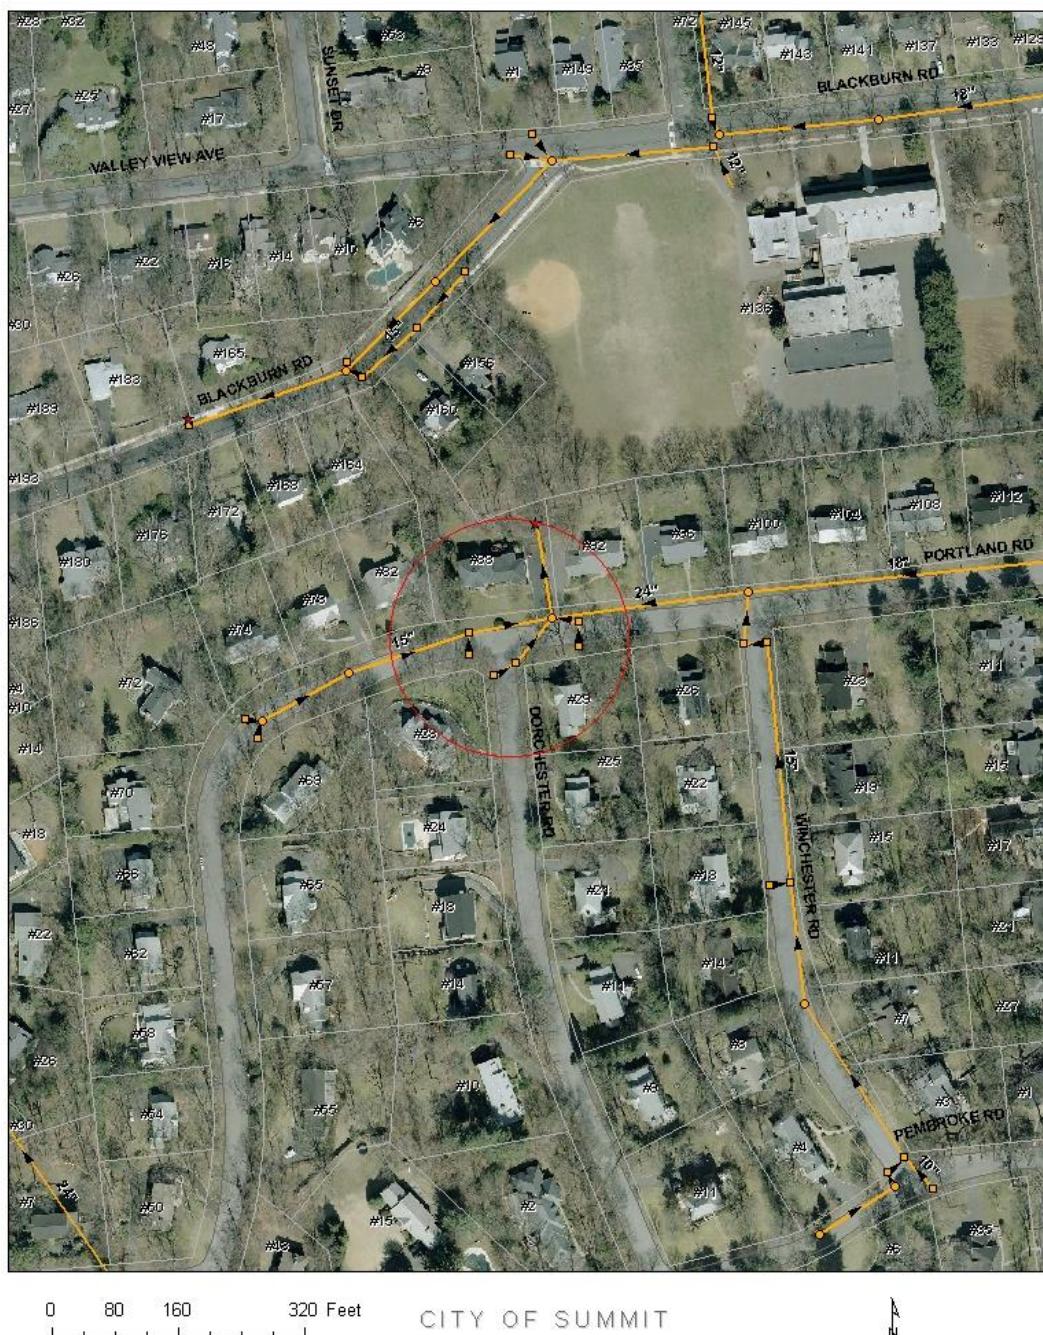
PORTLAND ROAD

During extreme rain events the storm sewer catch basins cannot handle the flow of rain water coming down Portland Road, Dorchester Road and Winchester Road. Flooding has occurred twice during Hurricane Floyd and Hurricane Irene.

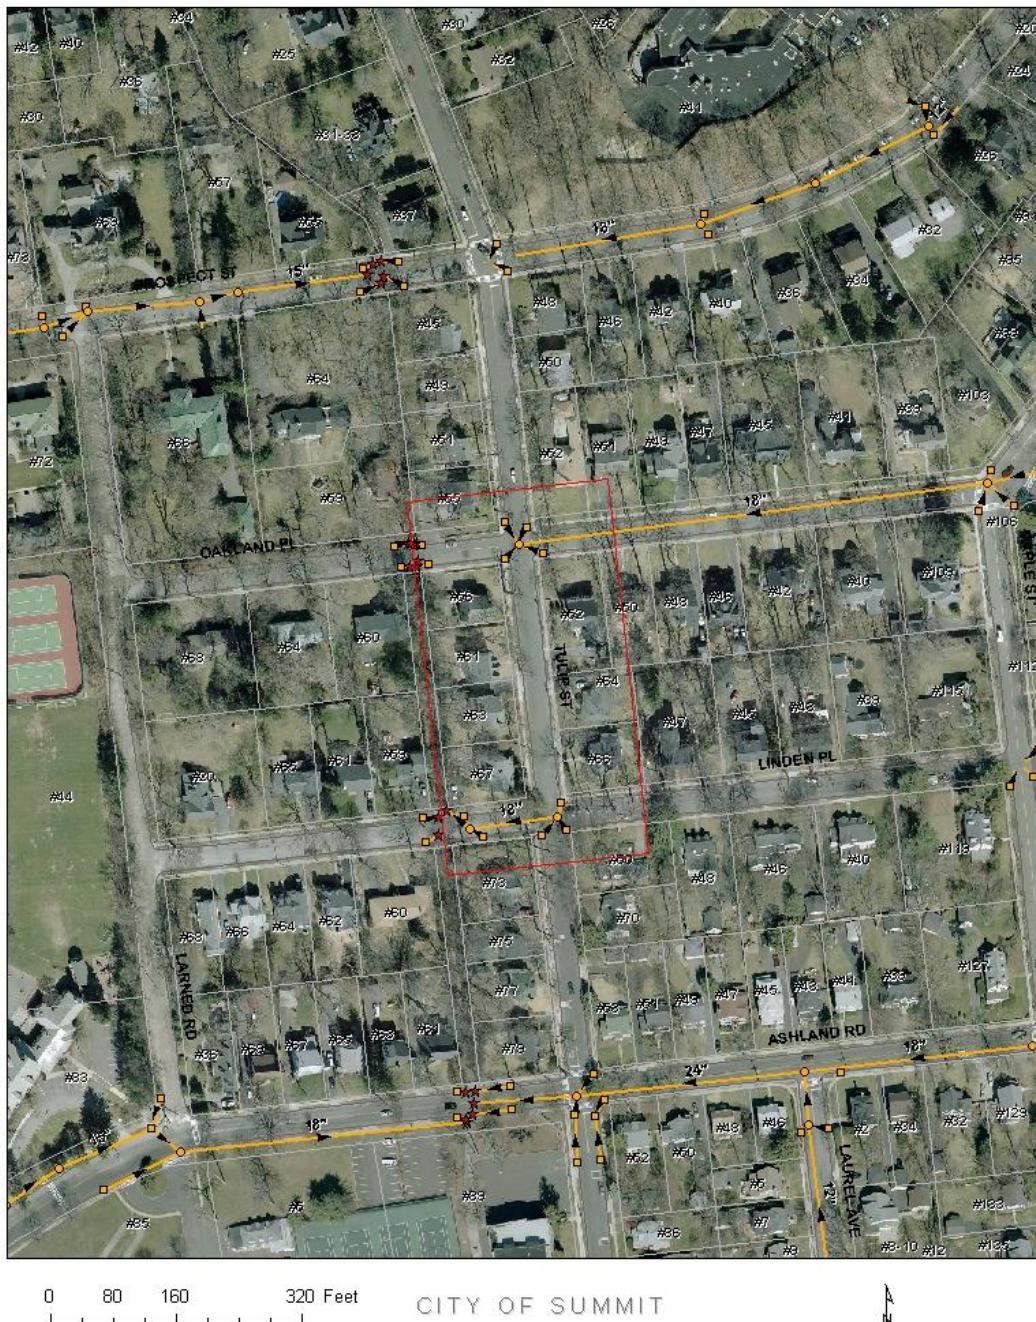
TULIP STREET - OAKLAND PLACE TO LINDEN PLACE

Tulip Street floods during intense rains at the intersections of Oakland Place and Linden Place. This appears to be a localized condition resulting in undersized catch basins and lateral lines. Further investigation is required. A contract was awarded to have these storm sewers inspected and cleaned. The footage has been reviewed and several undersized lines exist along with numerous utility blockages in the system. A final design of repairs is being prepared and shall be completed during the winter of 2014.

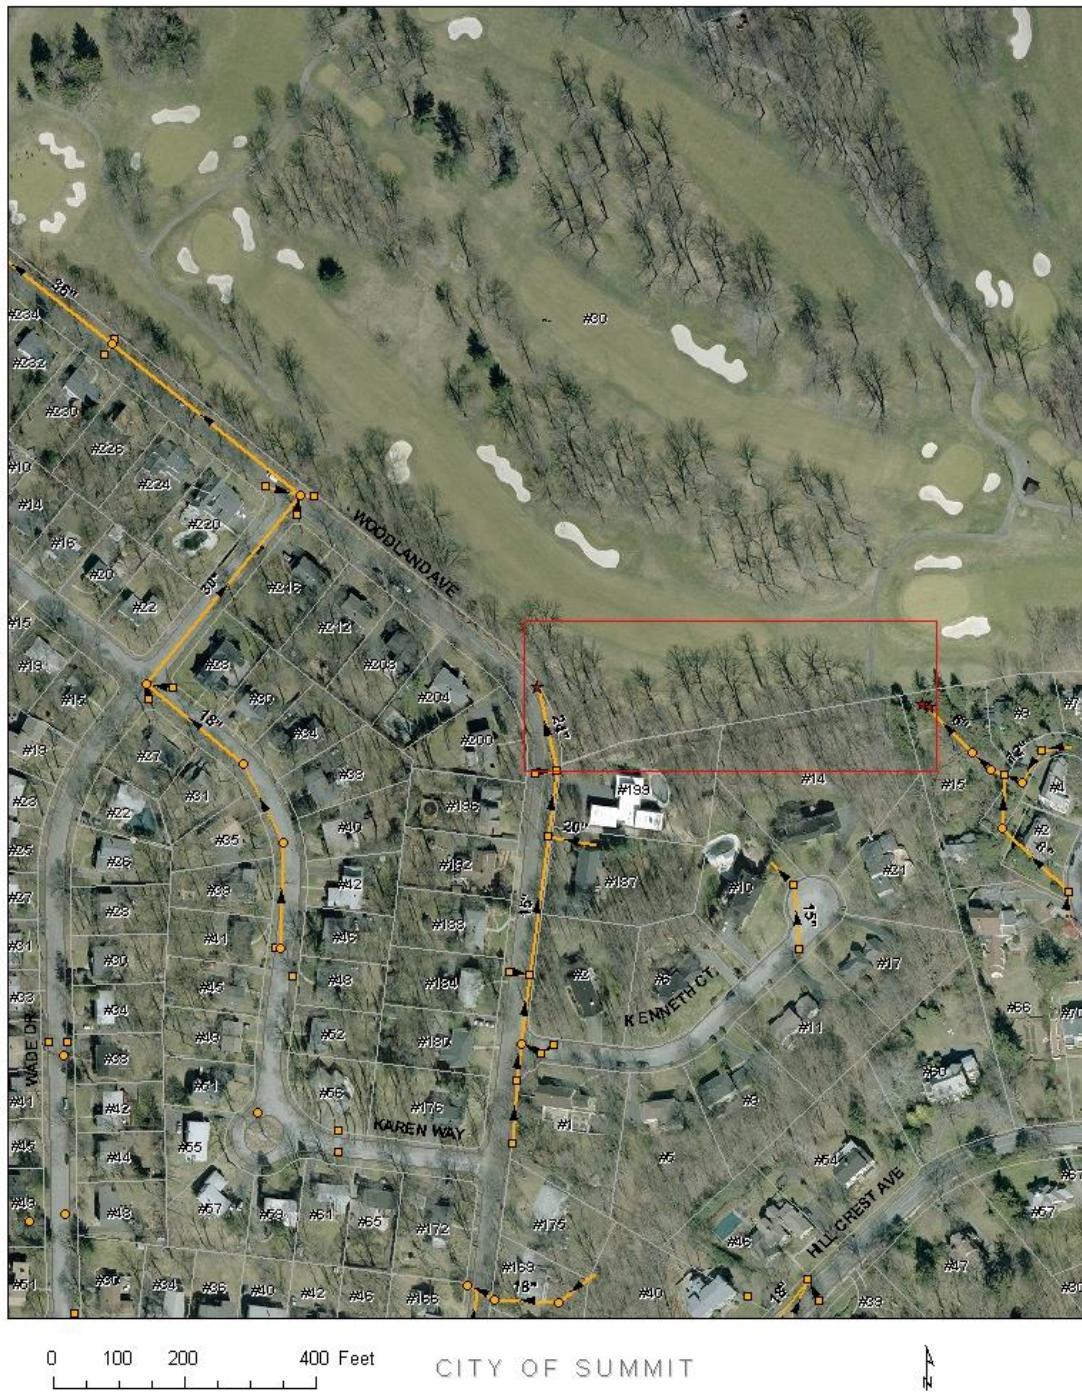
KENNETH COURT AND CREST ACRE COURT

In the area Kenneth Court and Crest Acre Court, the storm sewer from Crest Acre Court discharges into a private system and then a poorly defined ditch behind 14 Kenneth Court. Flow eventually makes its way to the ditch near #199 Woodland Avenue creating a mosquito breeding condition on private property. Unfortunately, no easements exist making any improvements difficult.

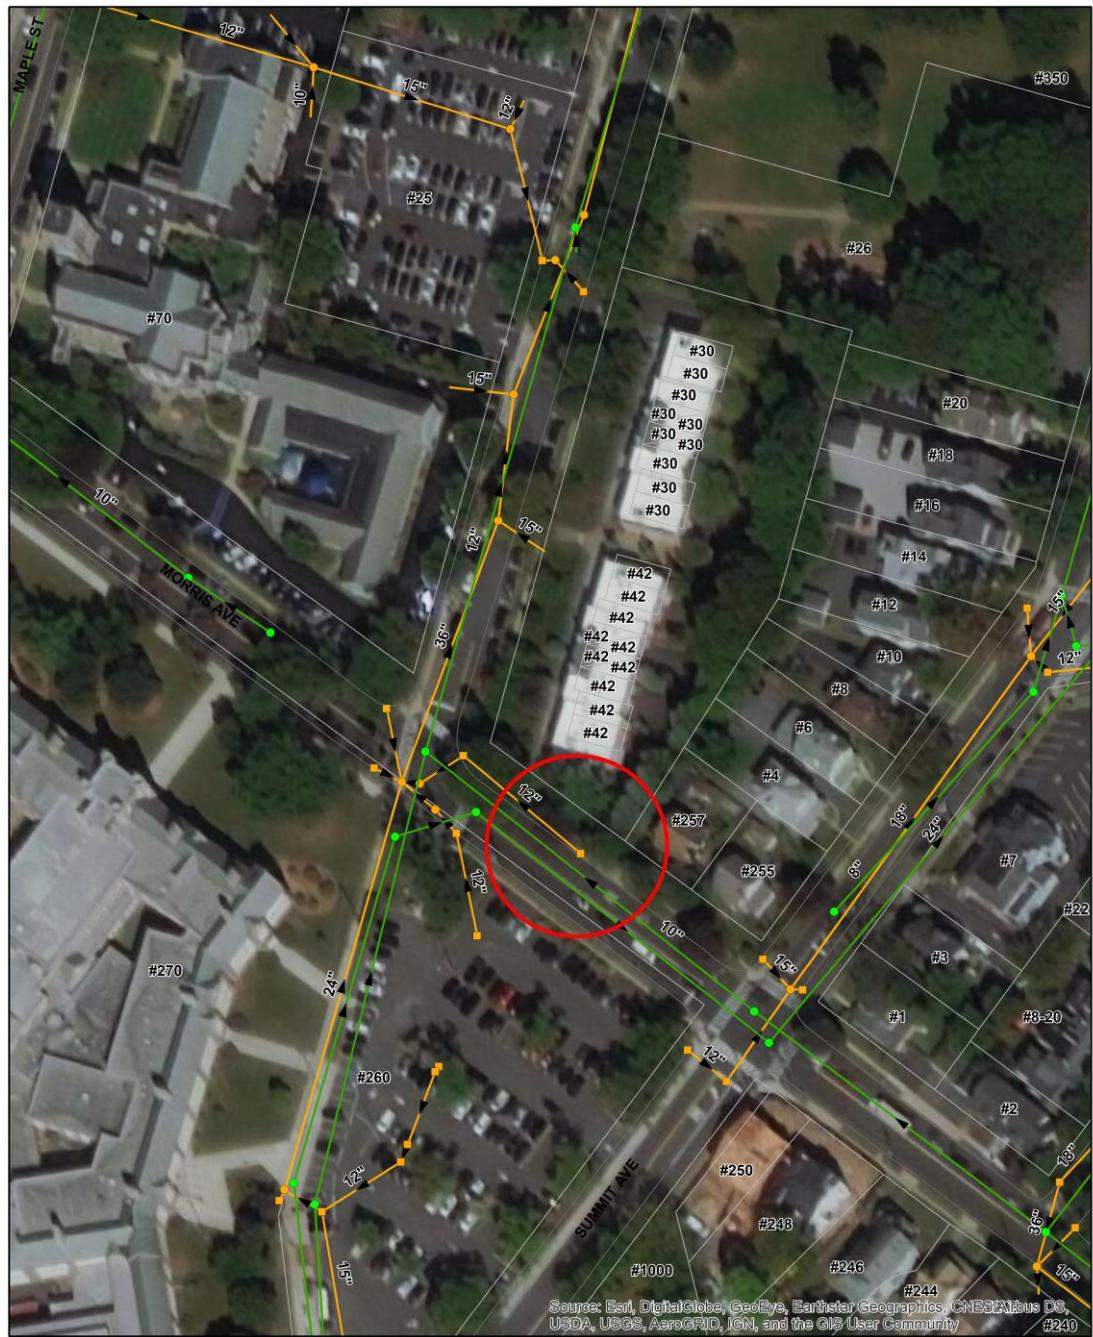
CITY OF SUMMIT - Division of Engineering  
Morris Avenue (at Elm Street Condos)

An existing Union County operated inlet located on Morris Avenue at the entrance to the Elm Street Condo Driveway has a low profile curb piece. This inlet, per Condo Resident reports, has been clogged with debris during heavy downpours. Flooding in the condo parking lot has raised concerns and residents have requested improvements to the infrastructure as they look to improve their own private drainage.

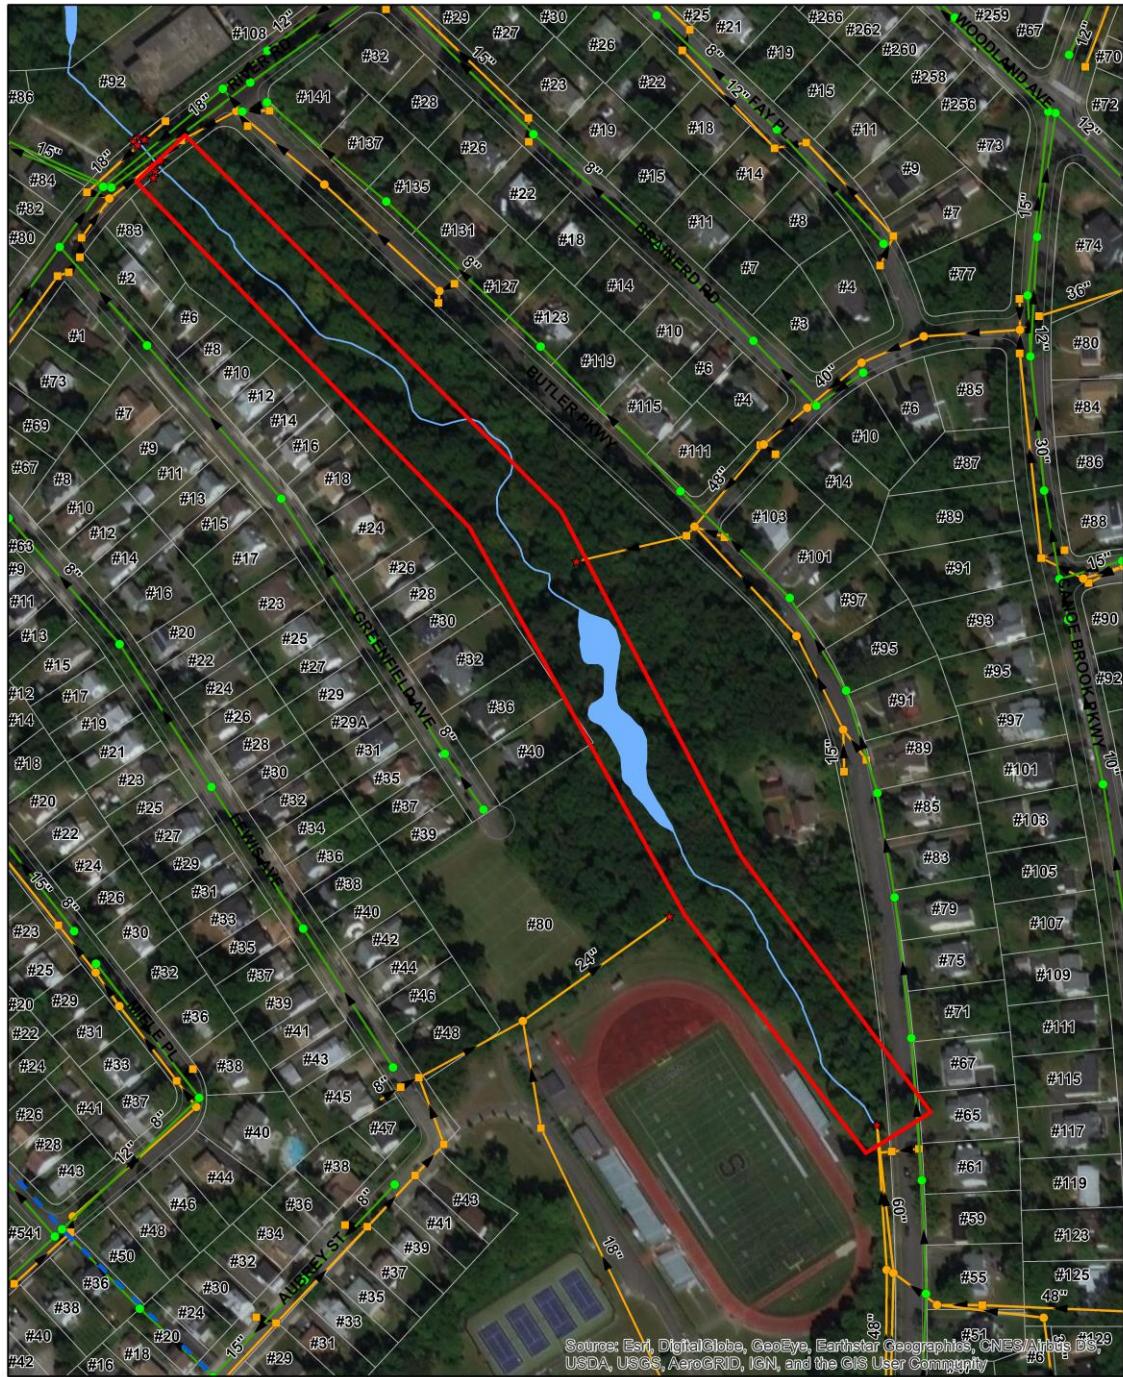
CITY OF SUMMIT - Division of Engineering  
Martins Brook

The stream known as Martins Brook receives a significant amount of drainage from upstream. It is imperative that the stream have proper flowing capacity to accommodate the flow. A stream cleaning project should be completed. Work can be accomplished by the City with City funds in addition to assistance from nonprofit organizations (i.e. volunteers) to ensure its proper use.

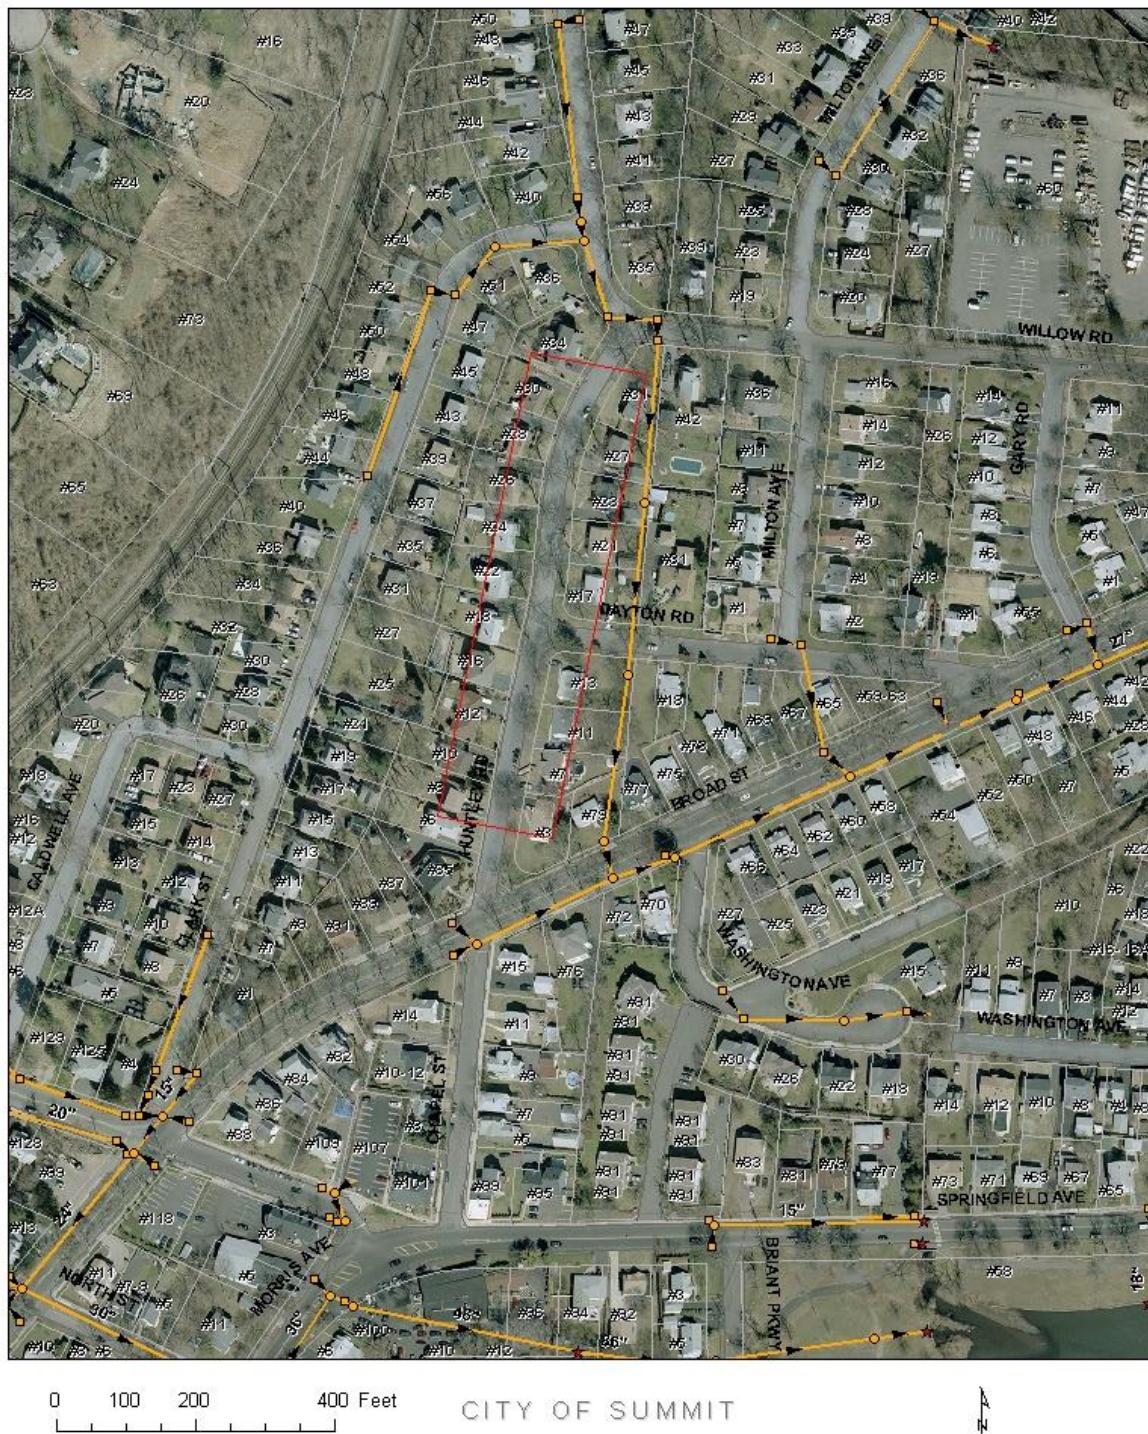
HUNTLEY ROAD

Due to a lack of catch basins on the street, runoff after storm events is discharged into the road and extreme ponding and wet conditions occur, potentially endangering motorists. A storm sewer system can be extended from either end of the street to capture the majority of the runoff.

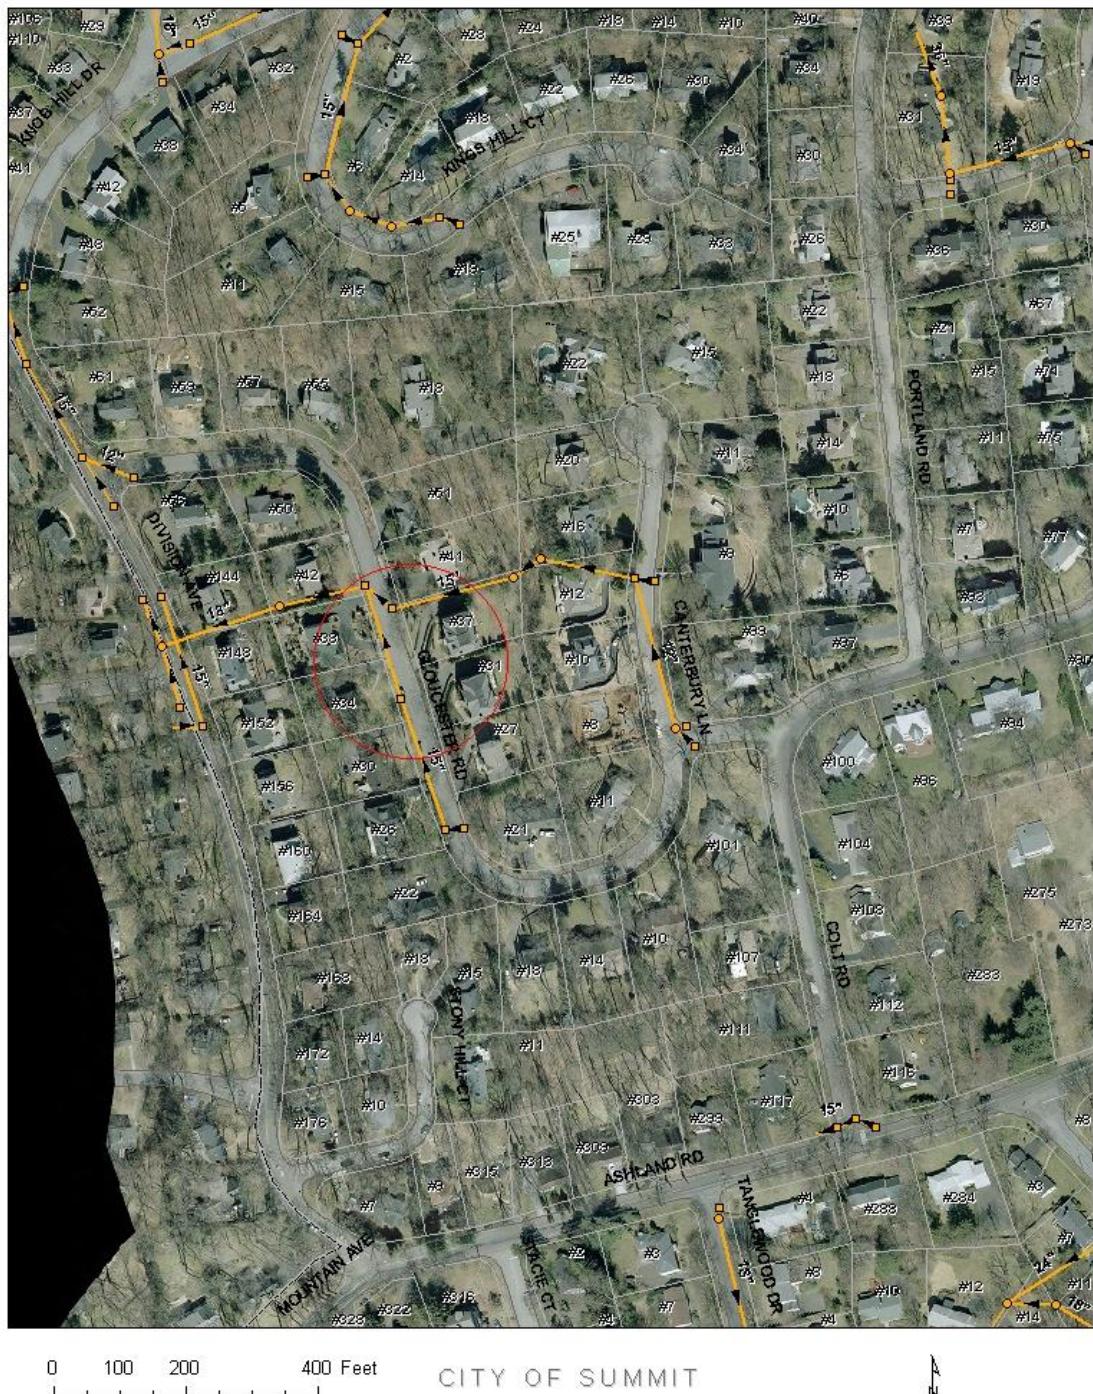
GLOUCESTER ROAD

Groundwater reaches daylight at the bottom of a hill along several private properties causing wet conditions during the summer months and icing during the winter months. Catch basins can be extended to capture the groundwater and direct it into our storm system.

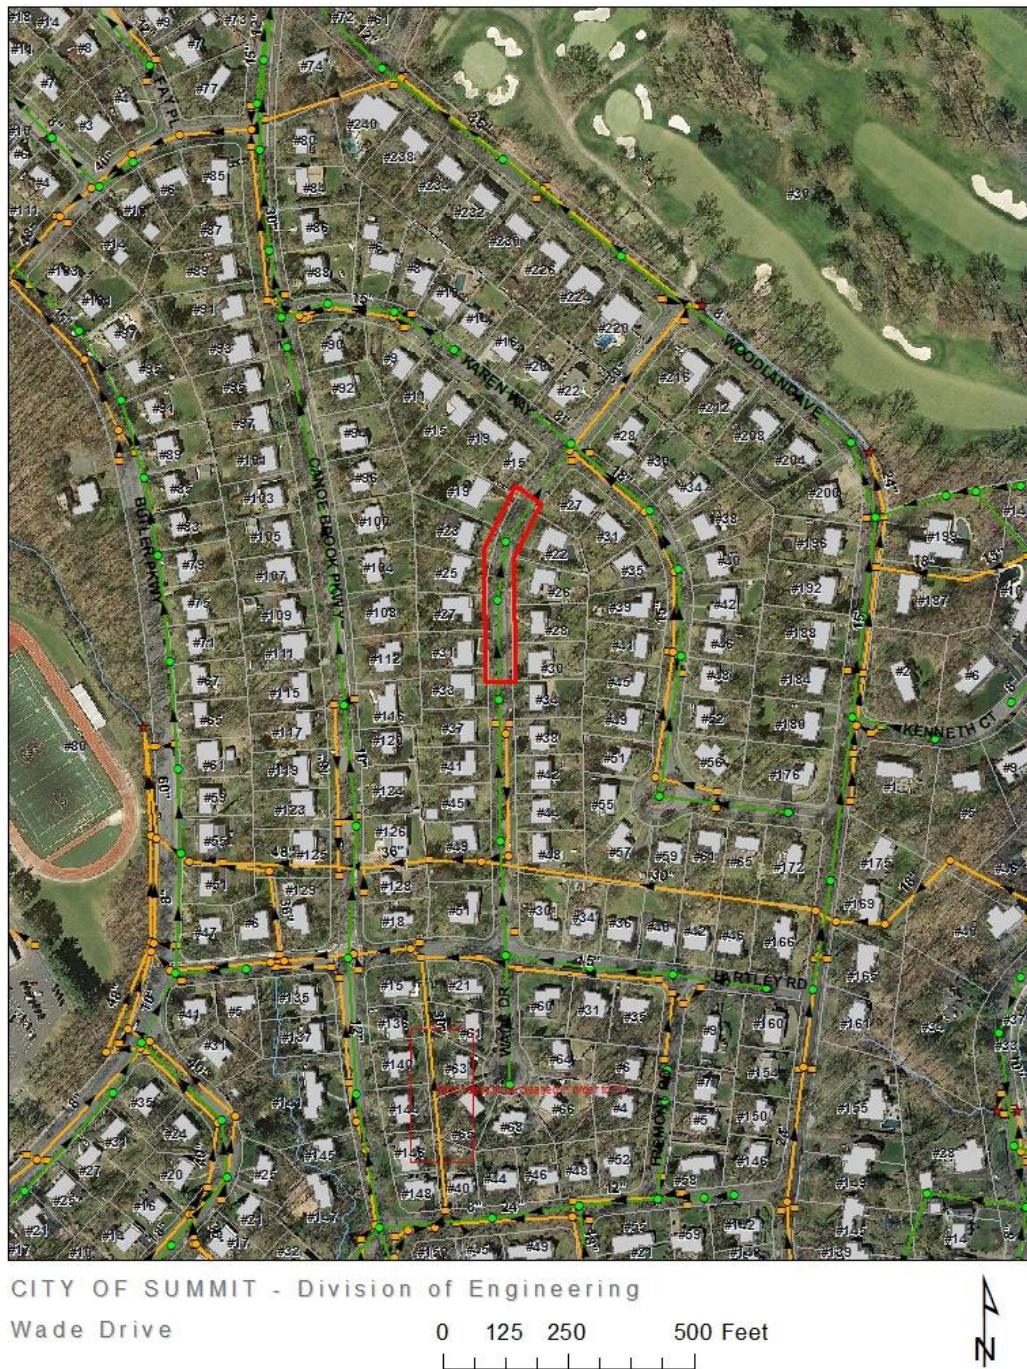
A Large Portion of Wade Drive is low lying and also has a lack of drainage structures which causes street flooding during high intensity storms. Although the street historically has had flash flooding issues related to the nearby Martins Brook, the addition of storm structures would significantly reduce the number of occurrences of flash floods.
