**City of**  
**Summit**

**City Wide**

**Drainage**

**Assessment**

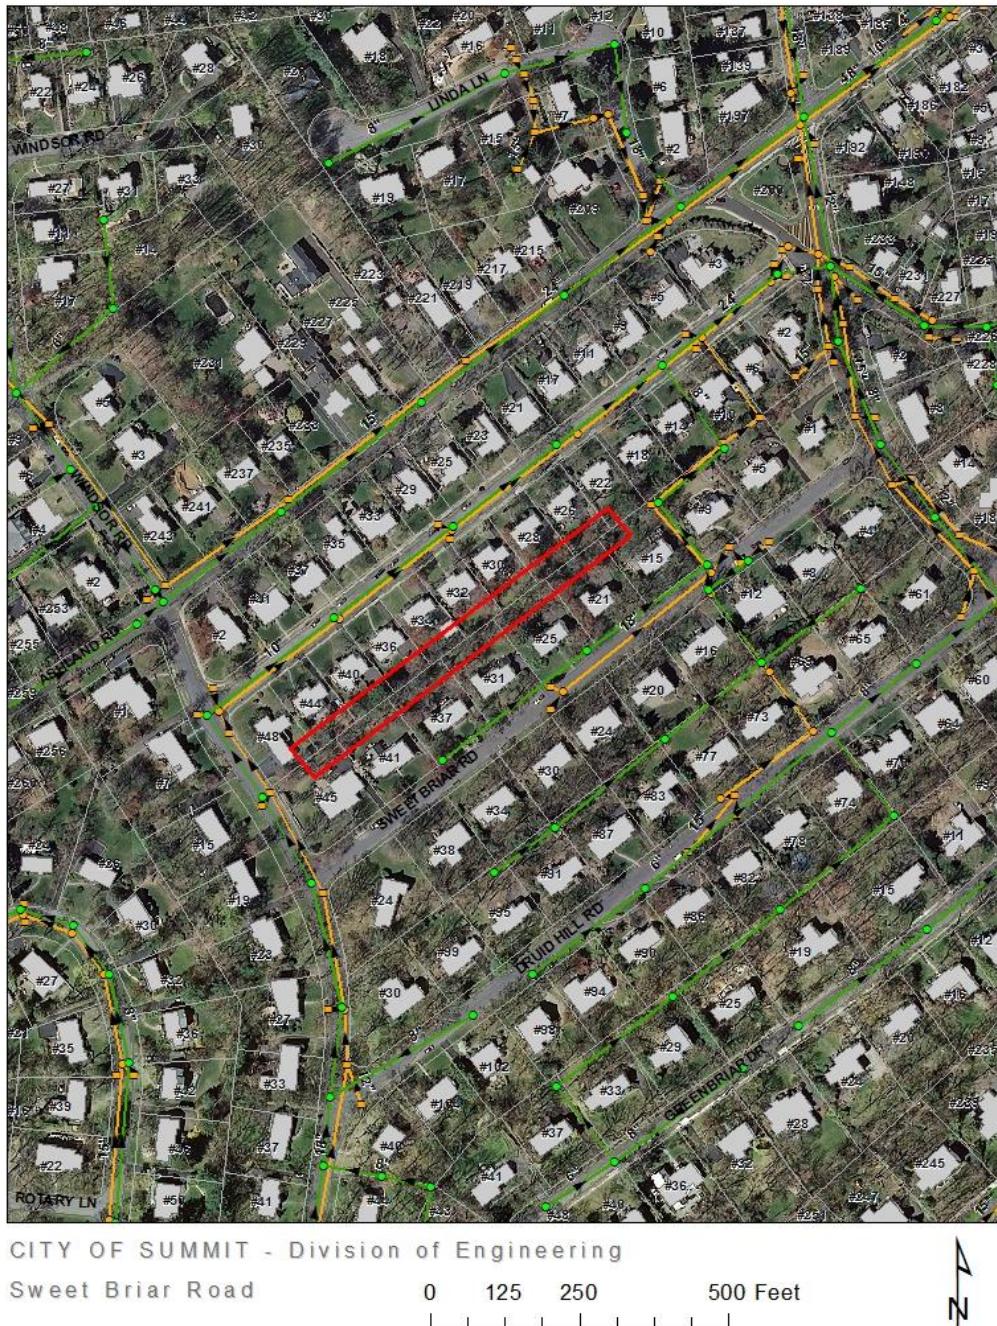
An old stream/brook used to flow at the rear of the properties between Sweet Briar Road and Plymouth Road. Easements were obtained by the properties along the rear during the subdivision process and a small low flow storm pipe was installed. Previously there has been no maintenance or updates to this storm pipe. The City is working on incrementally upgrading the pipe along the rear.

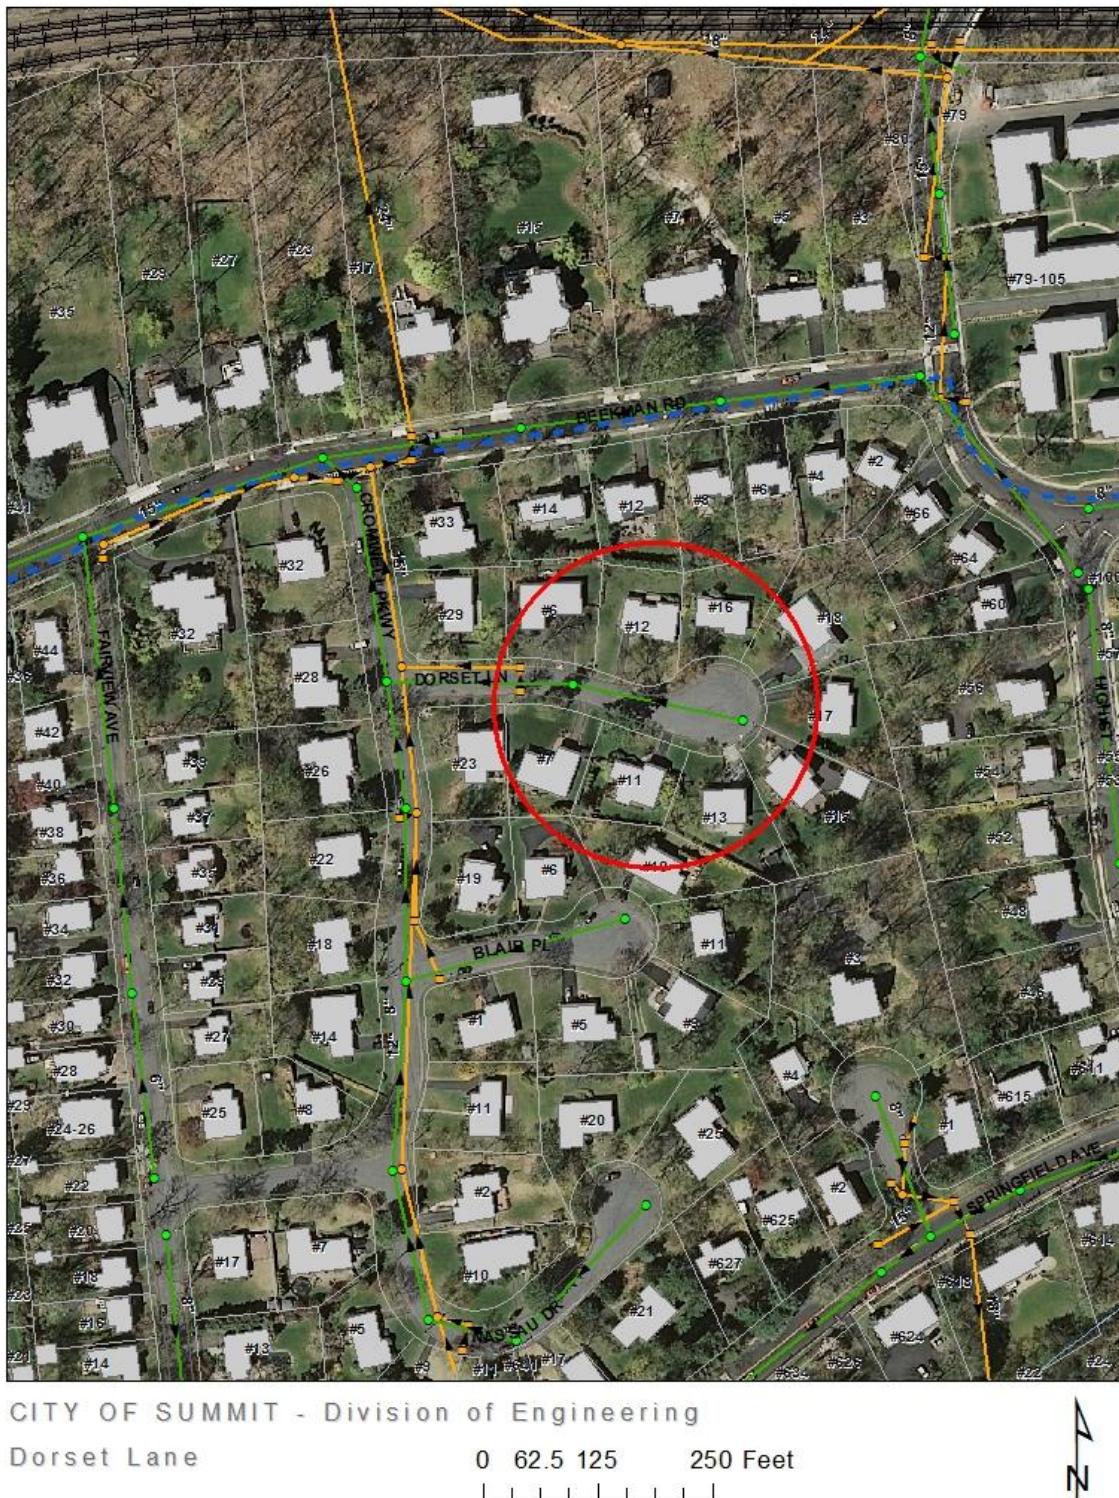
Icing conditions along Dorset Lane occur during the winter months. An additional storm sewer inlet to capture water draining from a low lying area may alleviate the condition.

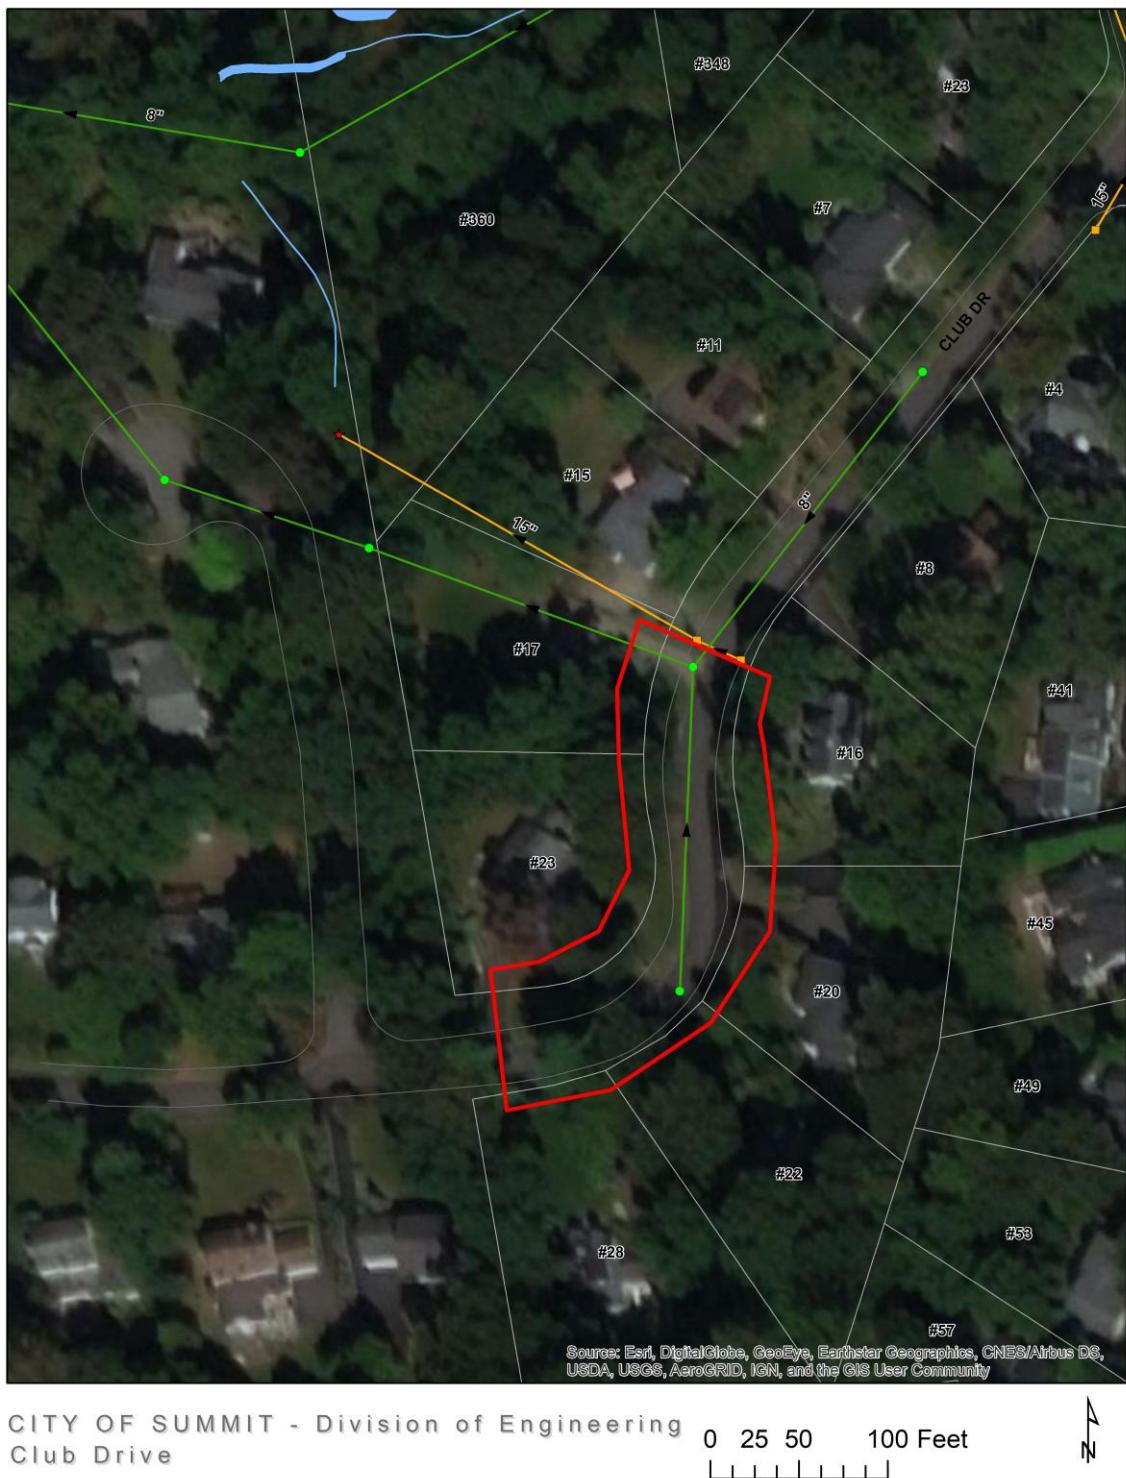
Icing conditions along Club Drive are caused by a ground water source. The extension of a storm sewer may prevent the building up of ice along the road.

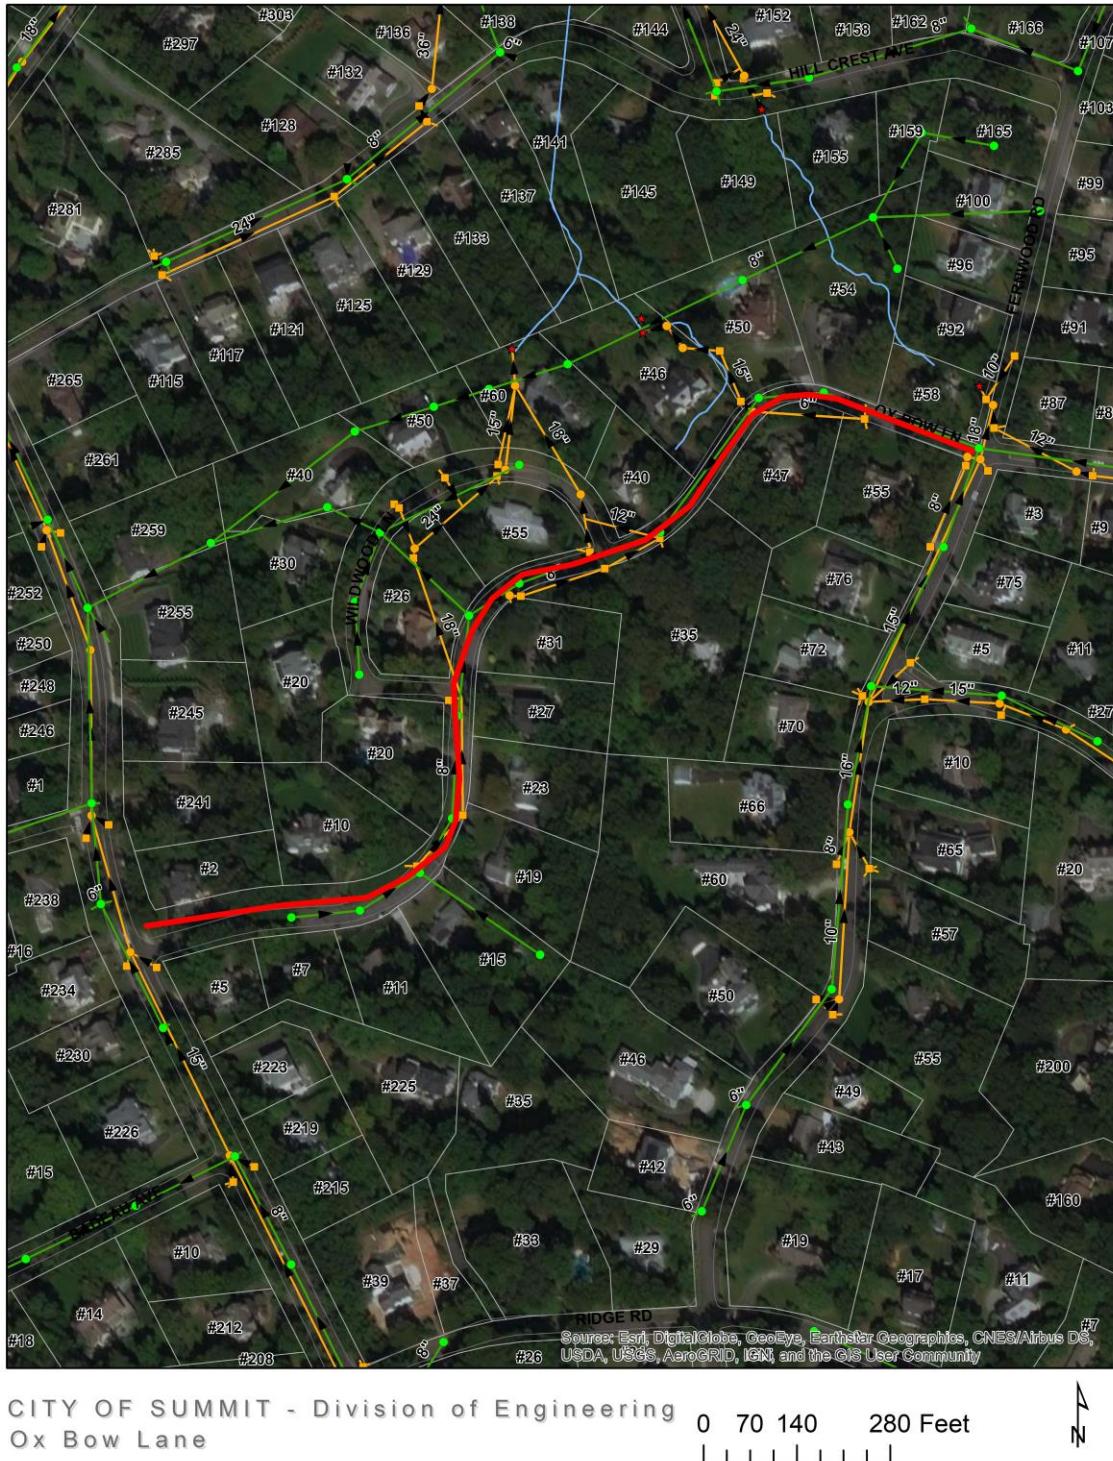
Deficient storm sewer infrastructure and poor pavement conditions cause ponding, icing and potholes along Ox Bow Lane. Additionally, existing storm sewer infrastructure runs along easements that need to be inspected and updated. Inlets should be added in various locations. All of the work can be accomplished as part of a road capital improvement.

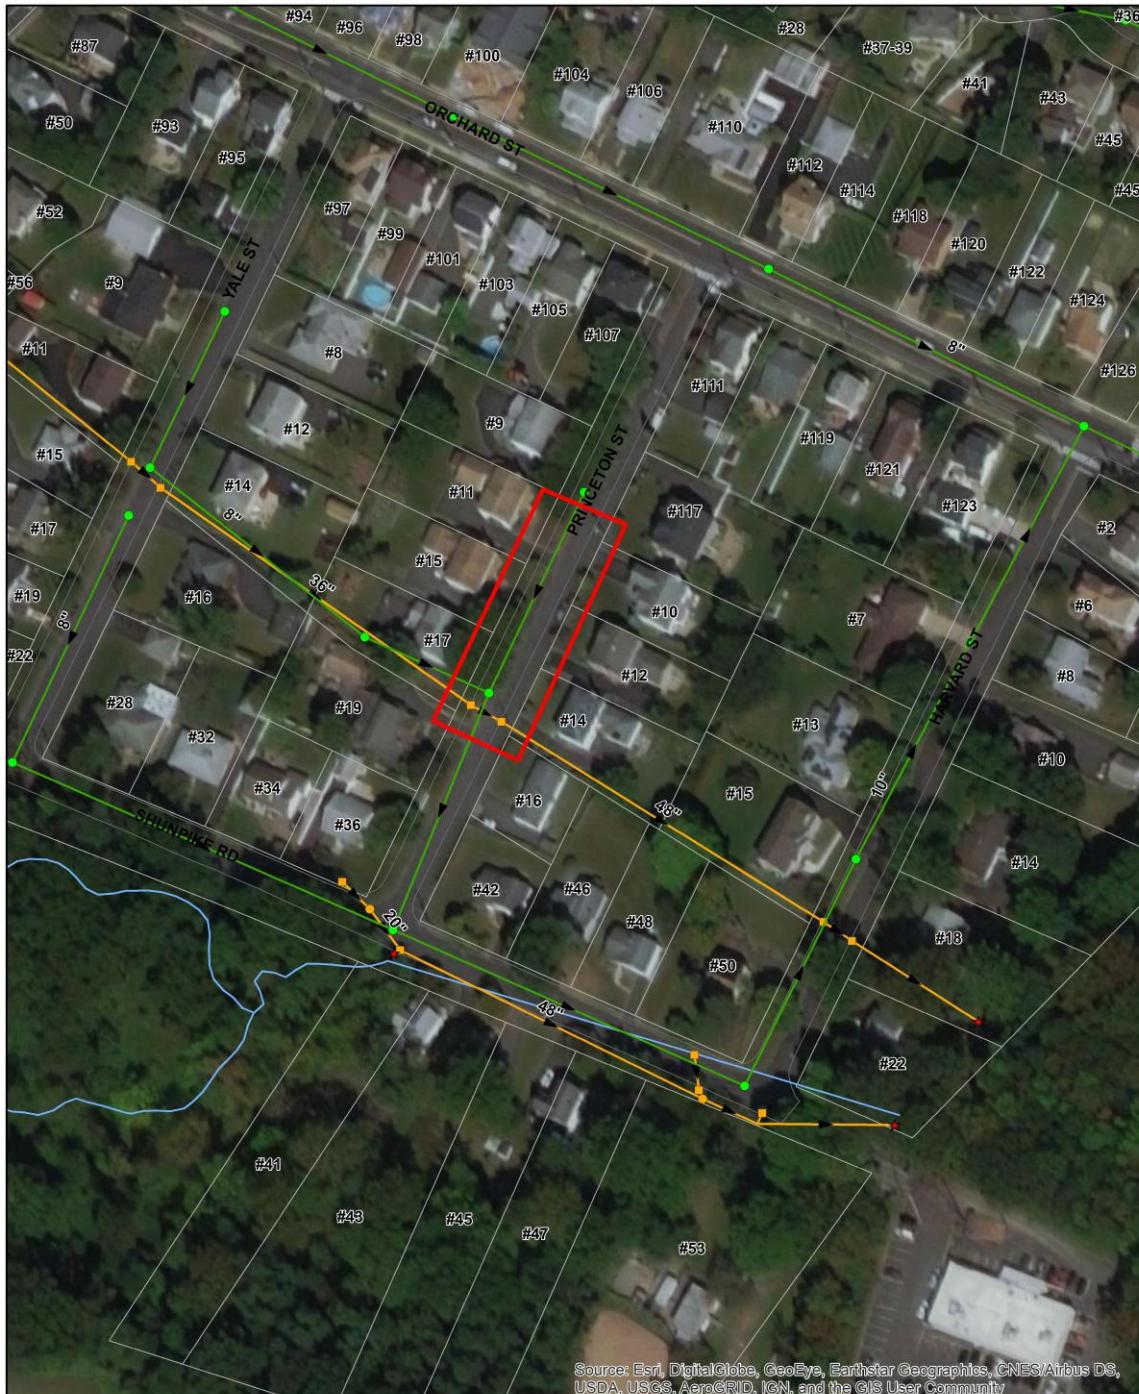
CITY OF SUMMIT - Division of Engineering  
Princeton Street

A low lying area towards the center of Princeton Street causes storm water to slowly drain towards to existing inlet. During cold temperatures, the water freezes before it reaches the inlet. During other periods where the water does not evaporate as quickly, the water has been seen ponding for days. An additional inlet, approximately 100 feet east of the existing inlet would alleviate this problem.

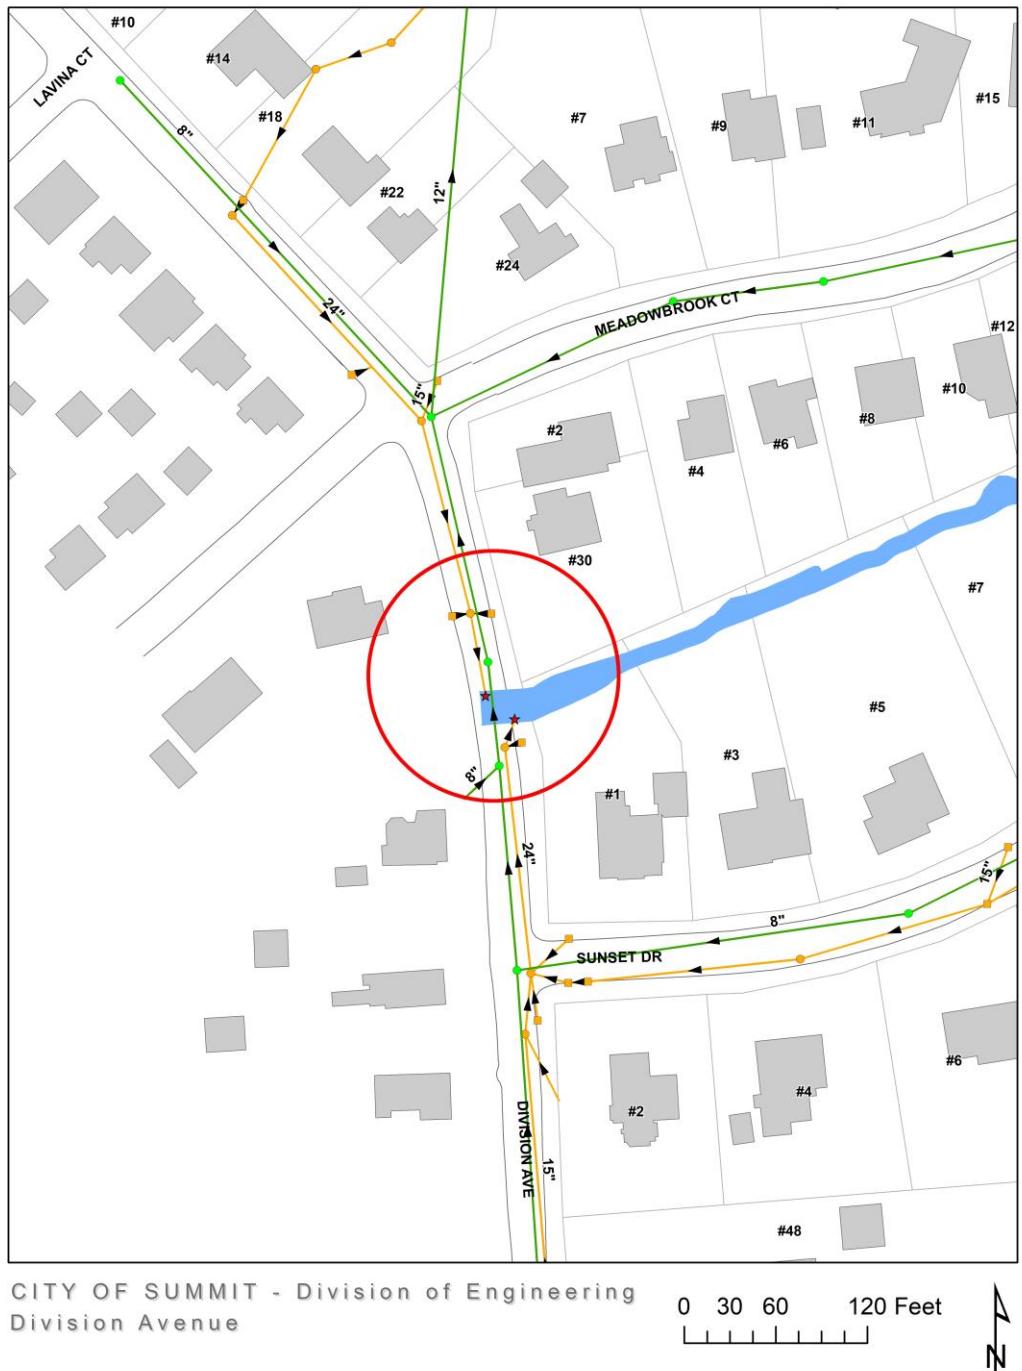
The Division Avenue Bridge is a Union County owned and operated bridge structure located on Division Avenue between Meadowbrook Court and Sunset Drive. Below the bridge at the stream bed lies a City of Summit operated Sanitary Sewer pipe that is slightly below the top of flowing water. This leads to a significant amount of debris that gets trapped at the pipe causing the backup of water onto private property. The Engineering Division is currently working on installing what is known as a trash rack to prevent debris from ever entering the bridge and allows for easier clean up.

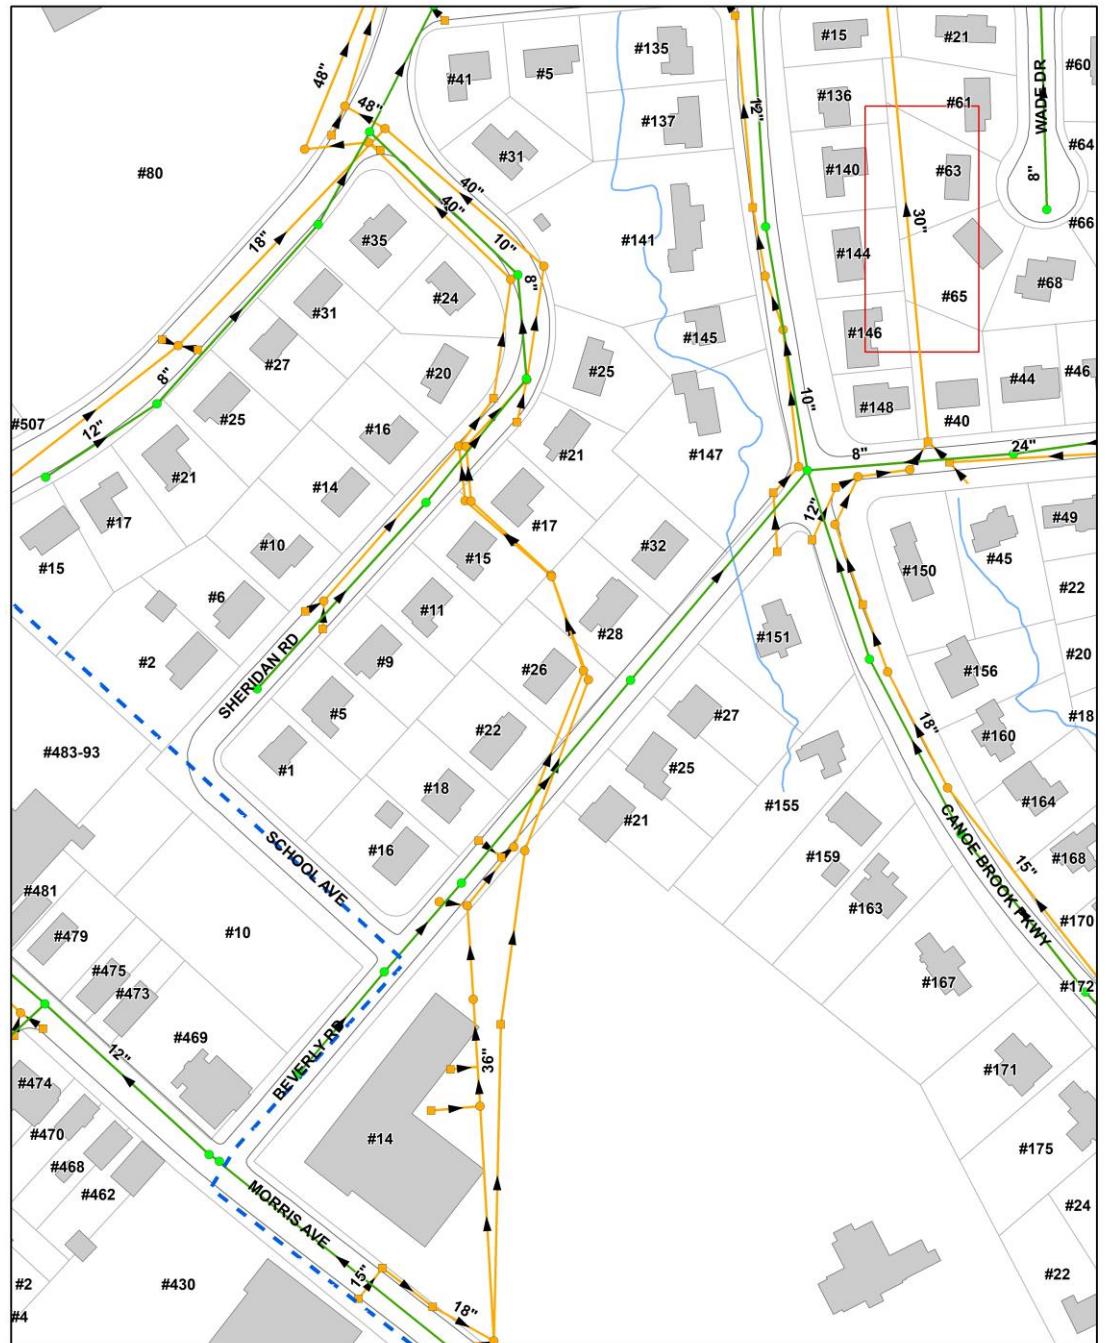
Beverly & Sheridan

The City owns and operates two large diameter storm sewers that run parallel between private property along easements between Beverly Road and Sheridan Drive. During heavy and intense rain fall, the manhole lids pop off the manhole frames and water shoots out under pressure. Water pressure build up through the pipes joints has caused damaged to a private driveway.
