# **PRELIMINARY INVESTIGATION**

## **BROAD STREET WEST, SUMMIT, NJ**

### **DATE: September 15, 2017**

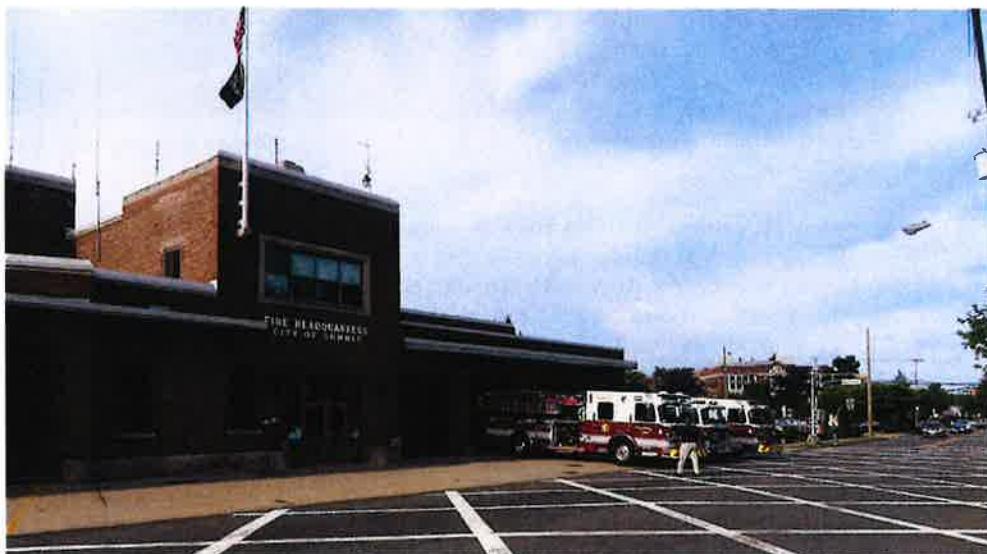
Image 4: Main Building Entrance

The front entrance is the only accessible entrance to the building. The Administrative Office entrance is located at the rear of the building, and there is a 9" step at the entrance door. This condition is unsafe; is not accessible; and is not compliant with current building codes. Two additional exterior doors are located in the rear courtyard that is accessed via steps from the Cedar Street parking lot. No handicap accessible parking spaces are provided on site.

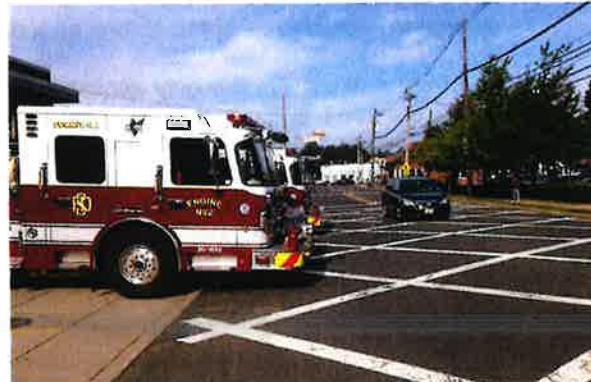
Image 5: Apparatus Bay Apron

The Apron at the Fire Headquarters building is only 20' to 24' wide, and as a result, the Fire Department must pull out and park the vehicles approximately 10' to 12' into Broad Street in order to complete the critical programmatic functions described above. The morning vehicle inspections typically occur from 8:00am-10:00am each day. During this time the pedestrian sidewalk is completely blocked and vehicular traffic must maneuver around the parked emergency vehicles through a narrowed bidirectional roadway. While on-site, the LEWA Team observed multiple pedestrians, including a woman with a baby in a stroller, forced to cross Broad Street at an unmarked location due to the sidewalk being blocked by the emergency vehicles. This condition is unsafe for pedestrians and vehicles on Broad Street and leaves the emergency response vehicles exposed to damage. (Reference Images 4 and 5)

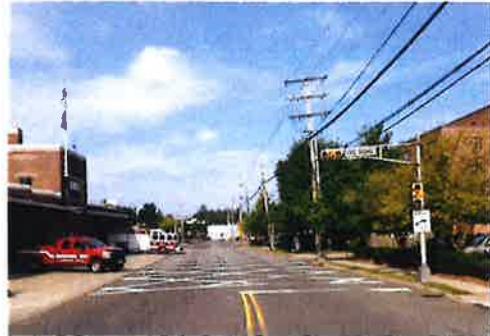
Image 6: Traffic Signalization

**Traffic Signalization.** The portion of Broad Street immediately in front of the Fire Headquarters building is painted with a diagonal cross-hatch pattern, and pole mounted traffic signals are provided at each end of the marked area to control traffic during emergency responses. On multiple occasions, the LEWA Team observed vehicles failing to yield during an emergency response, and on one specific occasion, an SUV proceeded through the marked area and swerved around the responding fire engine. (Reference Image 6)

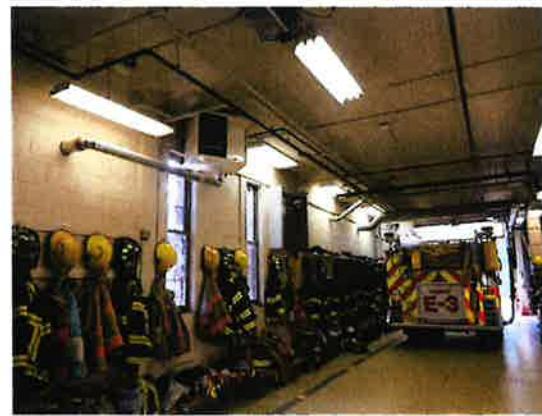
Image 16: PPE Storage

PPE (Personal Protective Equipment) refers to the protective gear worn by fire and rescue personnel. Cleaning and storage of this equipment is critical to the health of the building occupants and to the longevity of this very expensive equipment. The PPE gear is best stored in wire mesh lockers in a closed space (to protect against UV light exposure) adjacent to the Apparatus Bays, with an HVAC system specially designed to assist in drying wet gear and ventilating the space to exhaust the smoke and other

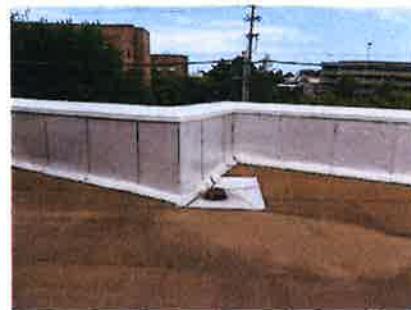
Image 21: Ponding on Low Slope Roof

The LEWA Team observed that the low-slope roof shows signs of insufficient roof slope and ponding of water on the roof membrane. This can shorten the life-span of the roof membrane and result in water infiltration. (Reference Image 21)

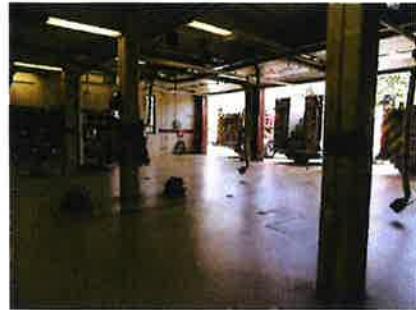
Image 22: Apparatus Bay Clearance Problems

As noted previously, insufficient storage is a significant issue throughout the Fire Headquarters building, and the storage issues are visible in the Bays. All wall surfaces

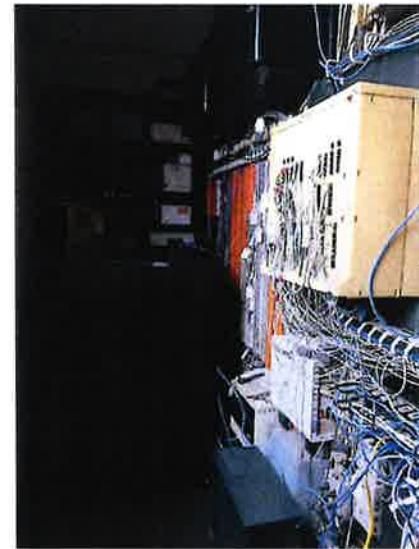
Image 30: Telecom/IT Room

**Telecom/IT Room.** The Telecom/IT Room is located in a closet in the Living/Dining Room. The room is small and the newest server rack blocks access to the equipment and panels on the rear wall. It appears that the systems and equipment have been added to over an extended period of time and that the size of the room is no longer adequate. A window unit air conditioner has been installed to provide cooling in this uninsulated east facing room. The LEWA Team noted signs of water infiltration around the window in the room and observed a temporary gutter pan and drain tube that had been installed at the window head. Fire Department staff confirmed that the exterior wall and window have experienced leaks in the past. With the significant role that telecommunications and IT serve in modern emergency response operations, a Telecom/IT Room must provide a secure, dry, and temperature controlled environment with appropriate room for equipment access and ventilation. (Reference Image 30)

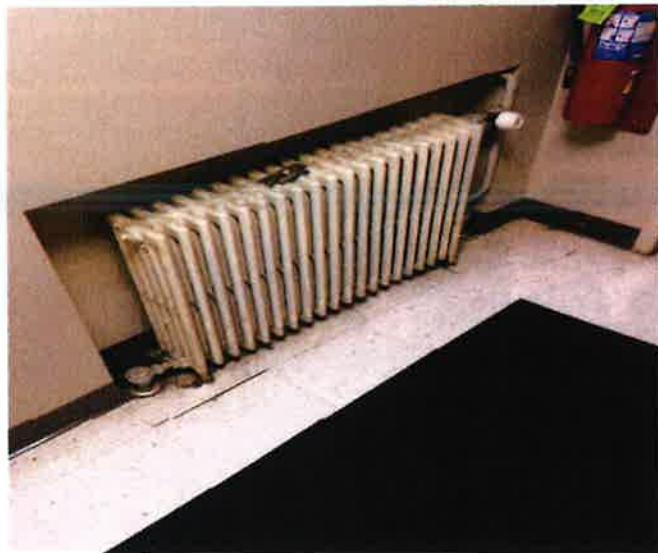
More recently, the boiler and steam heating system began to have multiple failures. To maintain and repair it was proving too costly for the fire department. So, per a 2010 design, the mechanical system was generally replaced in early 2011. The steam boiler and all of the hot water and steam terminal equipment were left abandoned in place. So there are numerous steam radiators, steam unit heaters and hot water convectors throughout the building abandoned and in varying states of disrepair.

*Abandoned Steam Radiator*
