**EXISTING FACILITY ASSESSMENT**  
**City of Summit Fire Headquarters**

September 30, 2014

**Purpose.** LeMay Erickson Willcox Architects (LEWA), under contract with the City of Summit, conducted an Existing Facility Assessment (EFA) for the City of Summit Fire Headquarters building located at 396 Broad Street in Summit, NJ. The Existing Facility Assessment was completed by a multi-disciplinary team conducting visual inspections of the existing building, systems, and equipment; review of existing building drawings, and interviews with Fire Department staff.

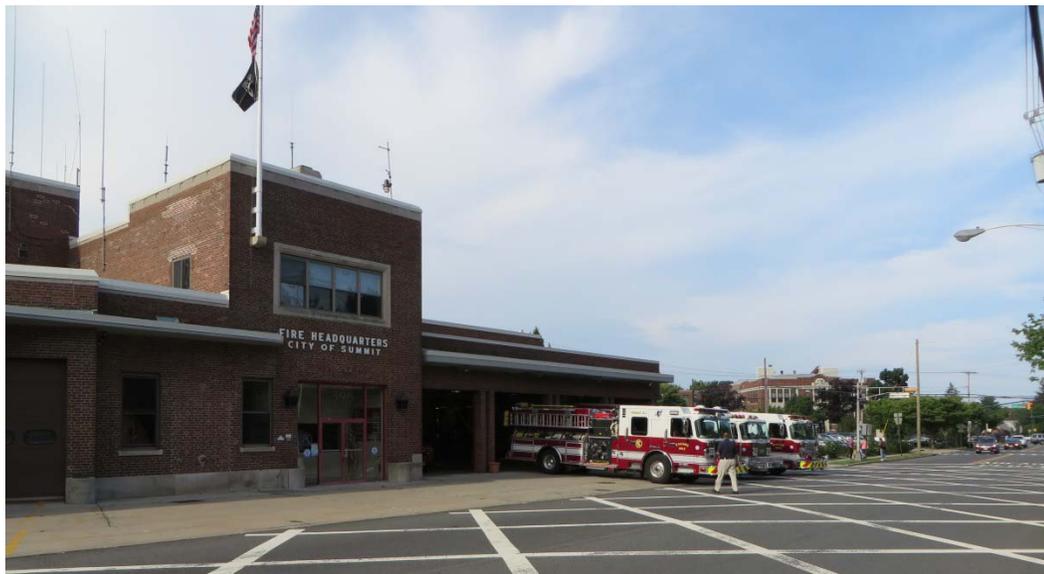
The front entrance is the only accessible entrance to the building. The Administrative Office entrance is located at the rear of the building, and there is a 9" step at the entrance door. This condition is unsafe; is not accessible; and is not compliant with current building codes. Two additional exterior doors are located in the rear courtyard that is accessed via steps from the Cedar Street parking lot. No handicap accessible parking spaces are provided on site.

Image 4: Main Building Entrance

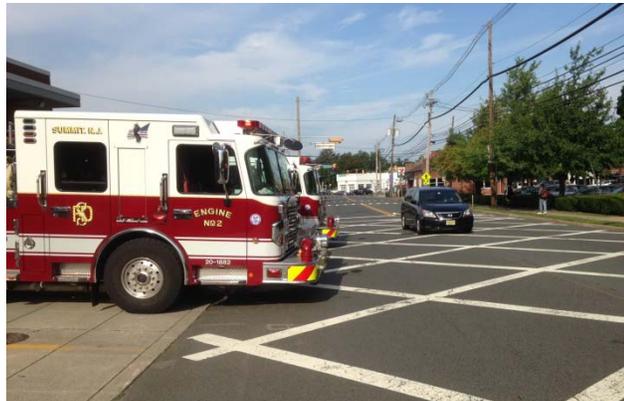
The Apron at the Fire Headquarters building is only 20' to 24' wide, and as a result, the Fire Department must pull out and park the vehicles approximately 10' to 12' into Broad Street in order to complete the critical programmatic functions described above. The morning vehicle inspections typically occur from 8:00am-10:00am each day. During this time the pedestrian sidewalk is completely blocked and vehicular traffic must maneuver around the parked emergency vehicles through a narrowed bidirectional roadway. While on-site, the LEWA Team observed multiple pedestrians, including a woman with a baby in a stroller, forced to cross Broad Street at an unmarked location due to the sidewalk being blocked by the emergency vehicles. This condition is unsafe for pedestrians and vehicles on Broad Street and leaves the emergency response vehicles exposed to damage. (Reference Images 4 and 5)

Image 5: Apparatus Bay Apron

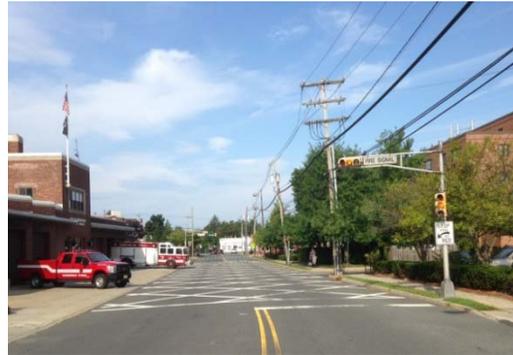
**Traffic Signalization.** The portion of Broad Street immediately in front of the Fire Headquarters building is painted with a diagonal cross-hatch pattern, and pole mounted traffic signals are provided at each end of the marked area to control traffic during emergency responses. On multiple occasions, the LEWA Team observed vehicles failing to yield during an emergency response, and on one specific occasion, an SUV proceeded through the marked area and swerved around the responding fire engine. (*Reference Image 6*)

Image 6: Traffic Signalization

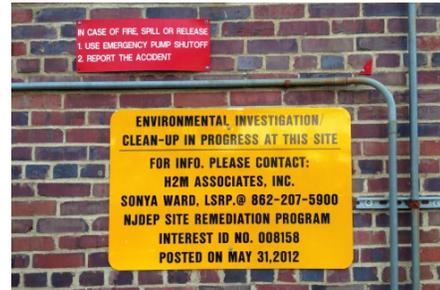
The LEWA Team observed a sign posted on the building over the fuel station stating that “Environmental Investigation / Clean-up in Progress at This Site”. The sign has a posted date of 5/31/2012. The LEWA Team has requested additional information regarding the environmental investigation from the posted point of contact, but no information has been received as of the preparation of this report. (Reference Image 9)

Image 9: Environmental Investigation Sign

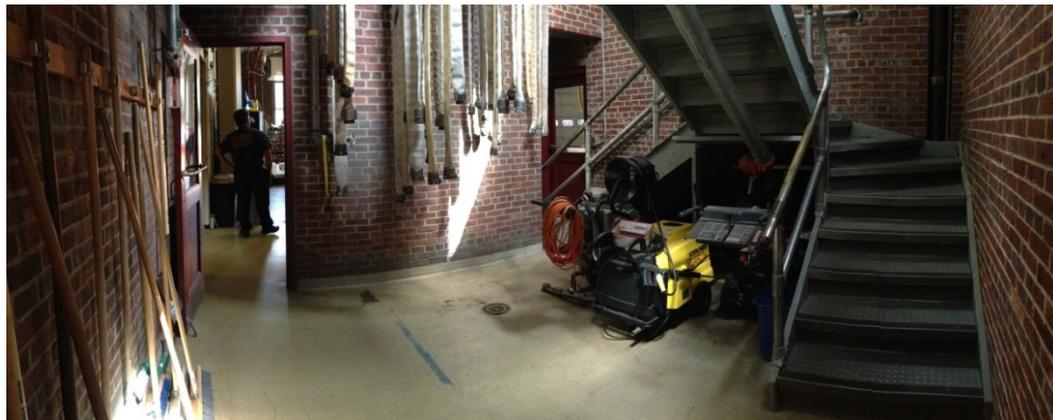
There are three stairs in the Fire Headquarters building. The Hose Tower stair is central in the building and serves as a primary circulation stair. The Hose Tower is also used to hang and dry fire-hoses; for training exercises; and to house several pieces of outdoor equipment such as a gasoline powered snow-blower. This multi-function use for a primary stair is typically not allowed as the other functions could potentially compromise the use of the stair as an egress path in an emergency. Also, the open stair and railings do not meet the design and safety requirements of the current building code. (*Reference Image 14*)

Image 14: Hose Tower

**Hose Tower.** As noted previously, the Hose Tower is central in the building and serves as a primary circulation stair. The Hose Tower is also used to hang and dry fire-hoses; for training exercises; and to house several pieces of outdoor equipment such as a snow-blower. The stair and railings do not meet the design and safety requirements of the current building code. *(Reference Image 14)*

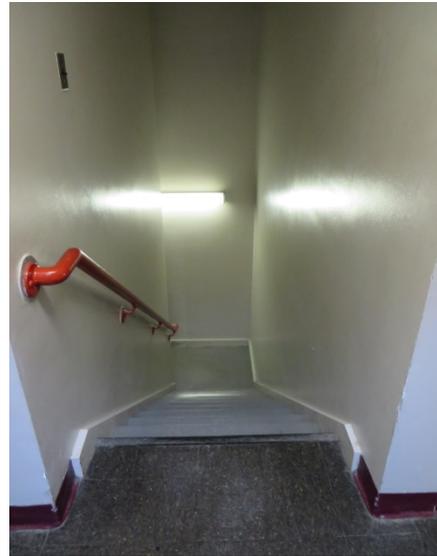
The Hose Tower stair is the only stair in the building with an exterior door. The other two stairs connect the second floor level to the Apparatus Bays, and both stairs require returning to the center of the building to reach an exterior door. This is counter to the intent of having at least two separate paths of egress in the event that one path is blocked. At Stair #1, near the Kitchen, there is a door at a mid-stair landing that is not large enough to provide adequate space on both sides of the door. It appears that the door was added to provide separation from the Apparatus Bays as there is no door at the top or bottom of the stairs, but the resulting condition is awkward and potentially unsafe. The LEWA Team heard from personnel that this stair is rarely used. Stair #2, nearest the Dormitories, only has handrails on one side. This is not compliant with current codes and is especially unsafe as this is the most direct emergency response path for firefighters sleeping in the dormitories. (*Reference Image 15*)

Image 15: Stair #2

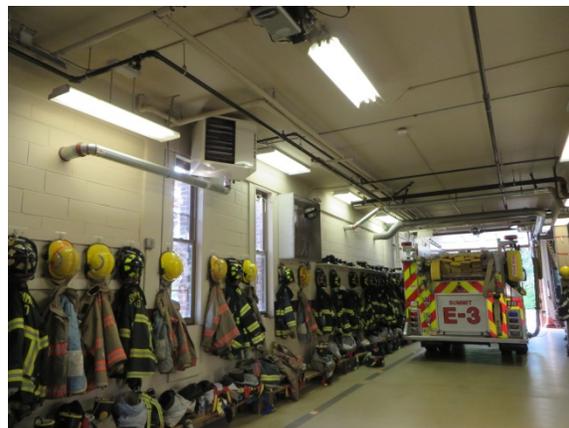
PPE (Personal Protective Equipment) refers to the protective gear worn by fire and rescue personnel. Cleaning and storage of this equipment is critical to the health of the building occupants and to the longevity of this very expensive equipment. The PPE gear is best stored in wire mesh lockers in a closed space (to protect against UV light exposure) adjacent to the Apparatus Bays, with an HVAC system specially designed to assist in drying wet gear and ventilating the space to exhaust the smoke and other

Image 16: PPE Storage

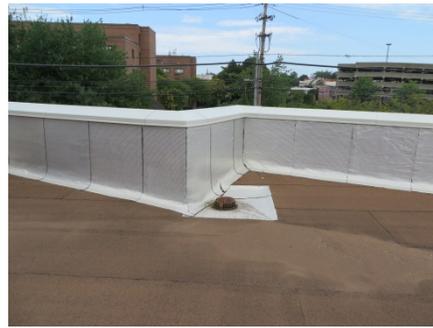
The LEWA Team observed that the low-slope roof shows signs of insufficient roof slope and ponding of water on the roof membrane. This can shorten the life-span of the roof membrane and result in water infiltration. (Reference Image 21)

Image 21: Ponding on Low Slope Roof

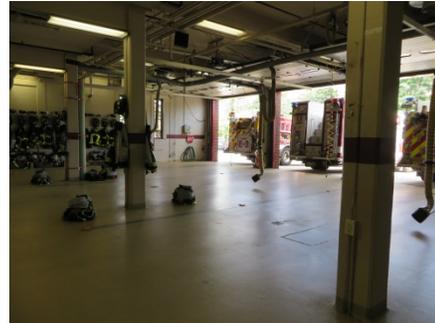
**Apparatus Bays.** The Fire Headquarters building has eight Apparatus Bays. The Bays are numbered from west to east, and the primary response vehicles are parked in Bays 1 to 4. Reserve vehicles are parked in Bays 5 to 7, and an antique Chemical Engine is kept in Bay 8. Bays 2 to 8 are back-in only. Bay 1 is longer and has drive-thru capability for the aerial ladder truck. As noted above, PPE (Personal Protective Equipment) gear is stored on the walls of the Bays exposing the Bays to off-gassing from the gear and exposing the gear to the conditions of the Bays. PPE gear is best stored in a well-ventilated, temperature and humidity controlled room that is immediately adjacent to the Apparatus Bays and is closed protected against UV light exposure. (Reference Image 22)

Image 22: Apparatus Bay Clearance Problems

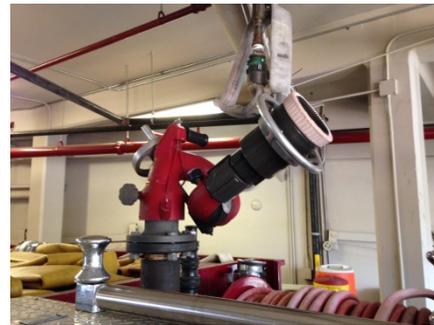
The clear height in the Bays is notably low. At one location, the LEWA Team observed that a water spray nozzle on top of one fire engineer was inches from the piping running across the ceiling. Preferably, the clear height should be 18' or more to allow the fire engine cab to be tilted forward and opened inside the Bays. (Reference Image 23)

Image 23: Apparatus Bay Clearance Problems

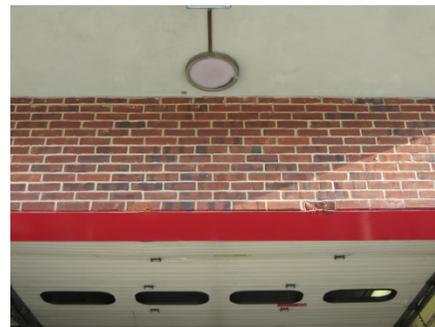
The Bay doors are small relative to current design standards and to the dimensions of the current vehicles. The doors in Bays 1-4 are 12' 2" wide and 11' 2" high. The doors in Bays 5-7 are 12' 0" wide and 11' 3" high, and the door in Bay 8 is 13' 2" wide and 13' 0" high. Current Apparatus Bay doors are often 14' 0" high and 14' 0" wide. Fire Department staff noted that the Apparatus Bay door height restricts the Fire Department's options when purchasing new apparatus as only select manufacturers make vehicles that will fit through the current Bay doors. The current aerial ladder truck has modified axels to help lower the overall truck height to allow it to fit into the Bays. The Bay door size has also caused problems with visiting or Mutual Aid vehicle from other fire stations which are too tall for the Bay doors. There are visible marks in the brick above Bay 1 where a vehicle from another station attempted to back in to the Bays. (Reference Image 24)

Image 24: Apparatus Bay Door Clearance Problems

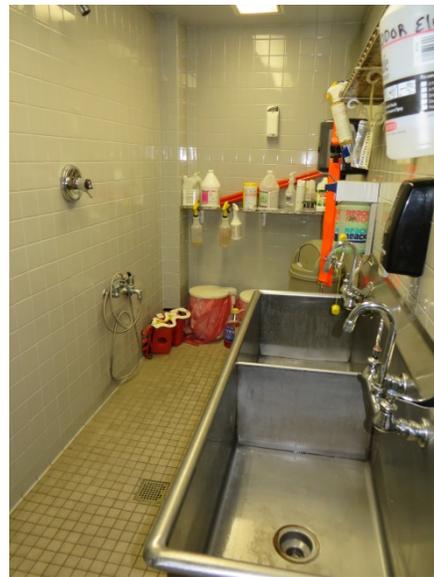
**Decontamination Room.** The Decontamination Room is located at the rear of the Apparatus Bays, and includes a long stainless steel wash sink, an emergency eye wash station, and standard shower. A bio-hazard trash receptacle is located in the room, and there is no closed storage. The contaminant control aspect of this room is compromised by a second door that connects to the Administrative Office men's restroom. *(Reference Image 25)*

Image 25: Decontamination Room

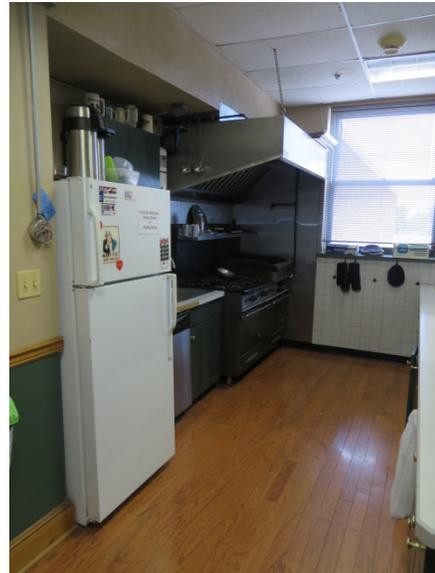
The Kitchen is adjacent to the Living/Dining Room and includes one residential refrigerator, a 6-burner commercial stove, and two microwaves. The Kitchen is small with minimal counter space and storage space. In fire stations such as this with rotating shift schedules, it is common to have dedicated refrigerators and dedicated pantry storage space for each shift. (*Reference Image 28*)

Image 28: Kitchen

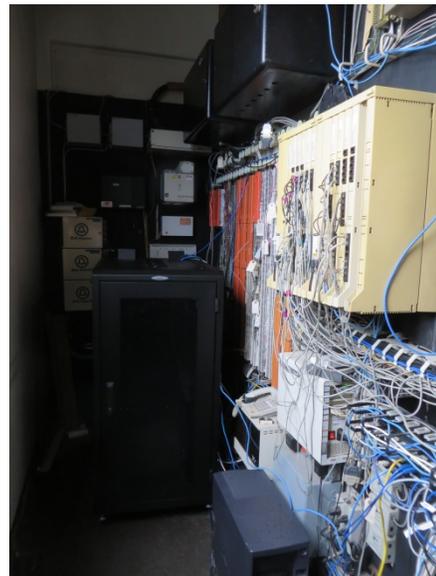
**Telecom/IT Room.** The Telecom/IT Room is located in a closet in the Living/Dining Room. The room is small and the newest server rack blocks access to the equipment and panels on the rear wall. It appears that the systems and equipment have been added to over an extended period of time and that the size of the room is no longer adequate. A window unit air conditioner has been installed to provide cooling in this uninsulated east facing room. The LEWA Team noted signs of water infiltration around the window in the room and observed a temporary gutter pan and drain tube that had been installed at the window head. Fire Department staff confirmed that the exterior wall and window have experienced leaks in the past. With the significant role that telecommunications and IT serve in modern emergency response operations, a Telecom/IT Room must provide a secure, dry, and temperature controlled environment with appropriate room for equipment access and ventilation. *(Reference Image 30)*

Image 30: Telecom/IT Room

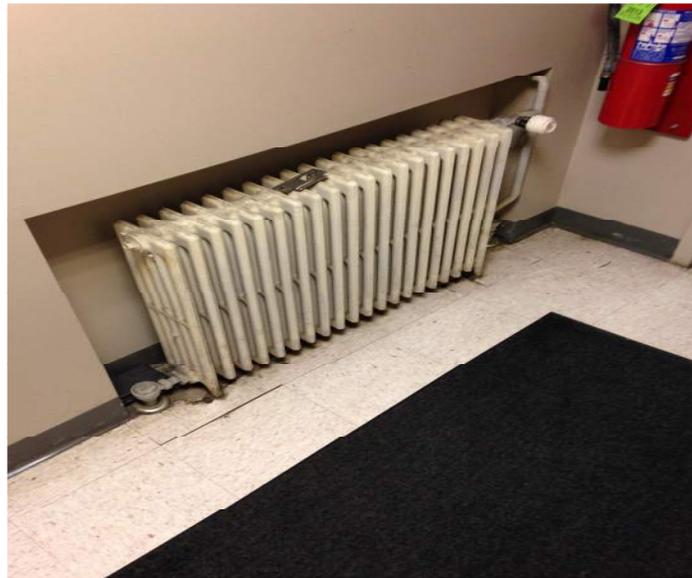
More recently, the boiler and steam heating system began to have multiple failures. To maintain and repair it was proving too costly for the fire department. So, per a 2010 design, the mechanical system was generally replaced in early 2011. The steam boiler and all of the hot water and steam terminal equipment were left abandoned in place. So there are numerous steam radiators, steam unit heaters and hot water convectors throughout the building abandoned and in varying states of disrepair.

*Abandoned Steam Radiator*
