**Re: Application for Development
90 Ashwood Avenue
Summit, New Jersey 07901
Block 4301, Lot 26**

November 28, 2022

**Re: 90 Ashwood Avenue
Summit, New Jersey
PBA Project No. I-5002**

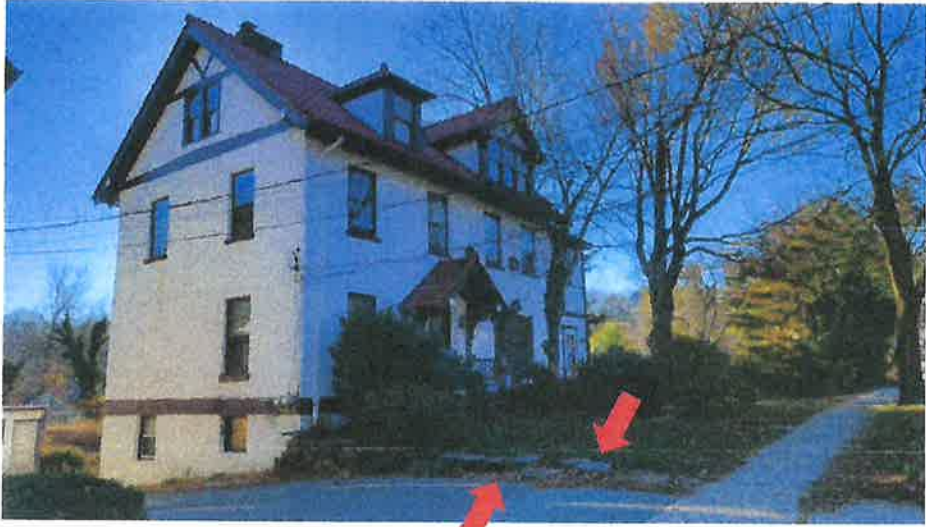
Photo No. 1

On November 22, 2022, at your request, a site visit was made to 90 Ashwood Avenue, Summit, NJ. The purpose of the visit was to visually examine the existing house and to determine what issues may be of the structure and other matters around the house. The house was reported to have been constructed in 1913 (Photo No.1). The house has two residential floors with an attic space that was not occupied. There is also an entire basement area. As the house was constructed on a fairly large sloping site the rear of the house is such that it is level with a single car garage at the rear of the house (Photo No.2). A relatively small retaining wall is on the left side of the house from the corner of the house to where the driveway meets with the sidewalk (Photo No. 1). It is easily seen that the retaining wall is of little ability to continue to hold the earth behind it as the blocks have started to shift (Photo No.3). At the rear of the house, there is a small deck with steps leading down to the driveway at the rear of the house. The condition of the deck and staircase is highly questionable (Photo No.4).

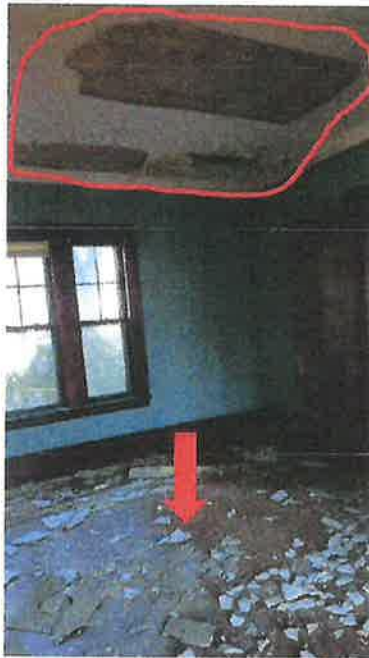
Photo No. 5

Entry into the house found numerous conditions that have deteriorated. At the rear of the house a portion of the ceiling on the first floor had collapsed partially due to water infiltration that could be seen along with other locations that do not appear to have failed due to water infiltration. Since the house is over 100 years old, showing that the security of the plaster is highly questionable (Photo No. 5). Observations within the house found that settlement has occurred causing windows to have been shifted out of its proper condition (Photo No.6). In the attic space it can also be seen that deflection has occurred over rear windows (Photos No.7 & No.8). Those windows on the exterior are in a highly deteriorated state and would need complete removal as are many of the windows around the house. The lintels above the windows

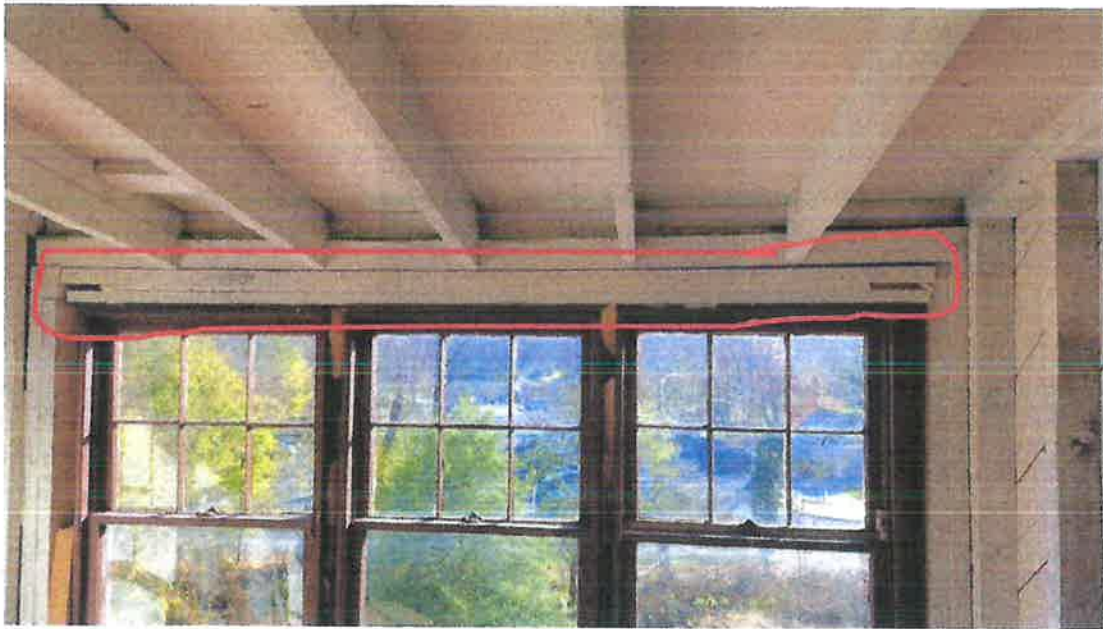
Photo No. 8

are also insufficient and would require full replacement (Photo No.8). The framing of the attic is very questionable as there is little to no restraint from lateral forces that are exerted on the exterior walls when snow covers the existing roof (Photo No.9). Observations around the house found other locations where deflection had occurred such as causing cracks in bathroom tiles (Photo No.10). Making observations around the house also found that another ceiling is not level and have some water infiltration (Photo No.11).

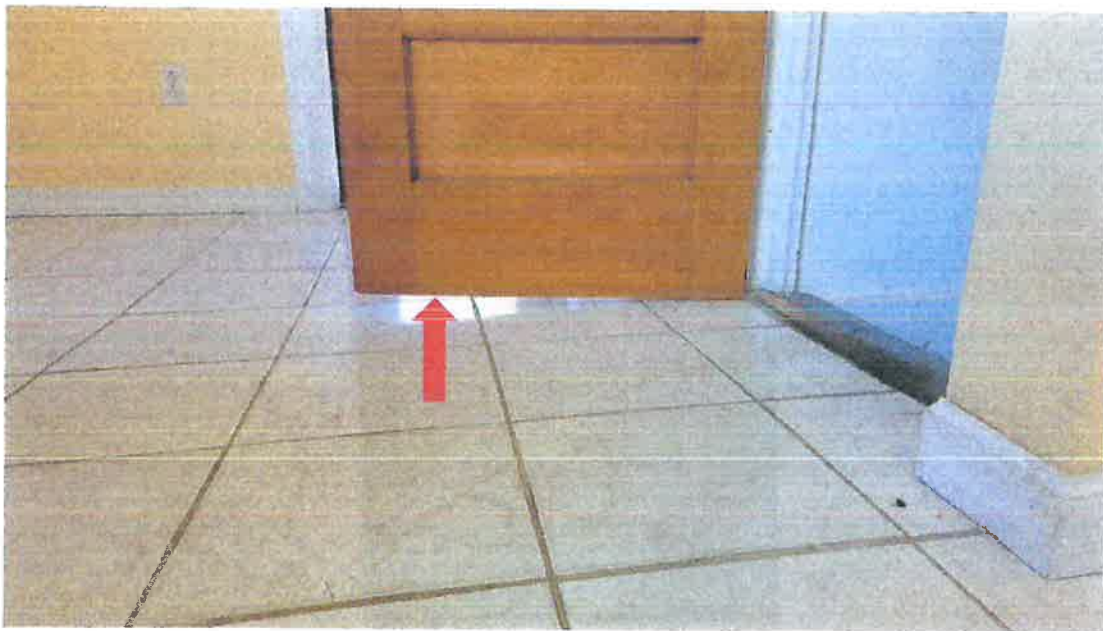
Photo No. 12

In other locations around the house, the settlement of the floor is easily seen (Photos No.12 and No.13). Observation in the basement area noted in some locations that water had come into the space (Photo No.14) along with various random routing of electrical services along with what appears to be a crack in the first floor above the location adjacent to the water heater (Photo No.14). One corner of the garage also appeared to be suffering from settlement (Photo No.15). Also on the exterior of the house, the gutters can be seen to be completely deteriorated (Photo No.16). In other locations around the house deteriorated roofing and wood framing could be easily found (Photo No.17).
