# **CITYWIDE DRAINAGE ASSESSMENT REPORT**

**Department of Community Services  
Engineering Division**

**November 2012**

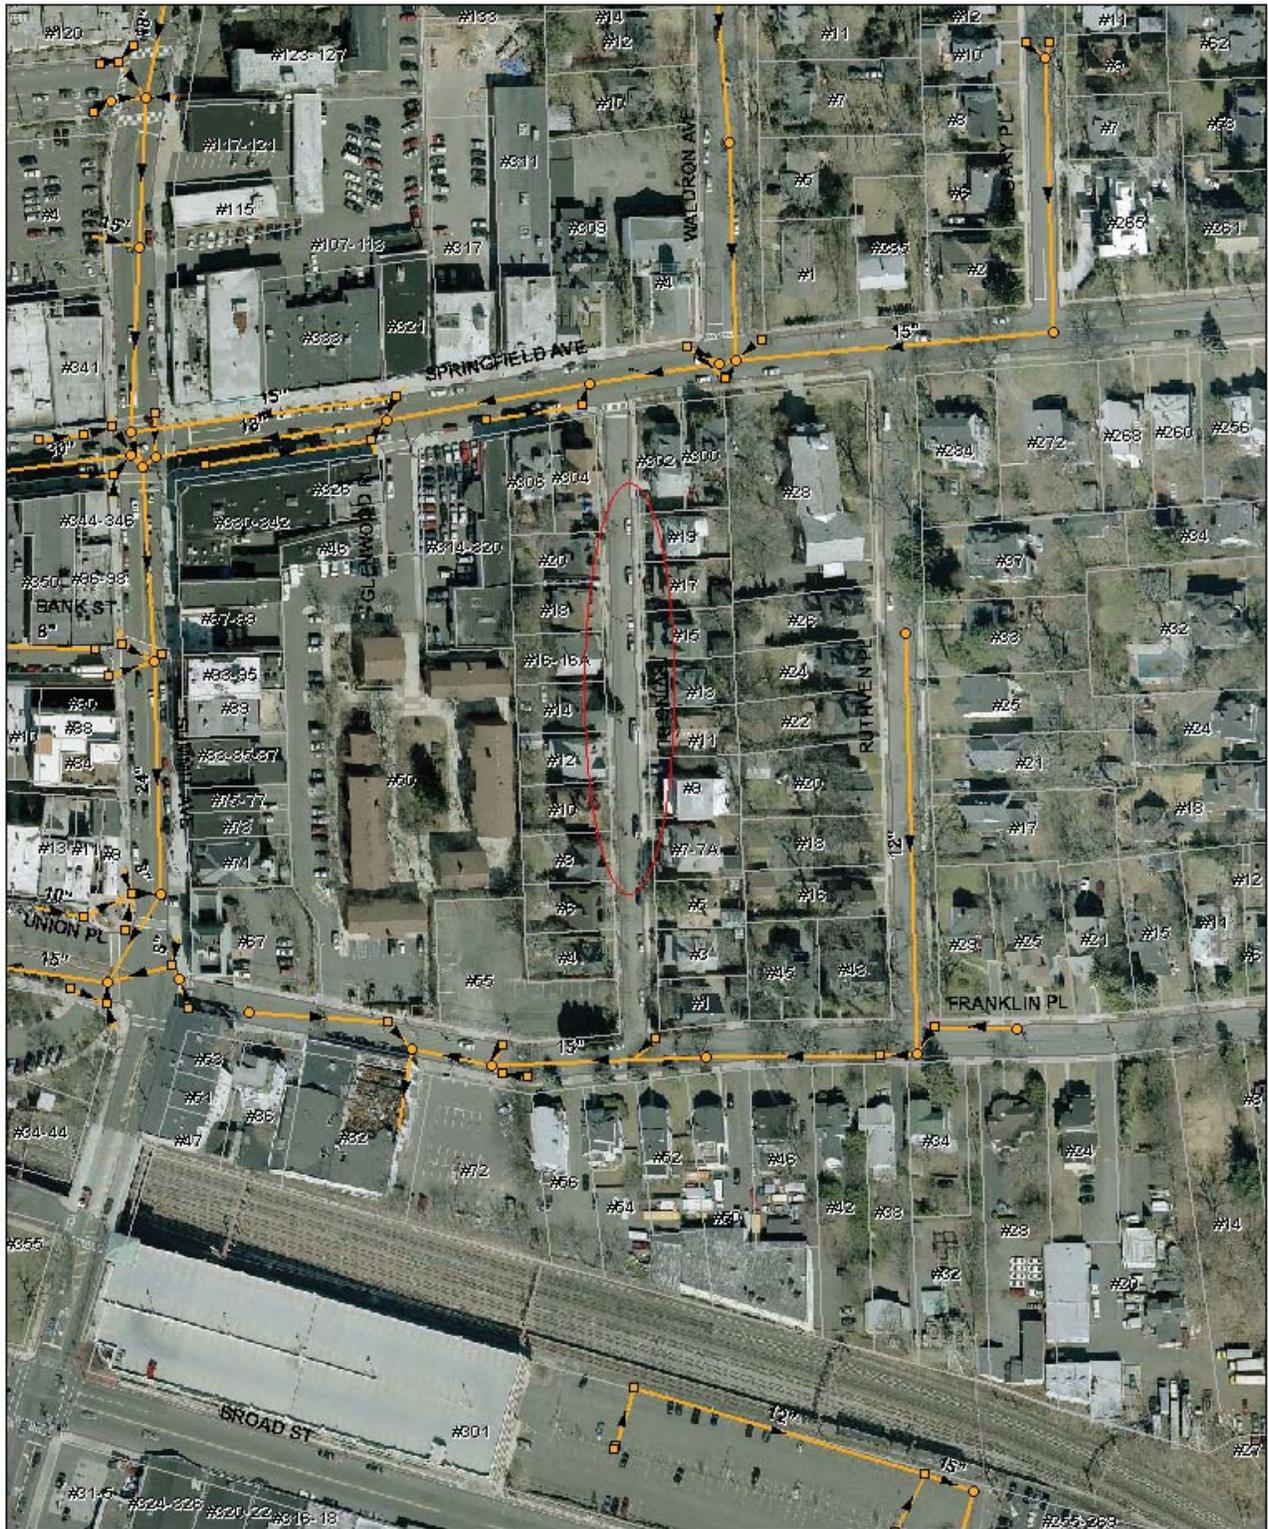
# WALDRON AVENUE

The drainage system within Waldron Avenue consists of several undersized pipes with inadequate slopes. During significant rain events, surcharging of the storm sewer floods the street and then overtops the sidewalk and floods several private structures and properties near 12-14 Waldron Avenue and across the street.

The hydraulic restriction that existed within the storm sewer at Springfield Avenue was removed which nearly doubled the capacity of the existing storm sewer. To further reduce runoff directed to this drainage system, the City is working with the County to implement a drainage project that will extend a storm sewer on Summit Avenue. This project complements two projects previously completed. The Whittredge Avenue Drainage Project (2007) and the Hobart Avenue Project (2009). Cumulatively, these projects will reduce the drainage area to Waldron Avenue by approximately 16 acres. The existing drainage within Waldron Avenue was approved in the 2012 Capital Plan.

- Design and construct the proposed storm sewer on Summit Avenue to further reduce runoff contributing to the Waldron Avenue system. (Winter 2012-2013)
- Reconstruct the intersection of Whittredge Road and Fernwood Road, install curbing and drainage within Waldron Avenue, and paving of Whittredge Road and Waldron Avenue. (Summer 2013)
- Complete Drainage construction along Summit Avenue to further reduce runoff quantity in the Waldron Avenue System. (Summer 2013 as part of the Waldron Avenue Project).

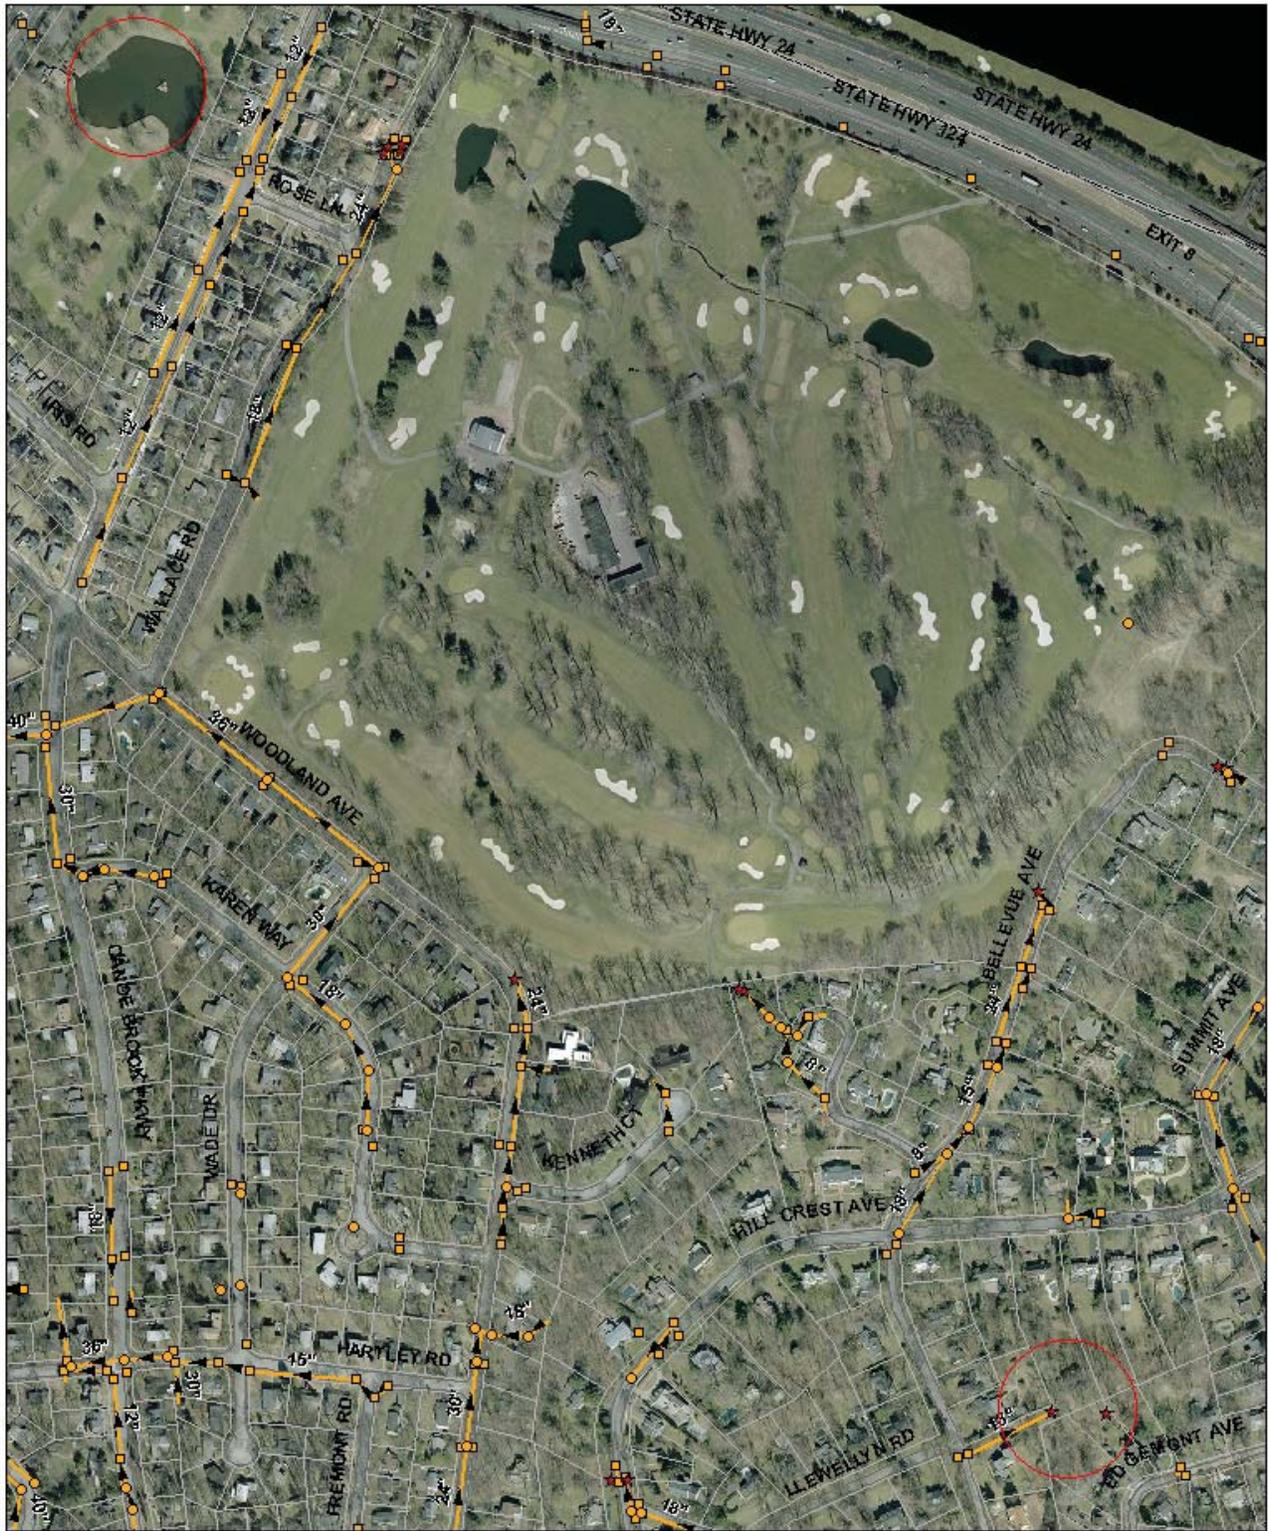
55 BELLEVUE & GOLF COURSE POND

In the area of the former Lyric Lane, the City storm sewers discharge onto private property in a low lying area in the center of Block 2006. Drainage then flows under an old railroad berm into a 100 year old clay pipe through private property. Eventually this drainage flows into the Canoe Brook Country Club golf course, through a culvert at Wallace Road, another culvert at Canoe Brook Parkway and into the pond at the City's Golf Course.

The existing dam at the Golf Course Pond has been analyzed to evaluate what improvements can be completed to the dam and pond to increase capacity of the drainage watershed. The next step will be to propose projects based on the report while working with the Department of Community programs and their Master Plan for the golf course. All options will most likely have high construction costs and be multi-year projects. The design will begin at the beginning of 2013.

Currently, drainage improvements to Bellevue Avenue are under construction. This project will upgrade the existing drainage system within Bellevue Avenue and install a new system where drainage is currently lacking. This project will greatly reduce flooding within Bellevue Avenue and will be followed by the reconstruction of the road in 2013.

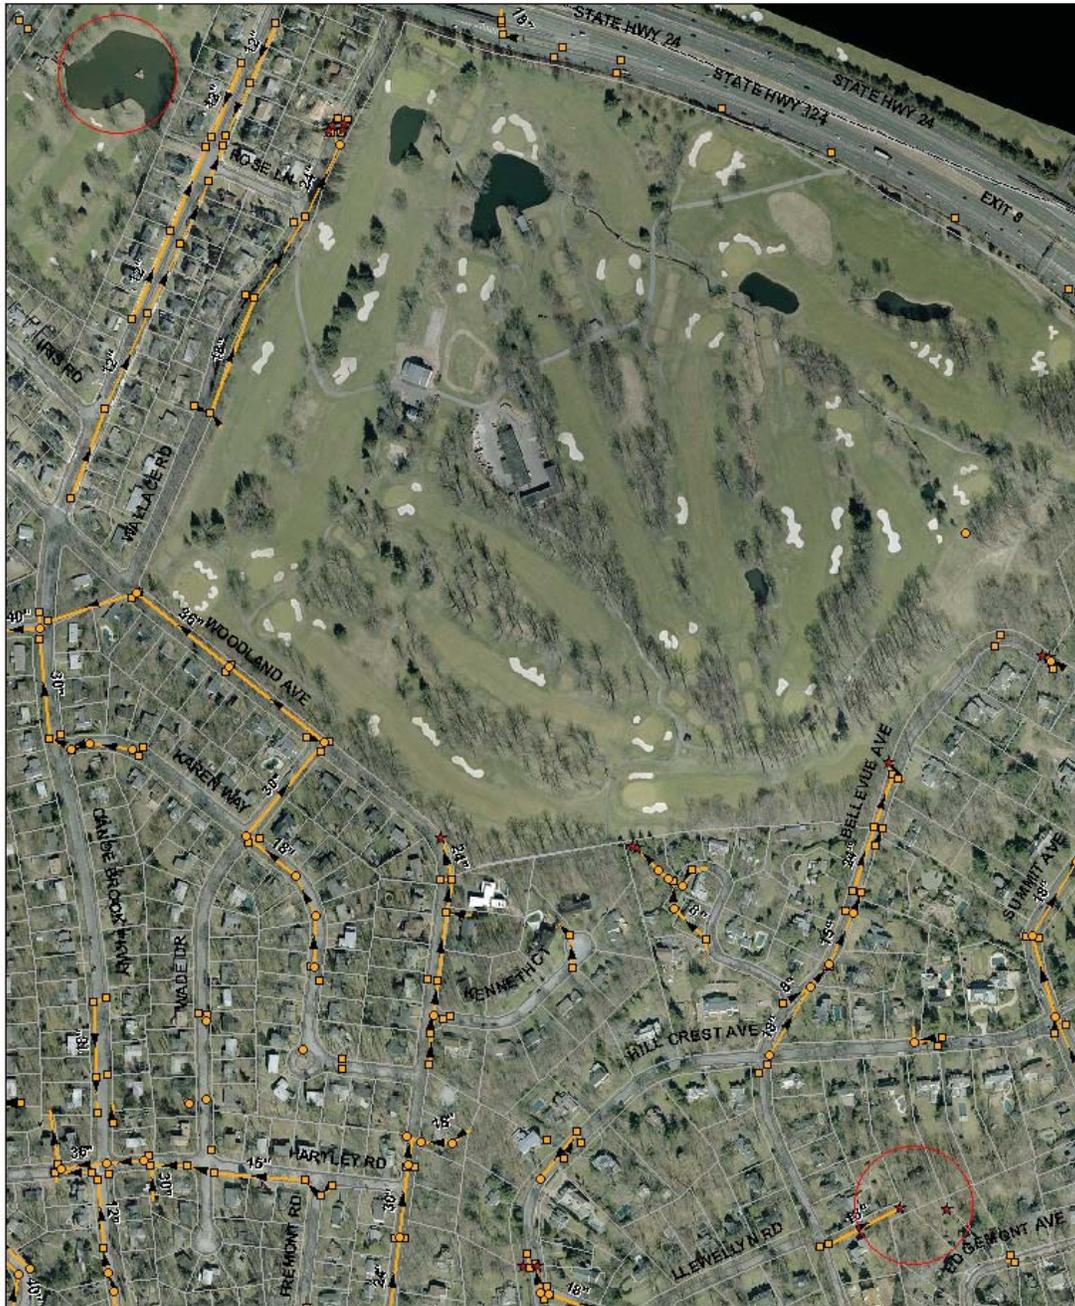
55 BELLEVUE & GOLF COURSE POND

Residents that live along the stream on Canoe Brook Parkway and Wallace Road experience flooding. In order to reduce the occurrence of flooding in this area the spillway for Golf Course Pond at the Municipal Golf Course must be redesigned. Any increase in flow will alleviate upstream flooding by increasing the size of the weir at the Golf Course and by raising the elevation of the low chord of the pedestrian bridge in the Golf Course. Both contribute to restricting flow upstream and flooding. Design for both will begin in 2013.

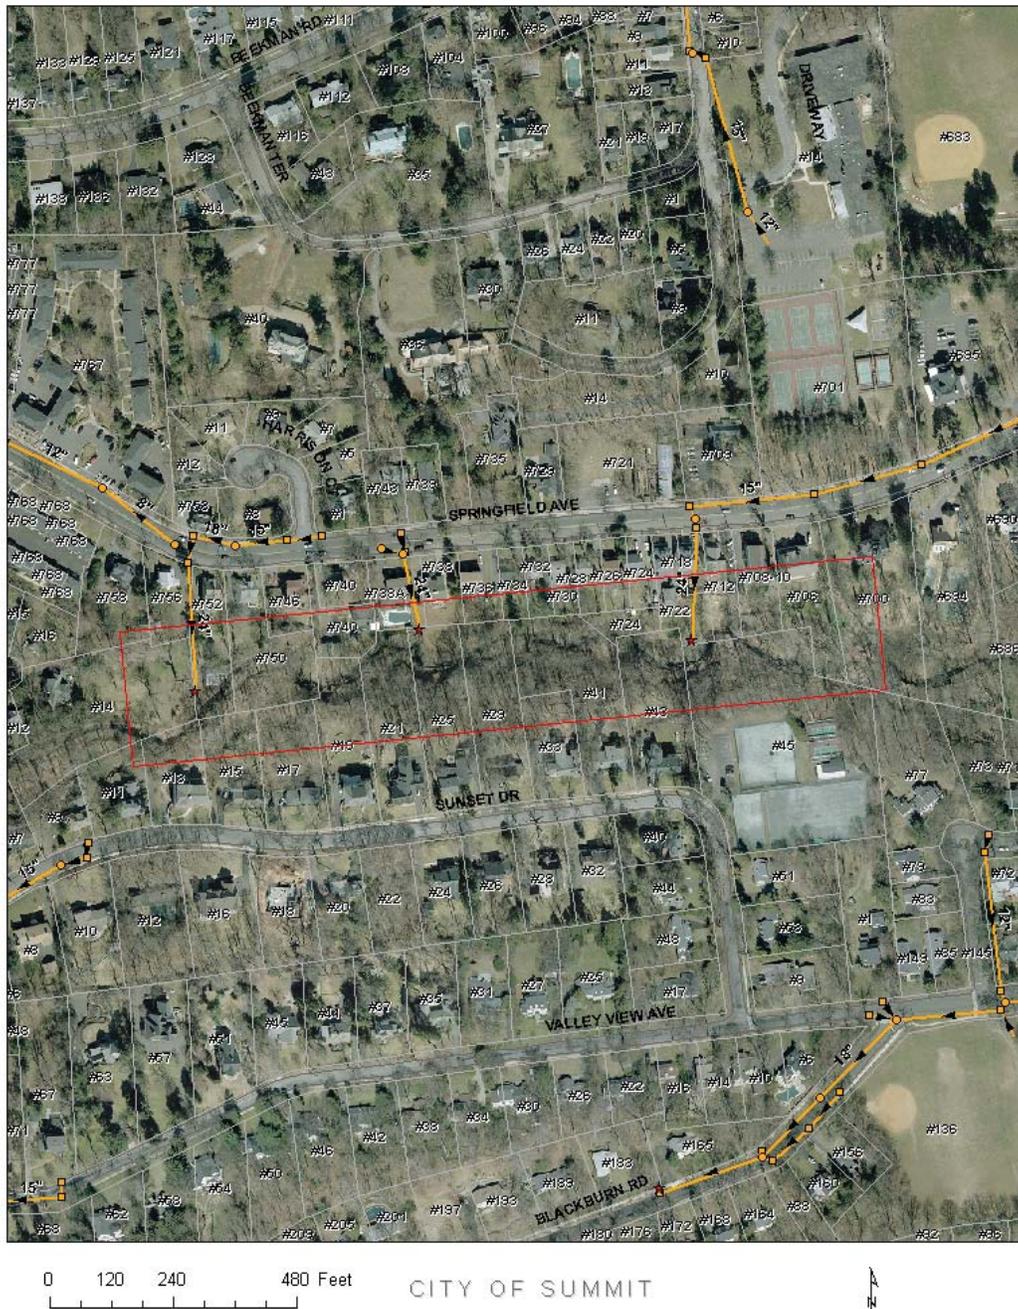
SALT BROOK EROSION

Erosion is evident along the banks of the Salt Brook and private properties flood during heavy storms. The Division has begun discussions with the most affected residents and a consulting Engineer hired by a resident. An investigation into the responsibility of the maintenance of the stream is underway. A neighborhood information meeting will be held in the winter of 2013. A survey of the Brook along portions that are City property has been requested and is currently being prepared. A full evaluation and recommendation will be completed during the first quarter of 2013.

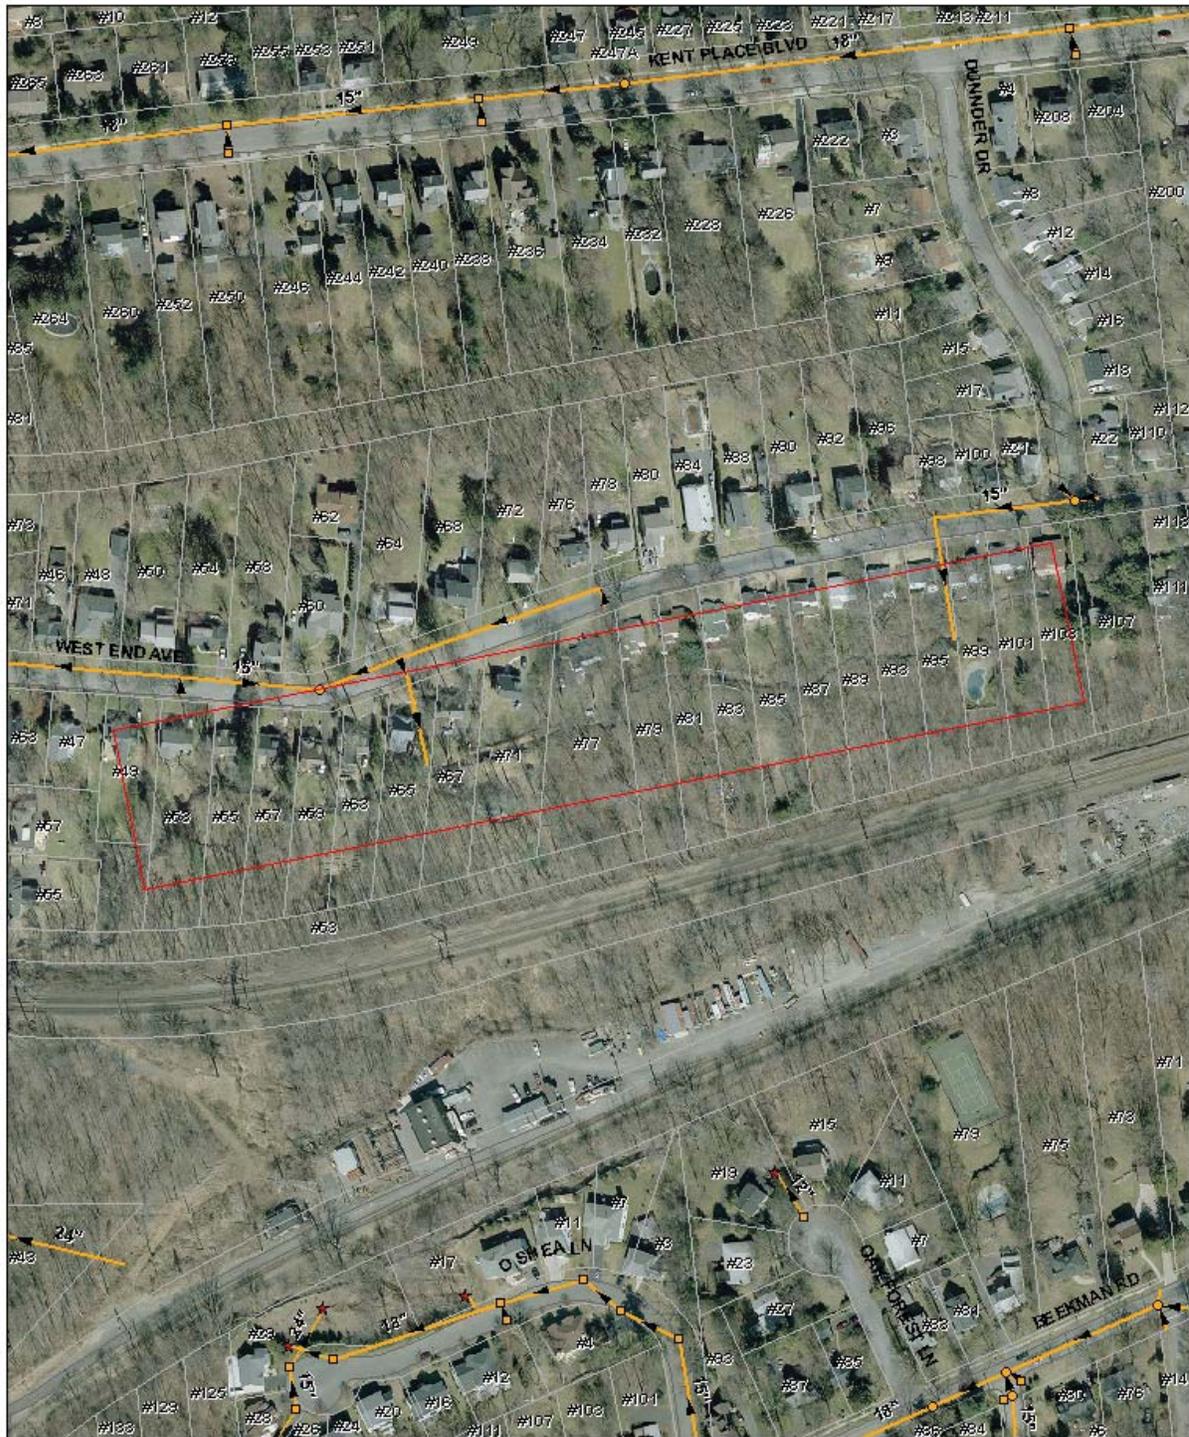
WEST END AVENUE

Erosion is evident along the banks of the brook and private properties flood during heavy storms. The brook is located entirely on private properties.

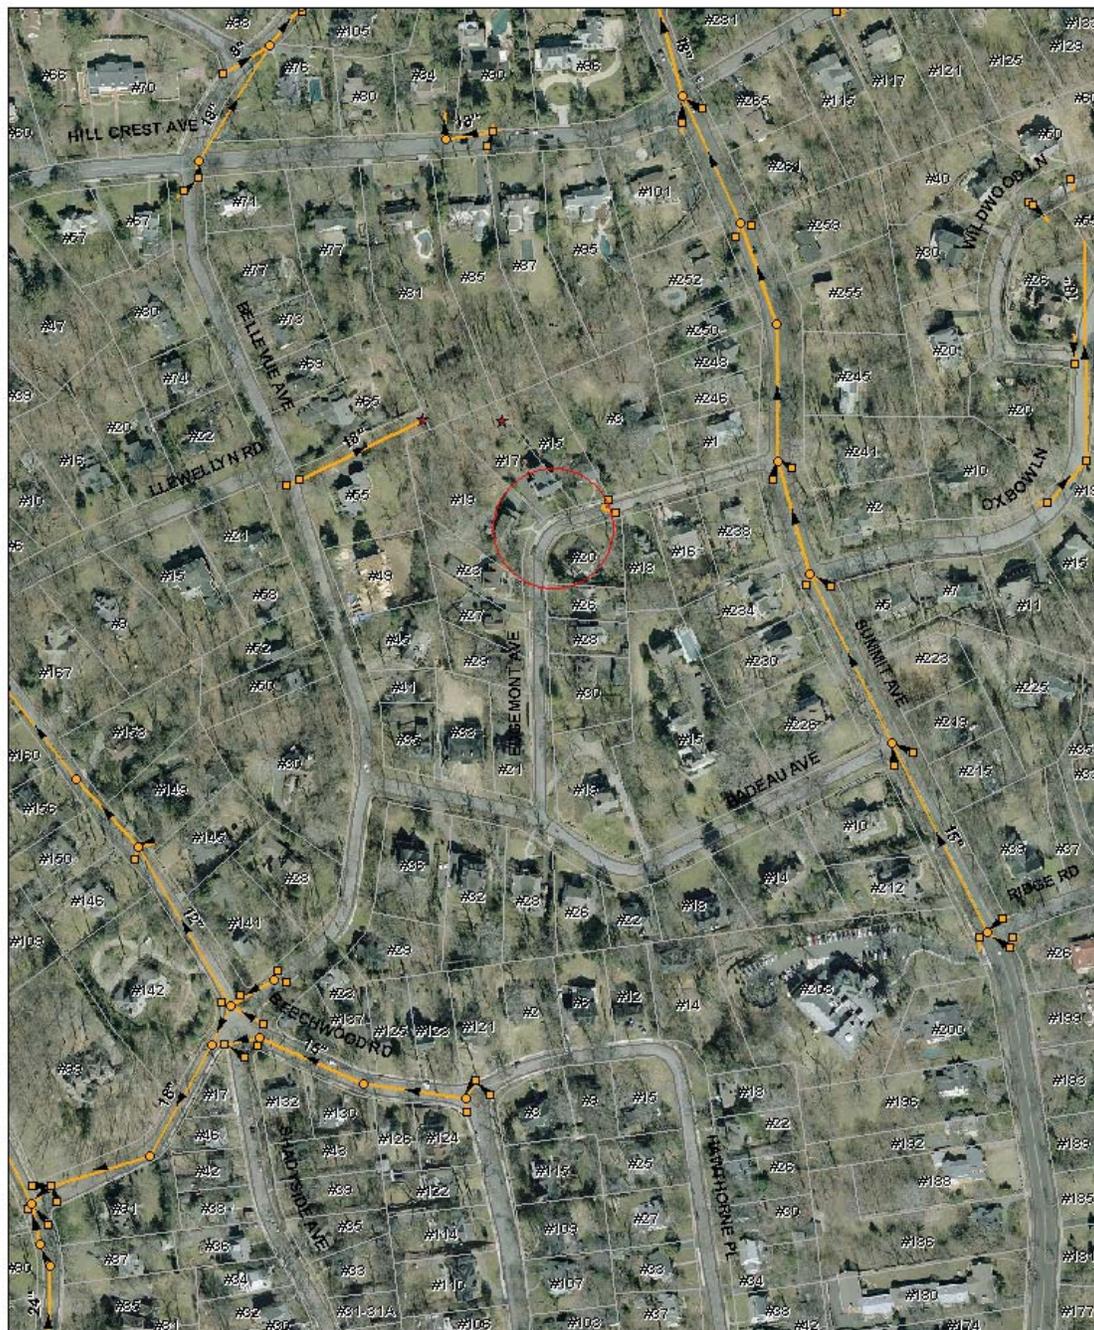
#### 3 EDMONT AVENUE

The grade of the pavement and sidewalk and the lack of adequate drainage inlets allow runoff to flow off the street onto private properties. The driveway of #3 floods and runoff continues through the rear yard of the next house causing erosion around the foundation and deck footings of #15 Edgemont Avenue. This project will be address when Edgemont Road is reconstructed which is currently in the 2013 Capital Plan.

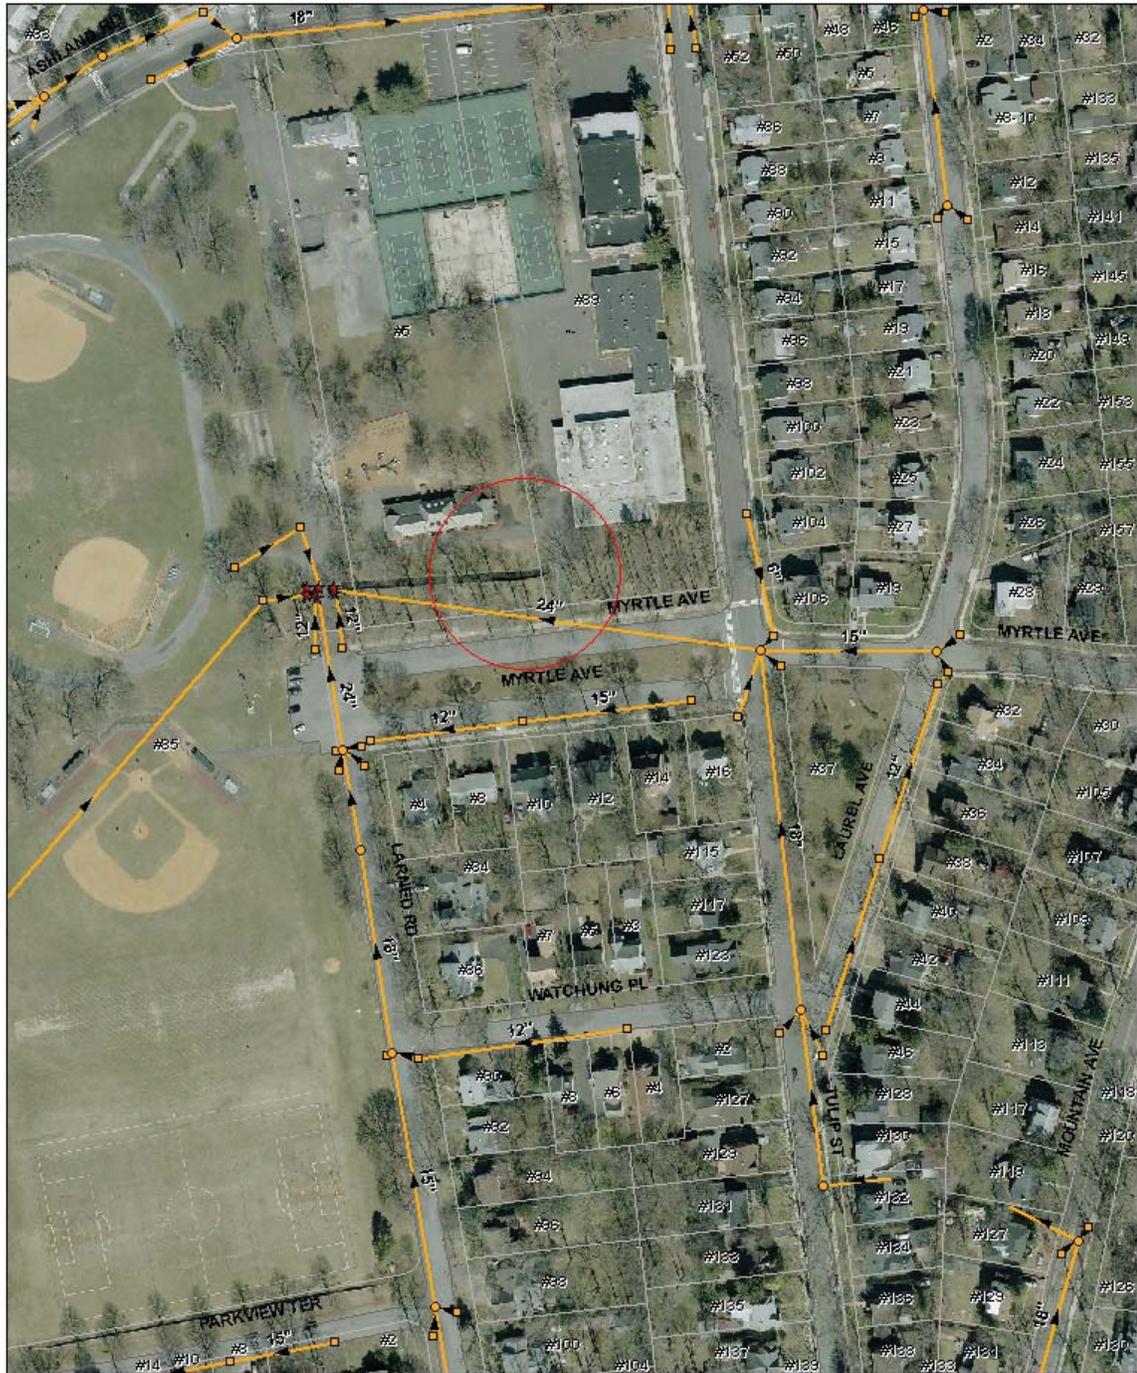
5 MYRTLE AVENUE

The open channel in front of the Cornog building floods, overtopping the channel walls and has reached into Brayton School through the door on the west side. The culvert has been cleaned and inspected and no significant deficiencies were discovered. A project to repair the culvert and desnag the stream is scheduled for the spring of 2013.

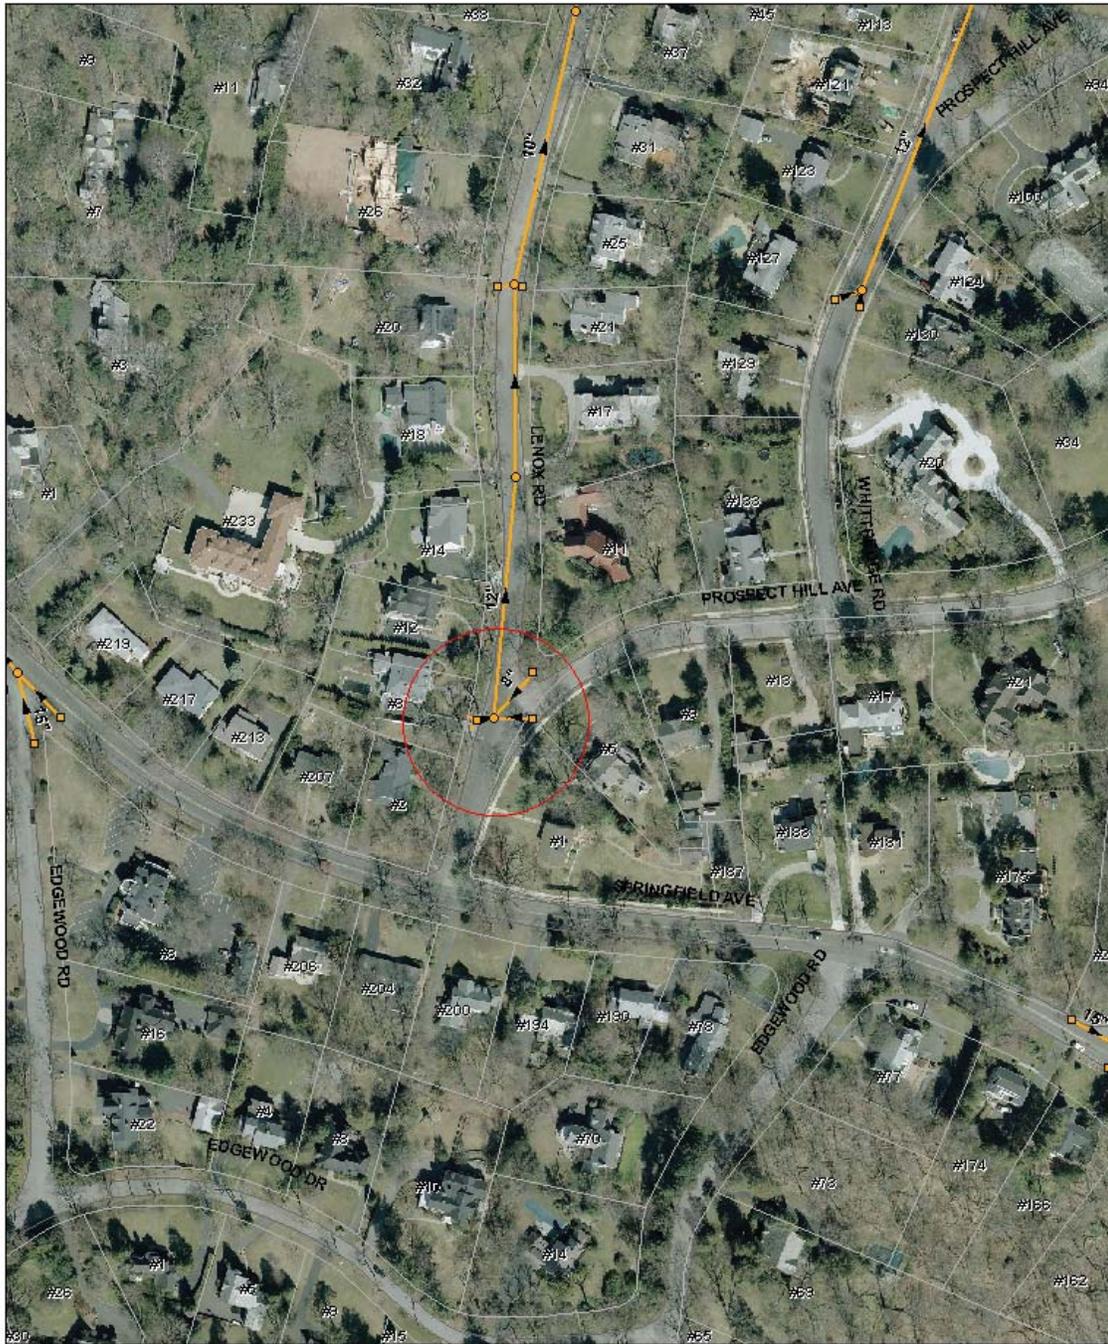
LENOX ROAD

A low area at the intersection with Prospect Hill Avenue is subject to flooding during heavy rains. The existing drainage system is outdated and undersized. This will be addressed when the road is reconstructed which is currently in the 2015 Capital Plan. The area shall be monitored to determine if any short term solutions can be completed.

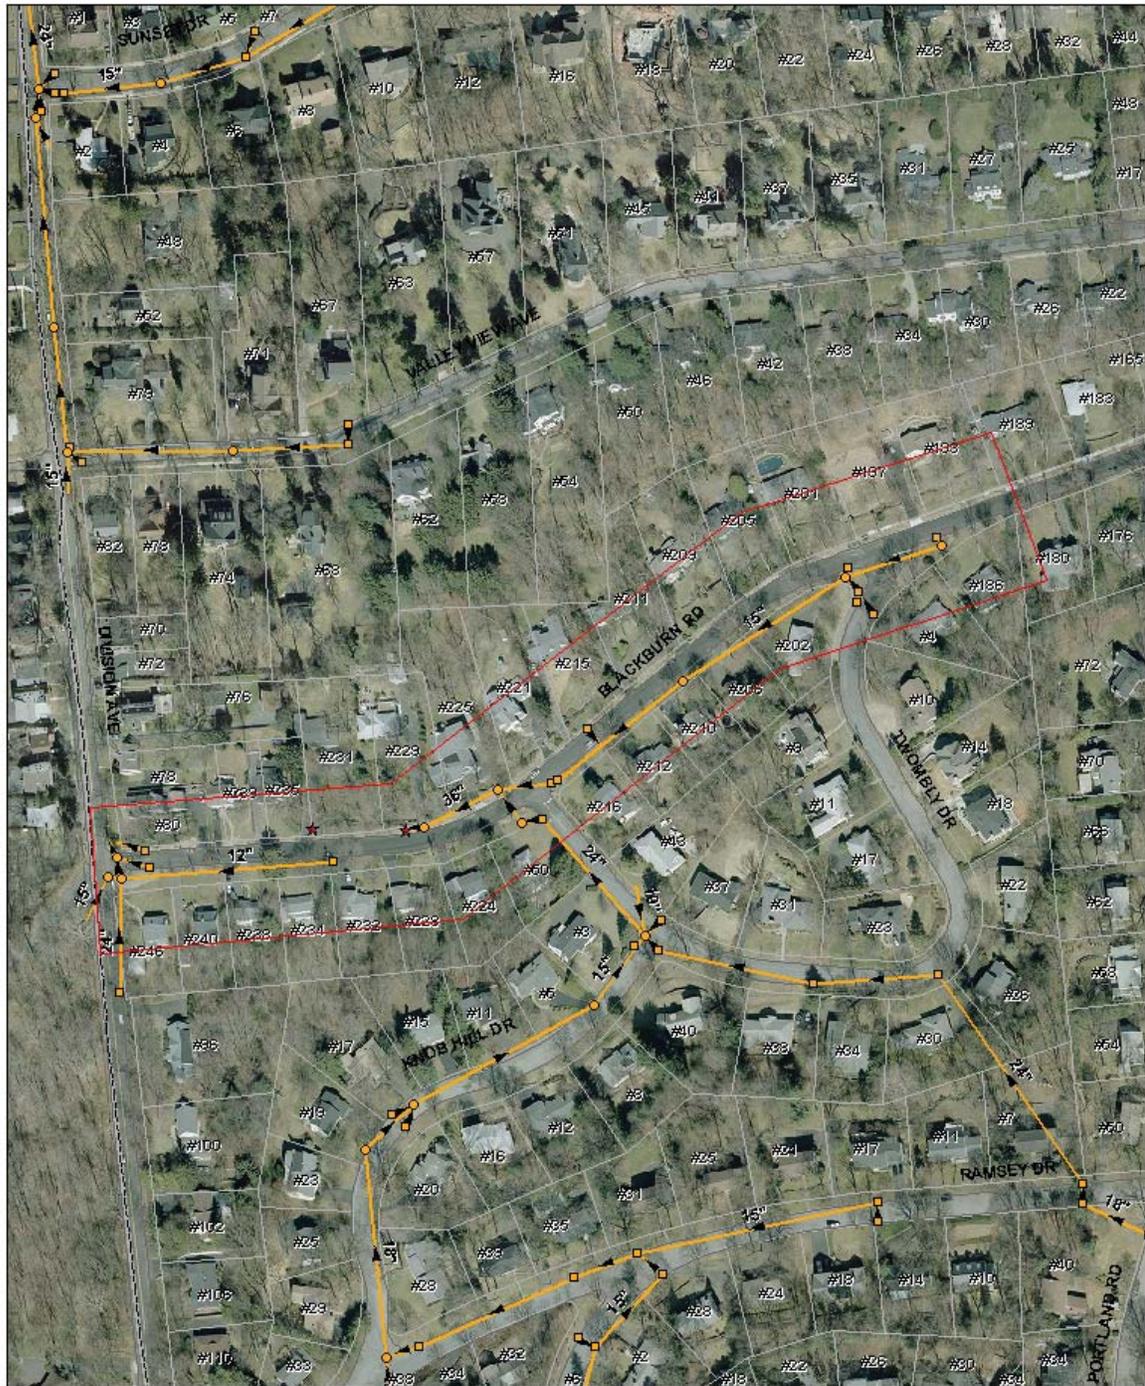
BLACKBURN ROAD - TWOMBLY DRIVE TO DIVISION AVENUE

In the area of Blackburn Road between Twombly Drive and Division Avenue, the brook will top its banks during severe rain events, but the continuous erosion is more problematic and may impact the private bridges. The brook is located entirely on private property.

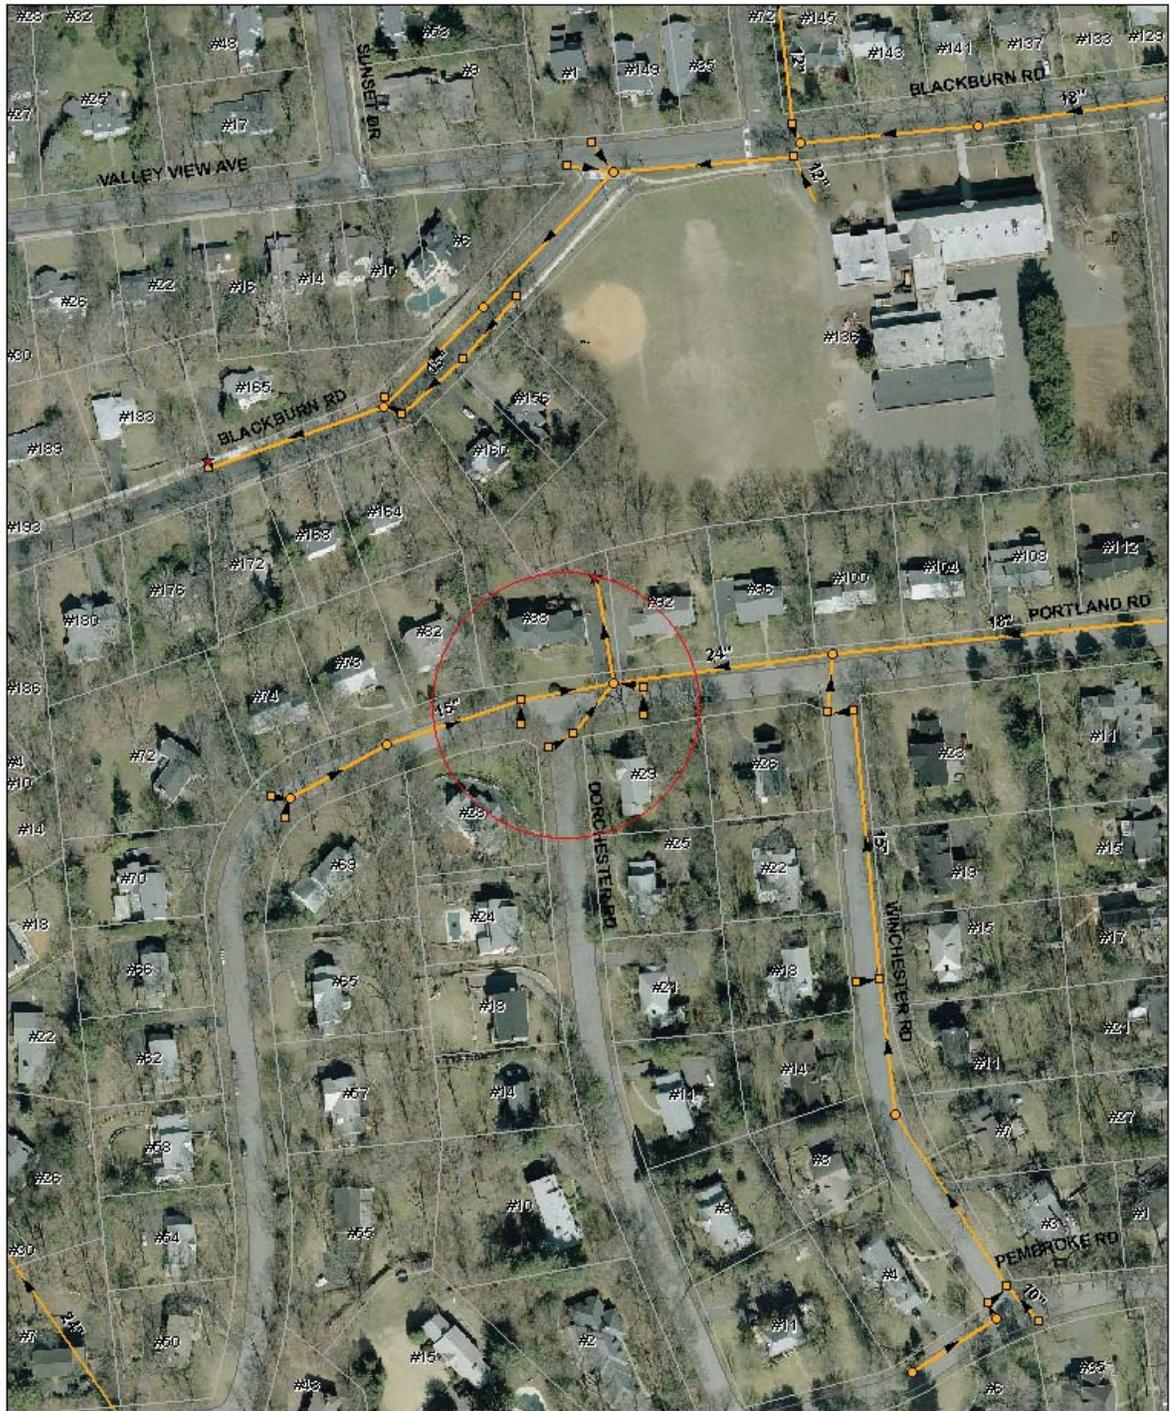
PORTLAND ROAD

During extreme rain events the storm sewer catch basins cannot handle the flow of rain water coming down Portland Road, Dorchester Road and Winchester Road. Flooding has occurred twice during Hurricane Floyd and Hurricane Irene.

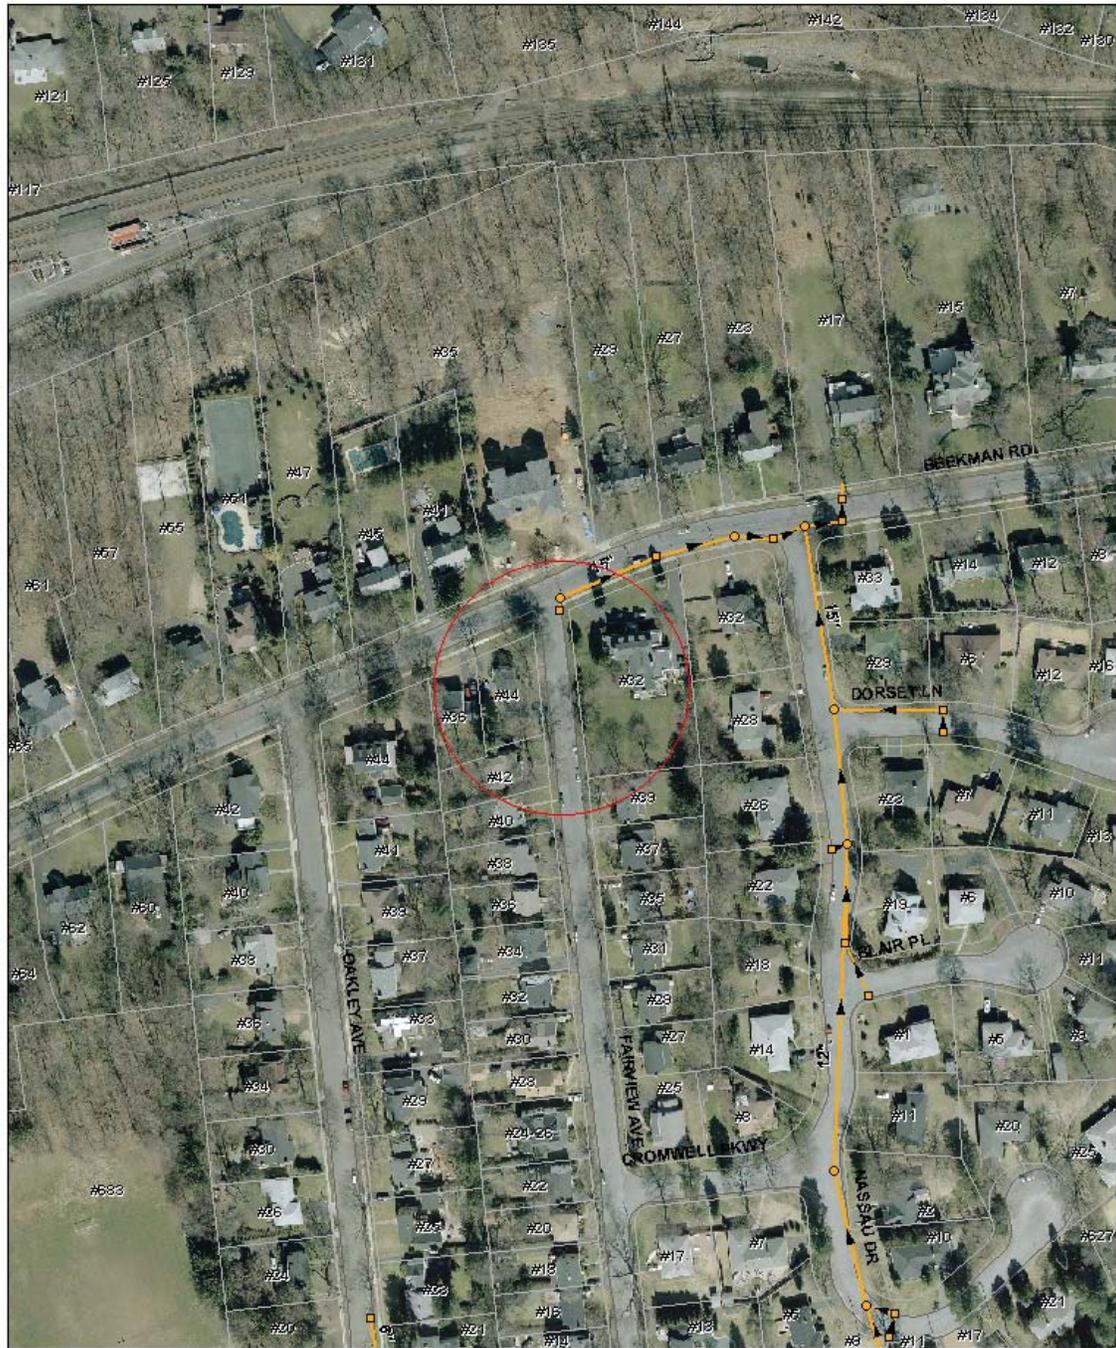
### FAIRVIEW AVENUE

Ponding occurs along the roadway edge on the north end of Fairview Avenue caused by leader drains discharging out on to the road. A drainage system was recently extended to the intersection of Fairview Avenue and Beekman Road during the Beekman Road reconstruction project. A new storm sewer system can now be extended up Fairview Avenue to capture the leader drains. This project is currently being designed and should be completed during the summer of 2013.

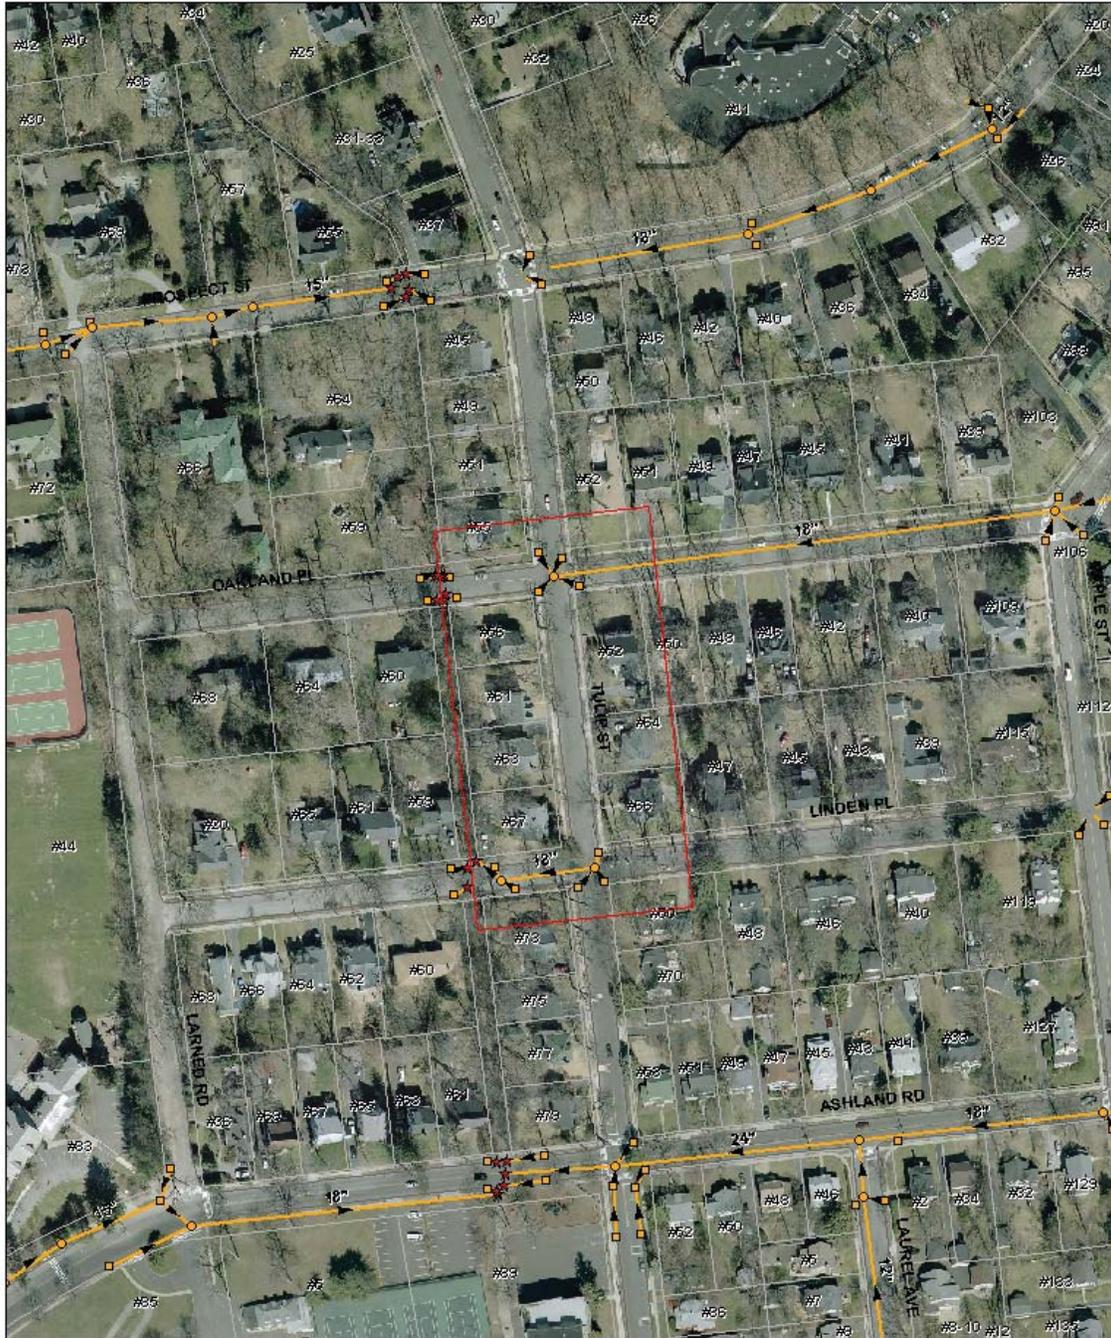
TULIP STREET - OAKLAND PLACE TO LINDEN PLACE

Tulip Street floods during intense rains at the intersections of Oakland Place and Linden Place. This appears to be a localized condition resulting in undersized catch basins and lateral lines. Further investigation is required. A contract was awarded to have these storm sewers inspected and cleaned. The footage has been reviewed and several undersized lines exist along with numerous utility blockages in the system. A final design of repairs is being prepared and shall be completed during the winter of 2012.

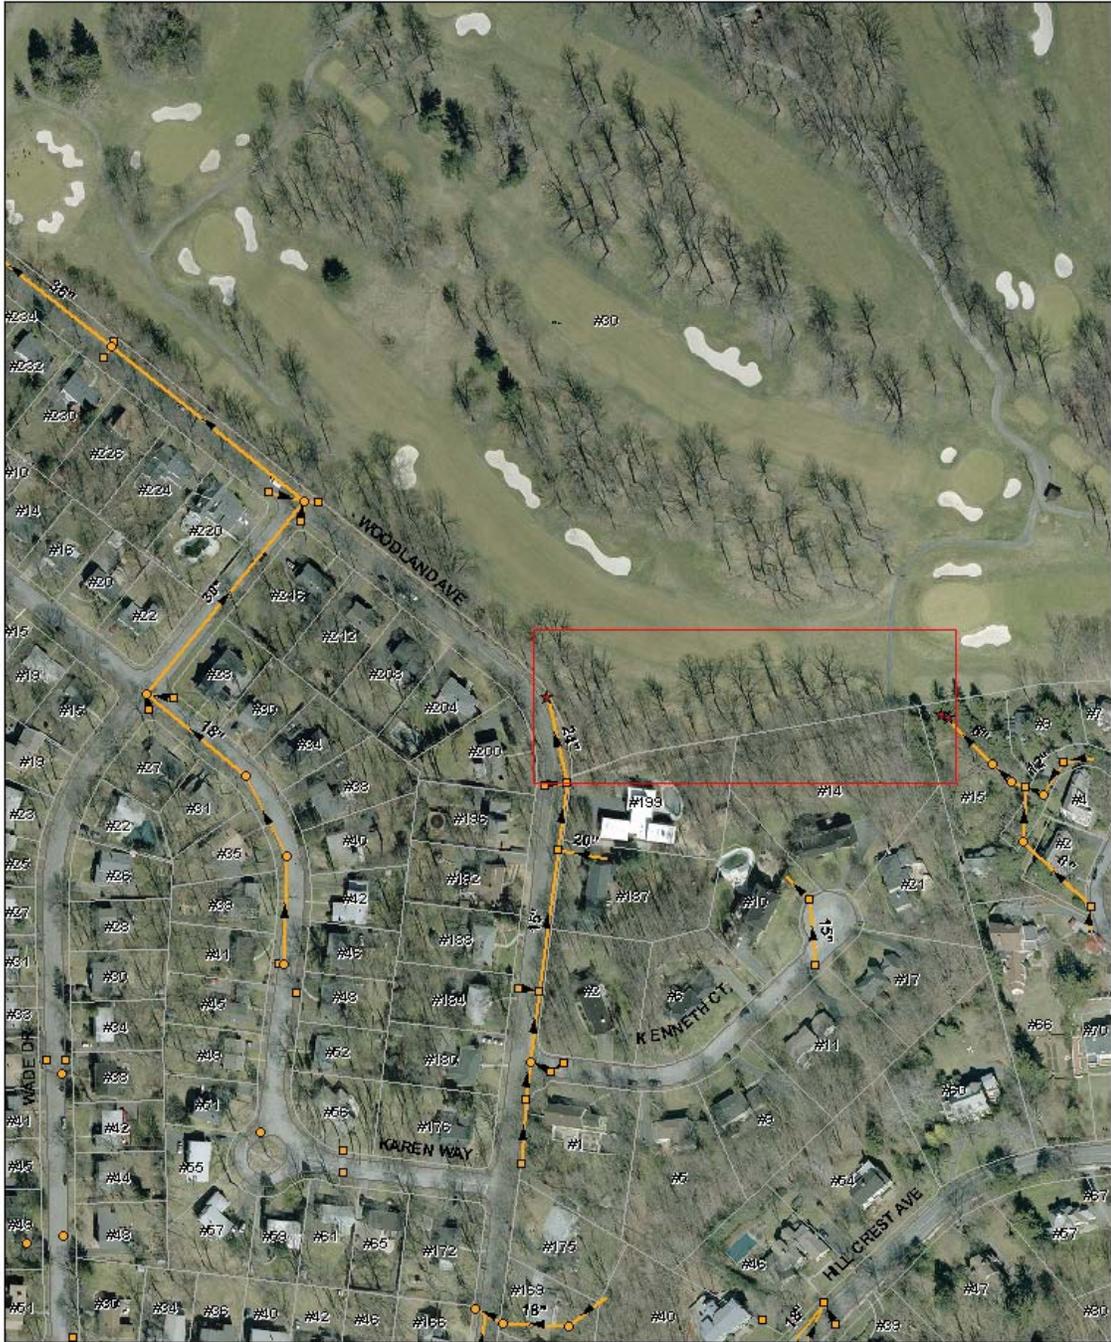
KENNETH COURT AND CREST ACRE COURT

In the area Kenneth Court and Crest Acre Court, the storm sewer from Crest Acre Court discharges into a private system and then a poorly defined ditch behind 14 Kenneth Court. Flow eventually makes its way to the ditch near #199 Woodland Avenue creating a mosquito breeding condition on private property. No easements exist which is problematic.
