# **CITYWIDE DRAINAGE ASSESSMENT REPORT**

**Department of Community Services  
Engineering Division**

**November 2012**

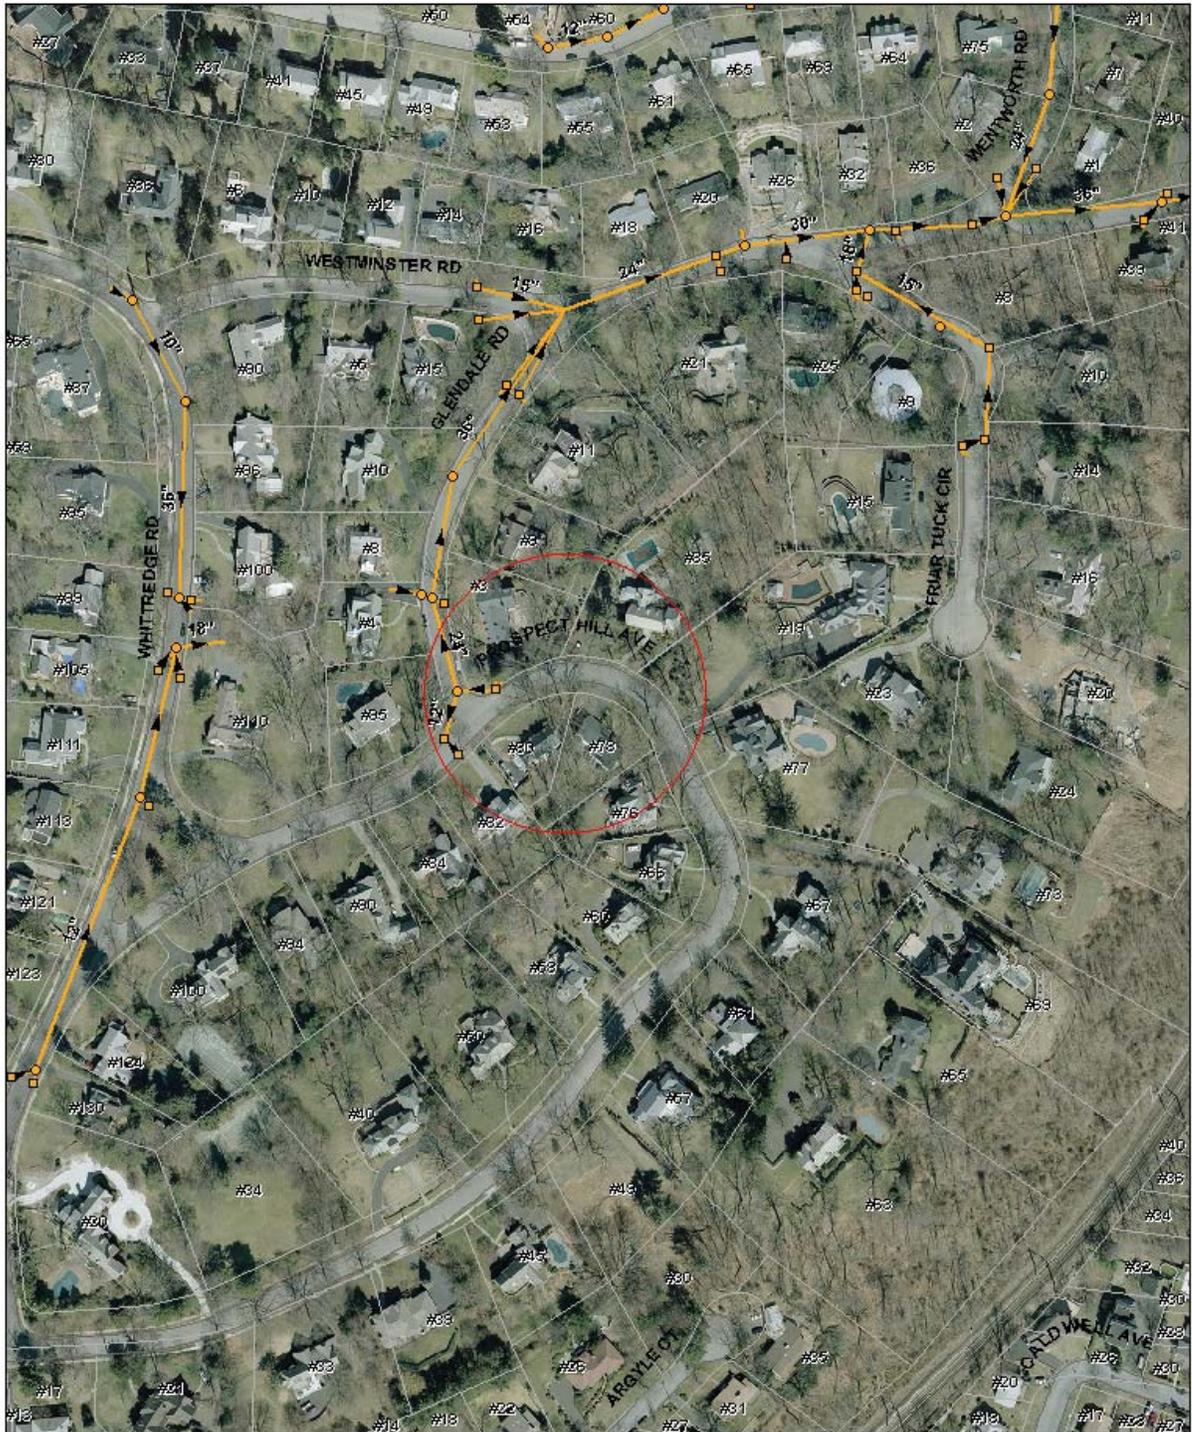
PROSPECT HILL AVENUE - SOUTH OF GLENDALE AVENUE

In the area of Prospect Hill Avenue, south (uphill) of Glendale Road, the slope of the street and bend in the road combined with a lack of inlets cause a runoff problem onto #85 Prospect Hill Avenue and the private common drive adjacent to it. Drainage washes out landscaping and floods the common drive.

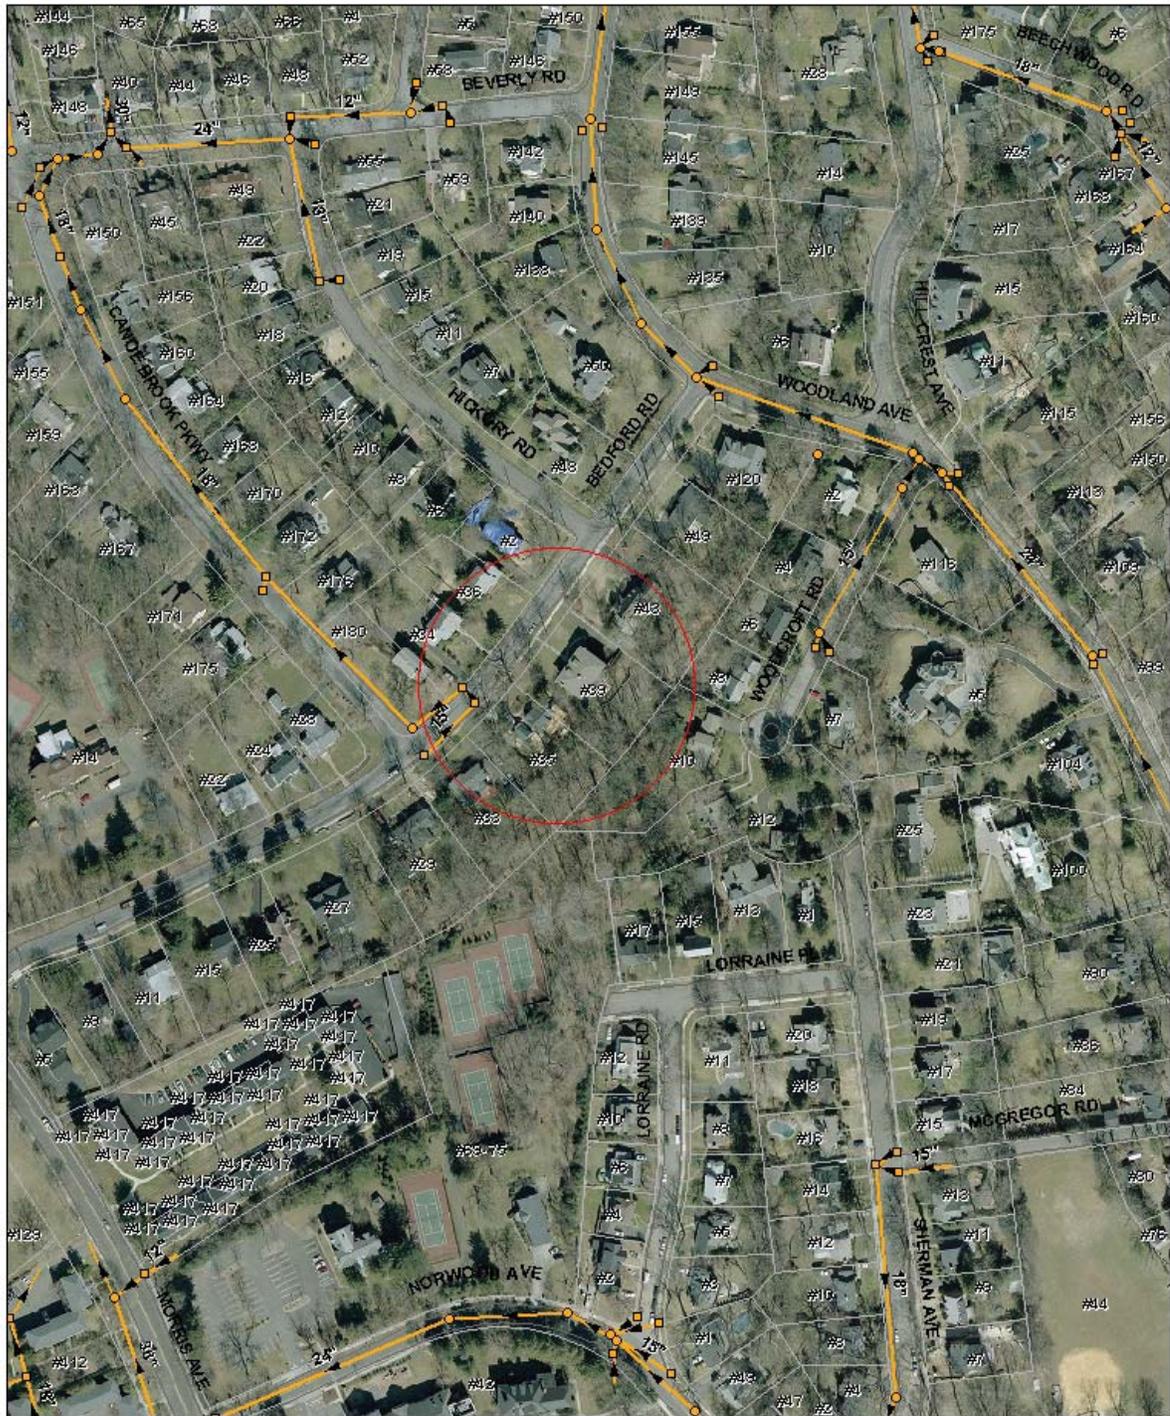
BEDFORD ROAD

Ponding occurs year round along the roadway edge on the south end of Bedford Road caused by leader drains discharging out on to the road. A drainage system exists on Bedford Road, which will be extended approximately 100 feet, to capture and prevent the ponding. This project is currently under construction.

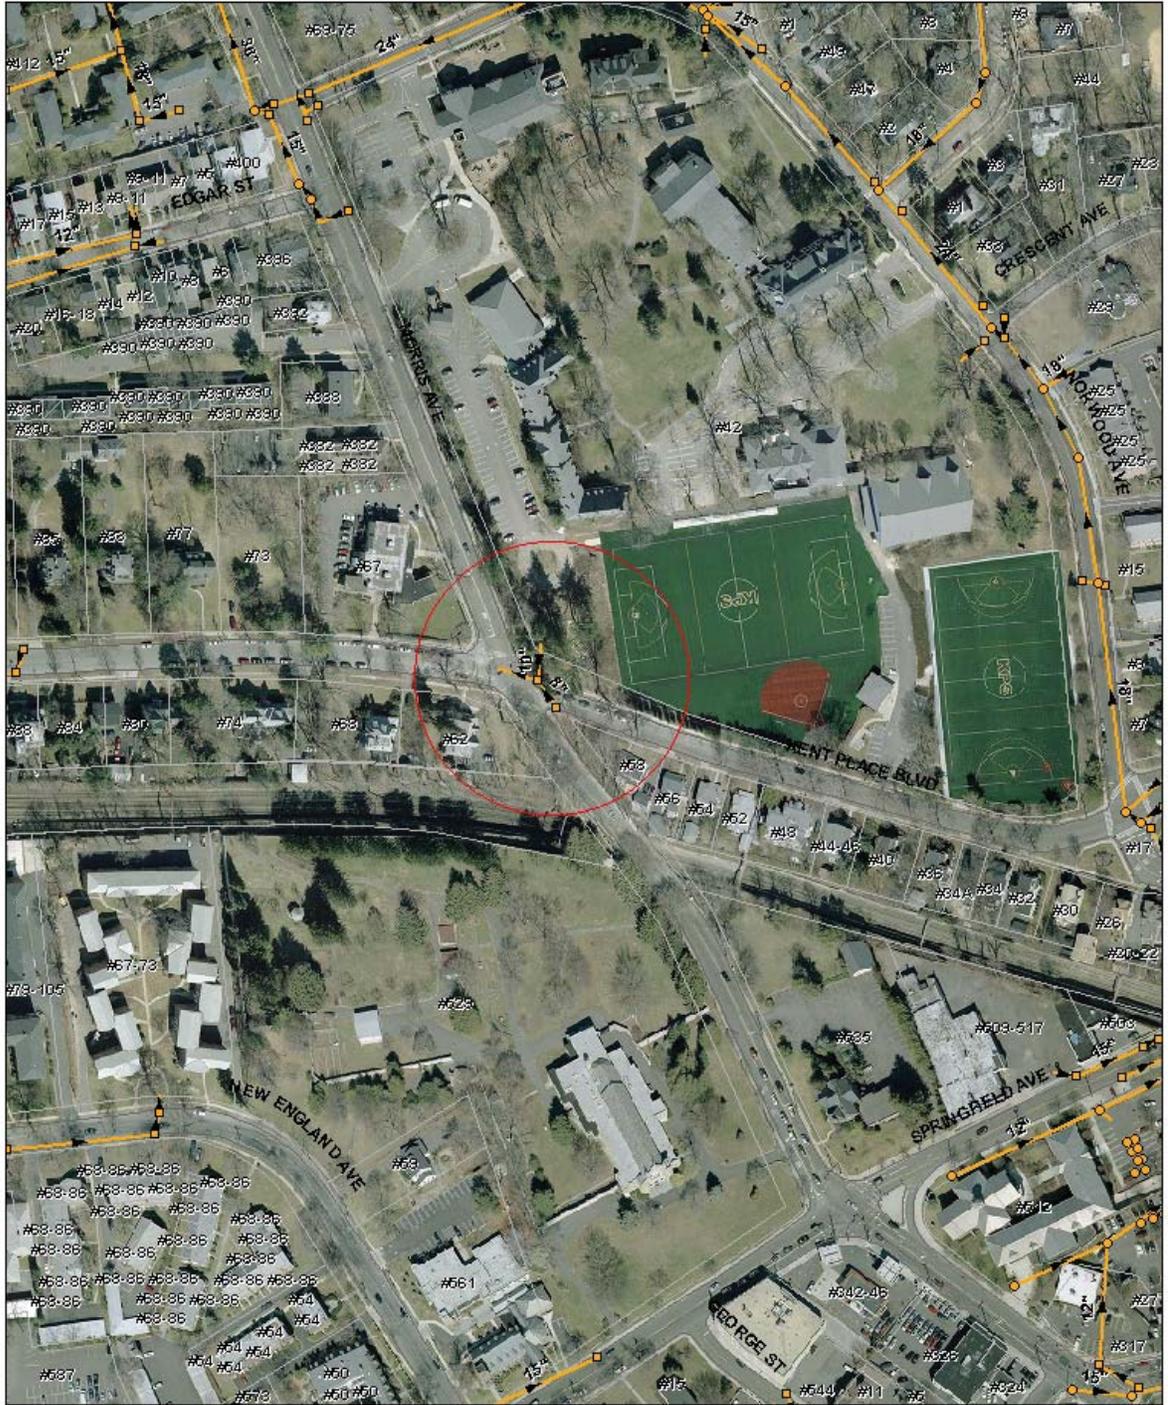
MORRIS AVENUE AND KENT PLACE BOULEVARD

At the Morris Avenue and Kent Place Boulevard intersection, the east side of the floods due to an inadequate storm sewer. The existing inlets discharge through a small diameter pipe on Morris Avenue, through the curb, just north of the intersection. This issue will be resolved with the Morris Avenue Bridge replacement which is scheduled to begin in 2013.

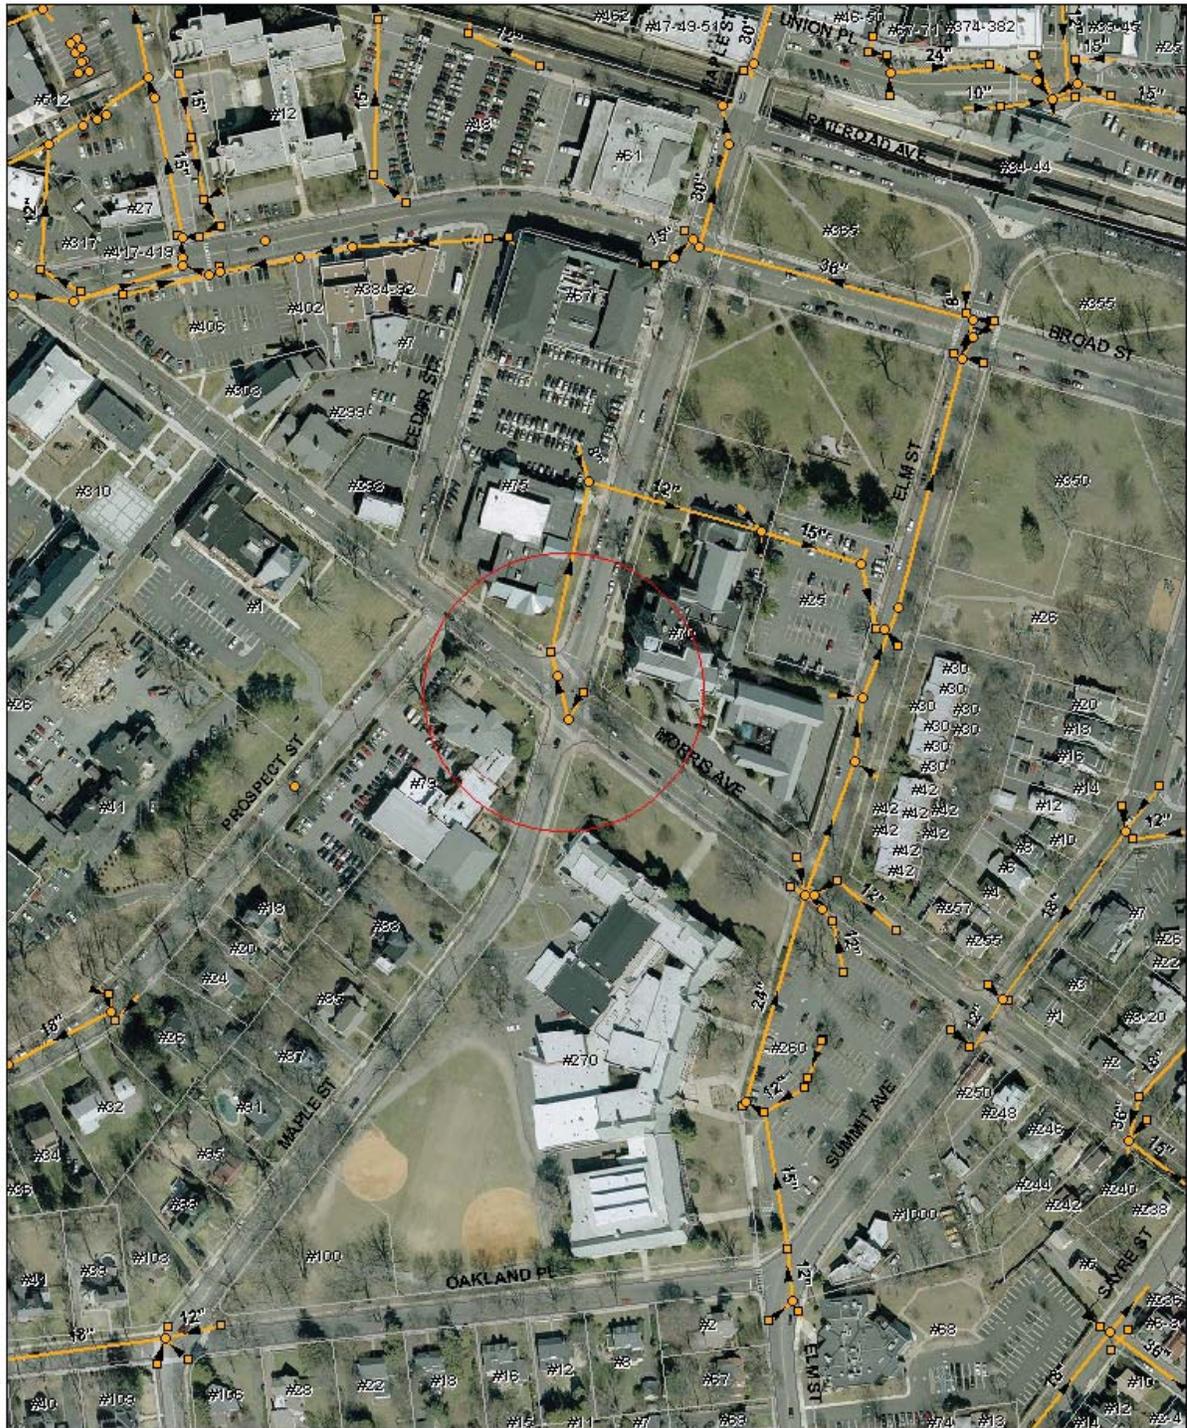
MAPLE STREET AT THE LIBRARY

The storm sewer has backups that cause street flooding during heavy storms.

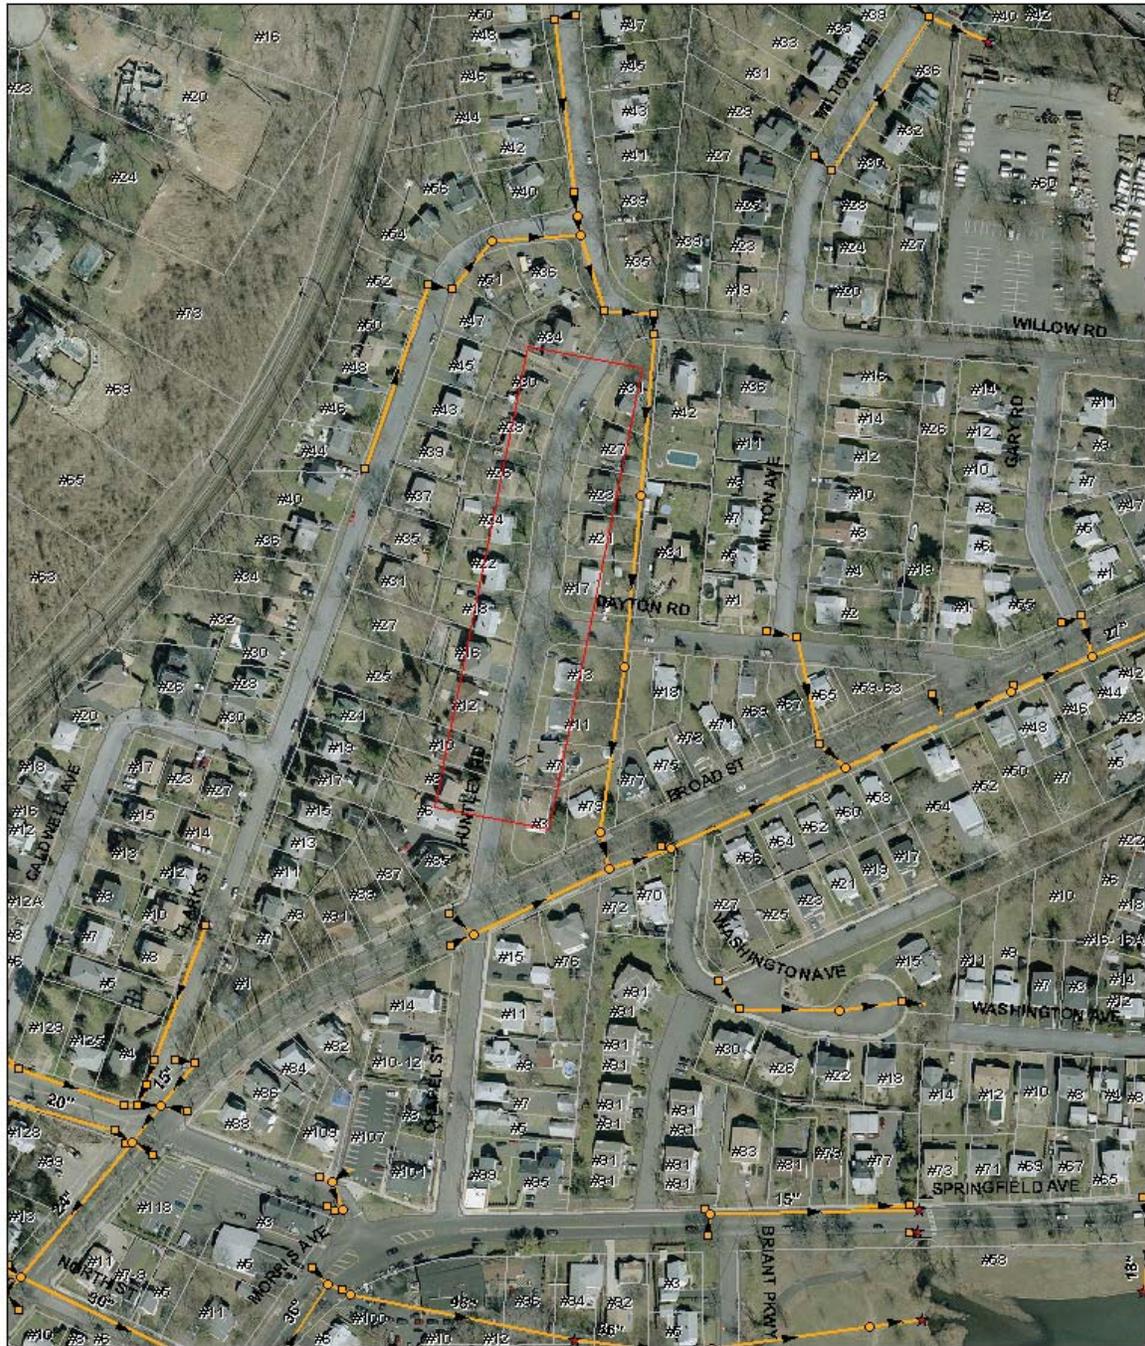
### HUNTLEY ROAD

Due to a lack of catch basins on the street, runoff after storm events is discharged into the road and extreme ponding and wet conditions occur, potentially endangering motorists. A storm sewer system can be extended from either end of the street to capture the majority of the runoff.

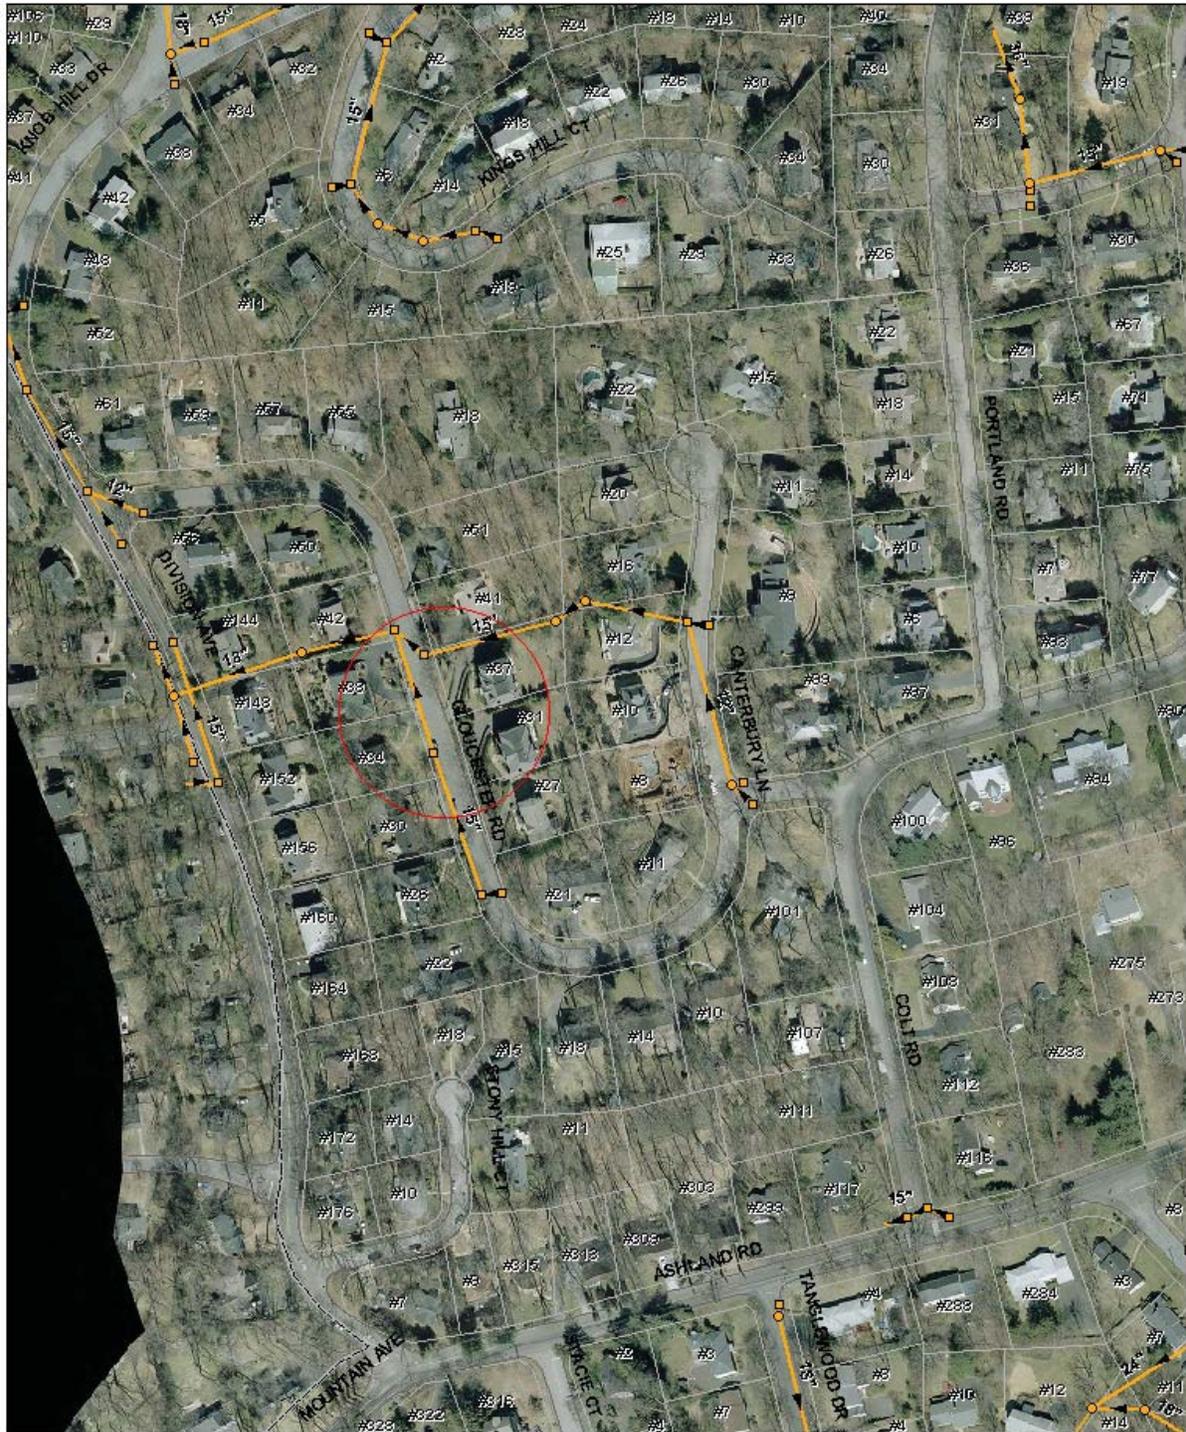
GLOUCESTER ROAD

Groundwater reaches daylight at the bottom of a hill along several private properties causing wet conditions during the summer months and icing during the winter months. Catch basins can be extended to capture the groundwater and direct it into our storm system.

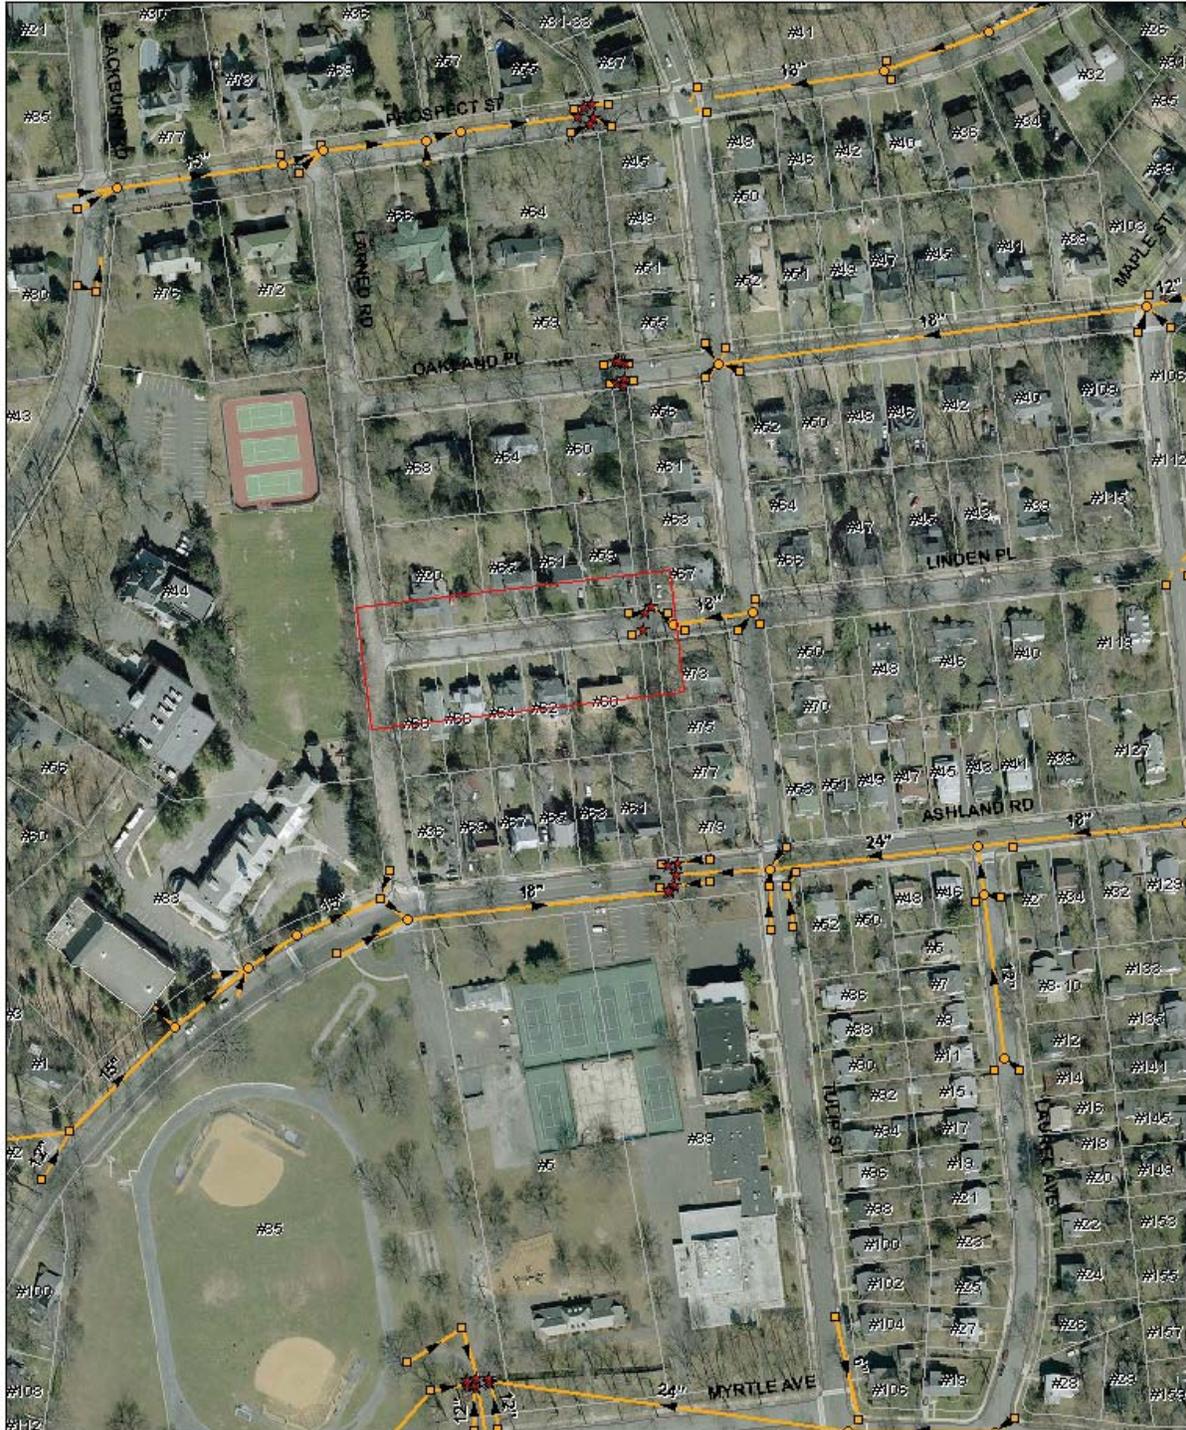
LINDEN PLACE

During rain events storm runoff from Larned Road drains down Linden Place causing ponding conditions along the edge of the road in front of private residences. A storm sewer can be extended from the culvert on Linden Place to capture this runoff.
