# **PRELIMINARY INVESTIGATION**

## **BROAD STREET WEST, SUMMIT, NJ**

### **DATE: September 15, 2017**

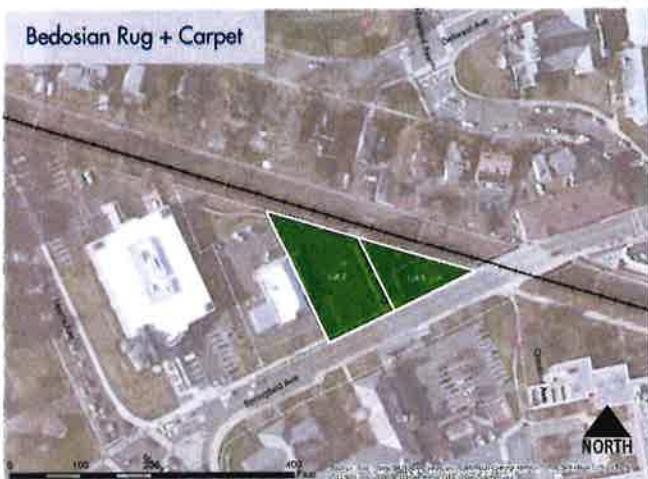
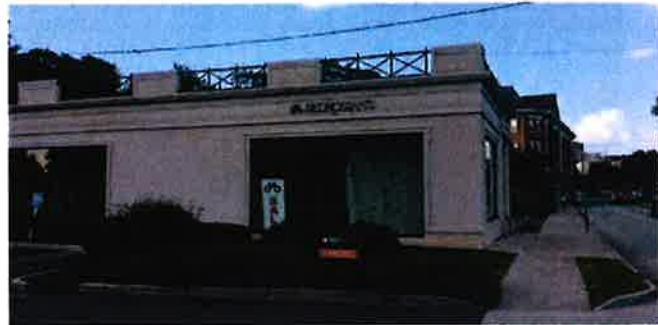
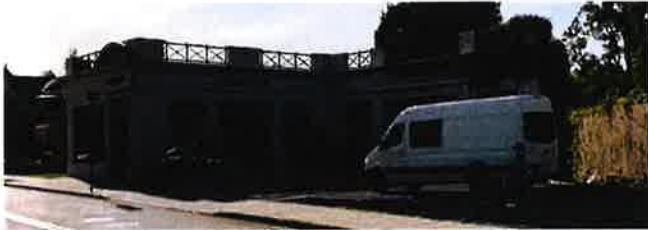
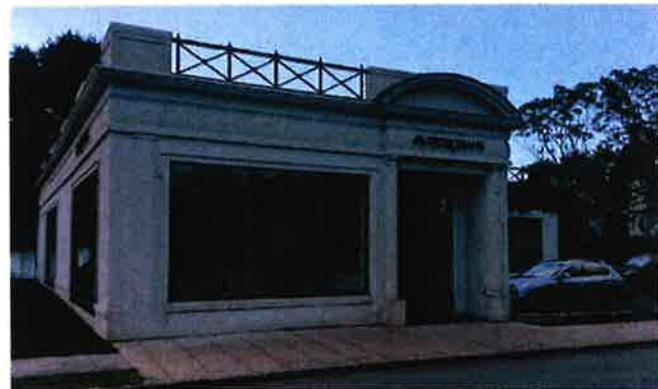
## Block 1913, Lots 1 & 2 - (Bedrosian Rug & Carpet)

Block 1913, Lots 1 & 2 contain a single-story commercial retail structure and seven-spot parking lot. The back of the lot is directly adjacent to the commuter rail right-of-way. The retail location that fronts on Springfield Avenue is owner-occupied and houses a carpet and rug store. The building and façade are in good condition. New retail windows were installed in 2008 and the stucco facade was updated as recently as 2015.

Based upon an inspection of the property and an examination of construction and inspection records, Block 1913, Lots 1 & 2 do not meet any of the criteria under the LRHL. While access was not gained into the building, the exterior of the structure and improvements to the site appear to be in good condition.

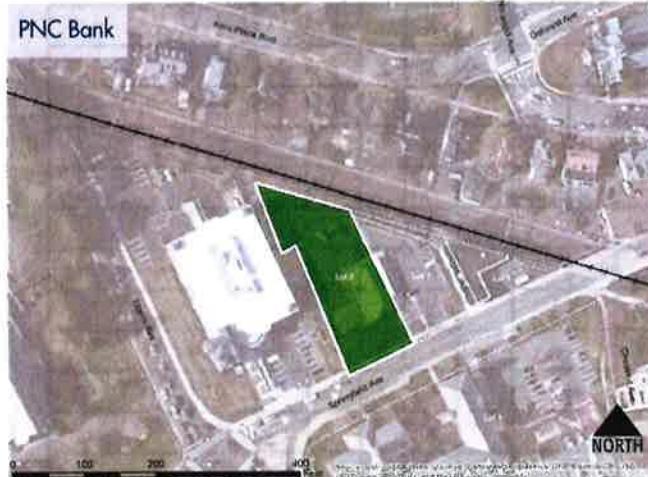
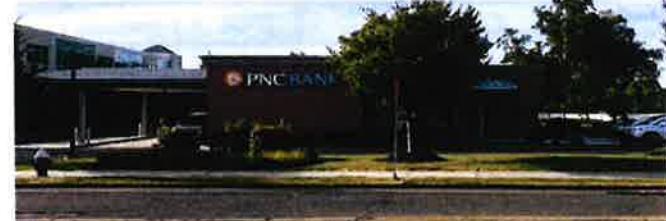
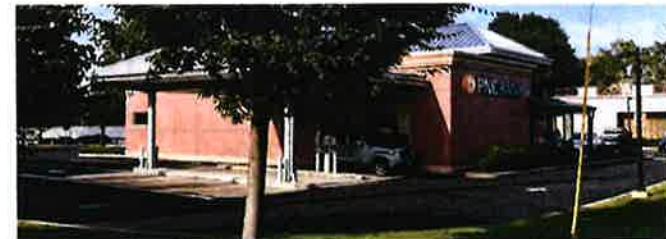
## Block 1913, Lot 3 - (PNC Bank)

Block 1913, Lot 3 contains a commercial bank location on a 0.55 acre site. A twenty-spot parking lot on the site serves bank employees and customers. The building also includes a drive-thru banking use. The commercial bank on the site was built in 2009 and is in good condition. The site is well-maintained and the

site design provides for landscaping and clear circulation markings. The façade is free of any visible signs of deterioration.

Based upon an inspection of the property and an examination of construction and inspection records, Block 1913, Lot 3 does not meet any of the criteria under the LRHL. While access was not gained into the building, the exterior of the structure and improvements to the site appear to be in good condition.

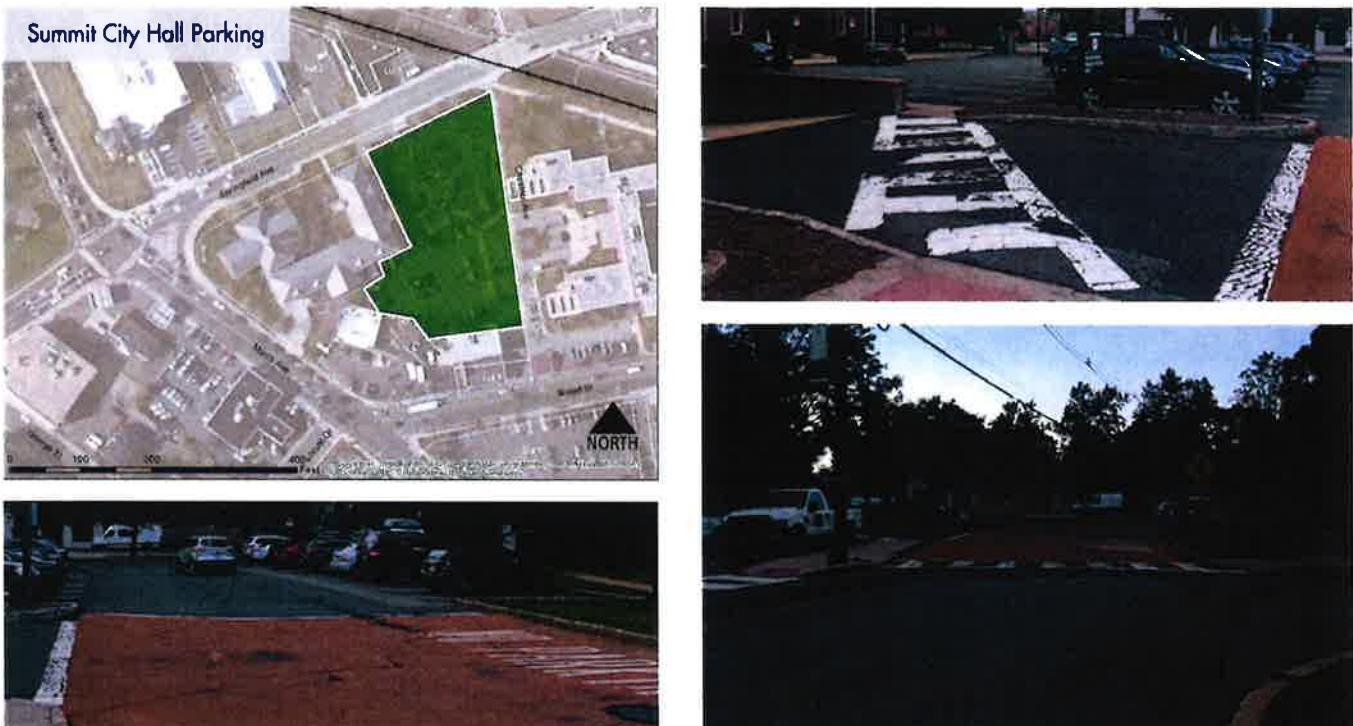
## Block 2701, Lot 1 - Partial (Summit City Hall Parking)

Based upon an inspection of the property and an examination of construction and inspection records, Block 2701, Lot 1 meets the following criteria under the LRHL:

While the City Hall Building was not found to meet any criteria under the LRHL, based on the foregoing, sufficient evidence exists to conclude that the current use and conditions of the parking lot in Block 2702, Lot 3 support designation under "Criterion D." The lot is an outdated and unplanned land use that evolved over time in a way that resulted in an inefficient, unsafe, and obsolete surface parking facility.

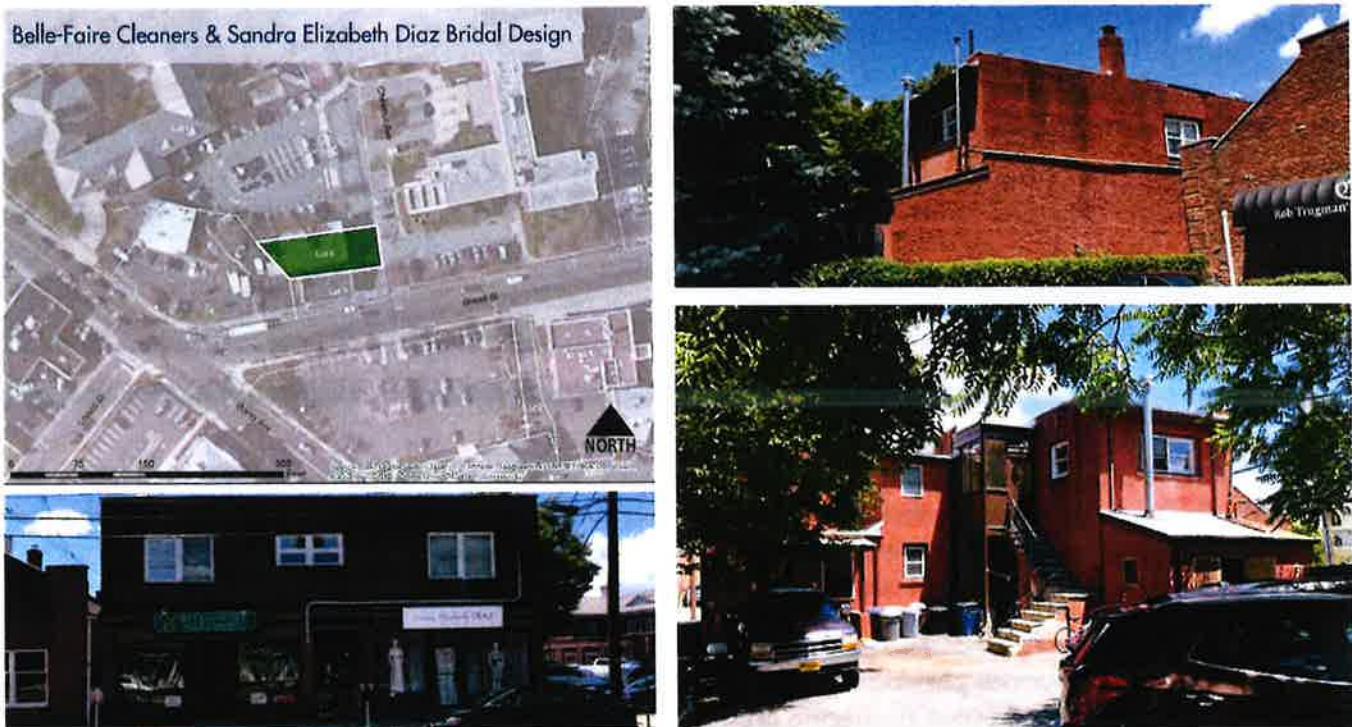
## Block 2701, Lot 6 - (Belle-Faire Cleaners & Sandra Elizabeth Diaz Bridal Design)

Block 2701, Lot 6 contains a two-story mixed-use structure on a 0.12 acre parcel. The ground floor of the building houses two retail storefronts that front Chestnut Avenue. A dry cleaner and a bridal design shop occupy the ground floor. The second story has residential units that are accessed through the back of the property. The service parking and loading areas are in the back of the property and can only be accessed via the adjacent City Hall parking lot.

While access to the interior of the building was not gained, an external inspection of the property supports the finding that the existing structure shows signs of obsolescence and the site design exhibits a faulty arrangement. Based on a review of historic Sanborn maps and current aerial photographs, it appears the current mixed-use structure is largely an addition to an existing frame dwelling that was observed in maps as early as 1903. This unique aspect of the existing building's history would explain the multitude of physical adaptations – the structure is in itself an adaption, not initially constructed for the purpose it ultimately came to serve.

One significant observation is the lack of parking for the second-story residential units, which would support a conclusion of obsolescence. Parking is generally demanded by the marketplace and is required by the City's zoning code for all new residential dwellings. Upon inspection of the building, several signs of deterioration were observed both on the façade of the building and building improvements. The stucco façade of the building shows signs of water infiltration and is spalled, which could have been caused over time by improper drainage of window air conditioning units. On the retail storefront of the building, the painted finish on metal panels of the storefront facades shows significant signs of wear and are in need of maintenance. Roof gutters and drainpipes were found to be detached from the building façade and in need of repair.

Inspection of the side and rear facades of the building revealed multiple furnace exhaust pipes projecting through the one-story roof. One of the pipes leading into the one-story roof shows significant corrosion. Furthermore, the parking area located at the rear of the building is not striped and the commercial refuse was not stored in an appropriate enclosure. The rear staircase, presumably second means of egress for the second-floor residential units, shows signs of multiple repair attempts and is likely in need of replacement. Taken together, the configuration of the existing improvements and faulty parking arrangement as well as its

The back of the building on Block 2701, Lot 6 has a parking area and rear entrance for deliveries, trash and service functions. Access to the rear of the lot is only provided through the adjacent municipally-owned City Hall parking lot. The property owner enjoys an easement right to access the back of the property via the municipal parking lot. Over time, the use of this building and the back area evolved to be interdependent on the basis of access arrangements that allowed for the continued use of this and adjacent property. Diverse ownership across these interdependent properties impedes the viable redevelopment of both Lot 3 and discourages the further improvement of the adjacent City owned surface parking lot. Based on the foregoing, the conditions of title surrounding this parcel and the adjacent City lot results in a stagnant or unproductive condition upon land potentially valuable for contributing to the public welfare, as contemplated in "Criterion E."

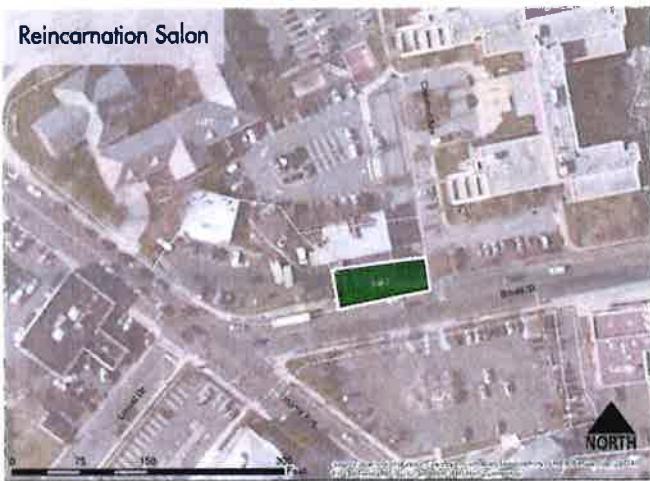
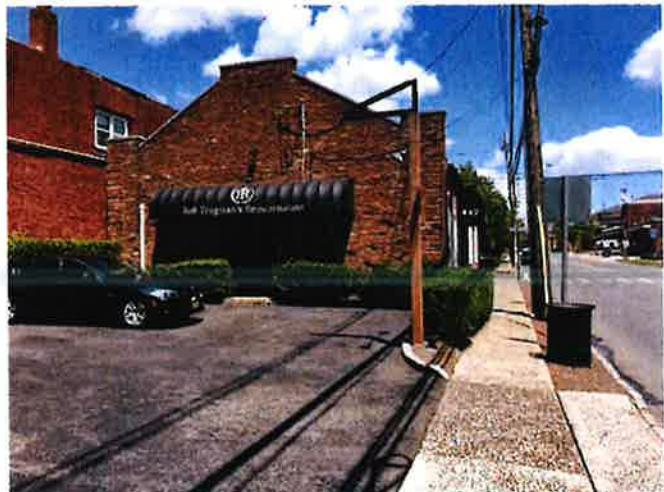
## Block 2701, Lot 7 - (Reincarnation Salon)

Block 2701, Lot 7 contains a one-story structure with a retail storefront on a 0.09 acre parcel. Rob Trugman's Reincarnation Salon occupies the retail location. The building is owner-occupied and located on the corner of Chestnut Avenue and Broad Street. There is a small four-space parking lot on the west side of the building that is used by the salon.

Access was gained into the building and both the exterior and interior of the structure appear to be in good condition. Based upon an inspection of the property and an examination of construction and inspection records Block 2701, Lot 7 does not meet any of the criteria under the LRHL, per se.

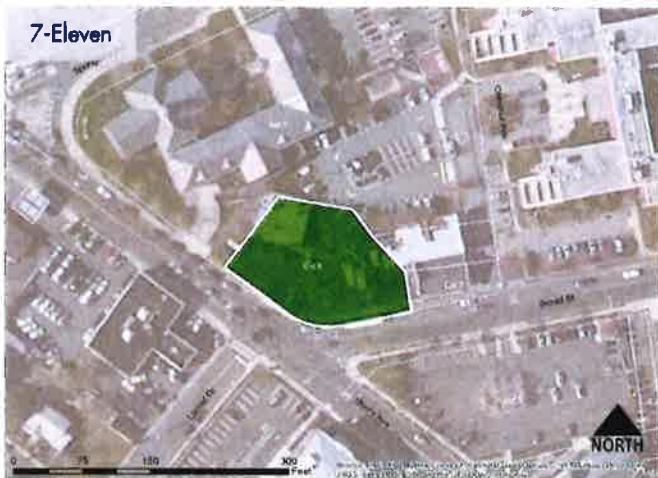
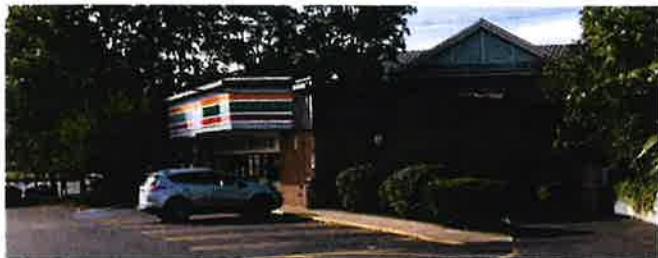
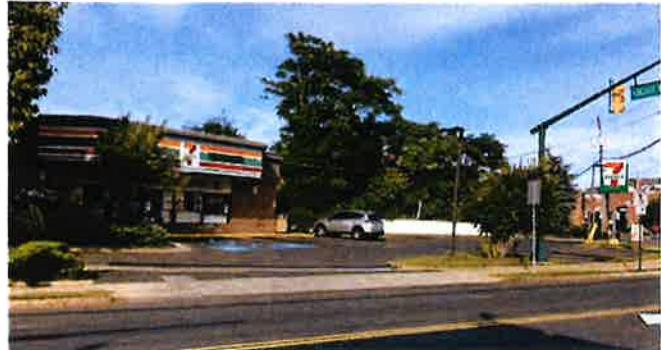
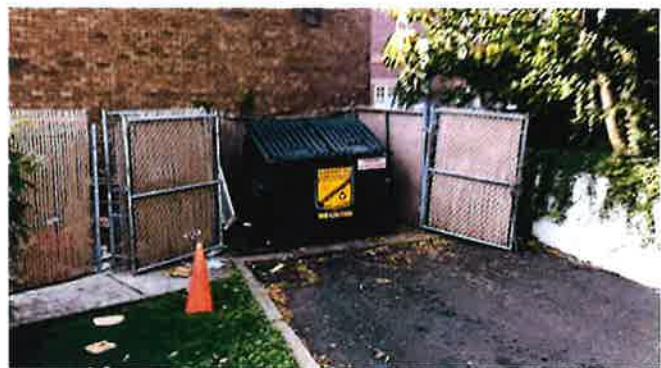
## Block 2701, Lot 8 - (7-Eleven)

Block 2701, Lot 8 is a 0.43 acre corner lot that is located at the intersection of Broad Street and Morris Avenue. The lot is currently occupied by a 7-Eleven convenience market that is open twenty-four hours a day. The single-story commercial building is situated at the back of the lot, making way for an eighteen-space parking lot at the front of the site that is used by customers and store employees. The parking lot provides for two points of access: directly onto Broad Street and Morris Avenue. The lot is adjacent to two commercial structures to the east and surrounded by City Hall and one of City Hall's parking lots to the northeast, north and northwest. The convenience store itself is less than seven feet from the City Hall building, which is directly behind the structure.

The arrangement and design of the site is faulty and found to be detrimental to the safety, health, morals and welfare of the community. The irregularly shaped lot contains a front-yard parking lot consisting of eighteen spaces without a marked loading area for deliveries. There is a long drive to access a side yard dumpster enclosure. The parking lot has two access points, one along Broad Street that egresses into a dedicated right-turn queue lane that is separated from oncoming traffic by a double-yellow line (i.e. no legal left turns). The other access point is along Morris Avenue, which contains a driveway that is not aligned with the signalized 4-way intersection, resulting in driver confusion where left egress turns would also require crossing of a double-yellow line. The high-volume parking lot has limited lines of sight, a particularly dangerous condition where vehicles are backing out of spaces on both sides of a two-way drive aisle. There were eight (8) vehicular accidents in this parking lot in 2016 alone and forty (40) such accidents between the years 2012 and 2017. This corner parking lot, necessitated by the faulty arrangement of improvements on the site, con-

Taken together, the faulty arrangement of the site design and the deleterious nature of the use itself, provides sufficient evidence to conclude Lot 3 meets the specifications of "Criterion D."

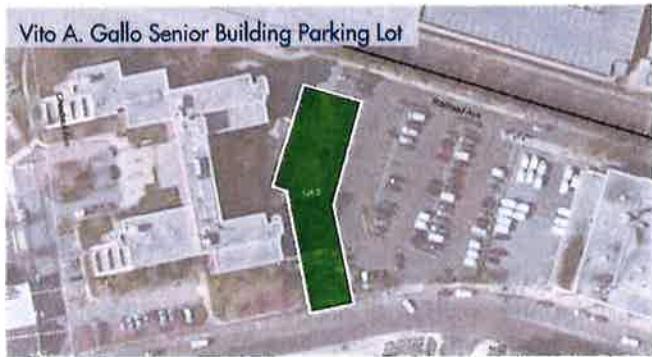
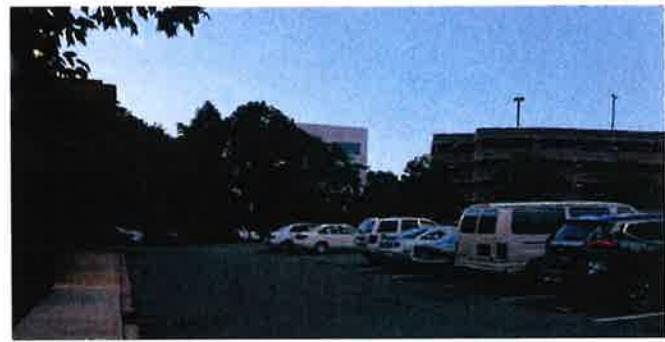
## Block 2702, Lot 3 - Partial (Vito A. Gallo Senior Building Parking Lot)

Lot 3 is a 1.84 acre parcel owned by the City of Summit Housing Authority. The structure on the parcel is the Vito A. Gallo Senior Building which contains 125 units of senior housing. This Study does not include the senior housing building, only the parking lot located on the western portion of Lot 3 which is .33 acres and has 39 parking spaces.

be part of a thriving downtown district is, in itself, significant to this analysis. Sufficient evidence exists to conclude that the current use and conditions of the parking lot in Block 2702, Lot 3 support designation under "Criterion D." The lot is an outdated and unplanned land use that evolved imperfectly over time, resulting in an inefficient, unsafe, and obsolete surface parking facility.

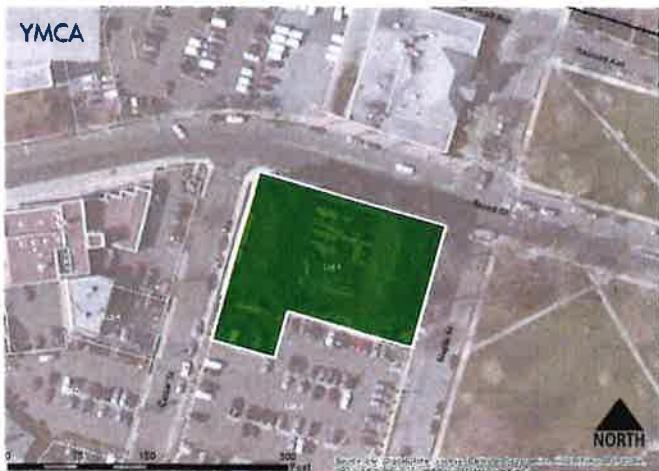
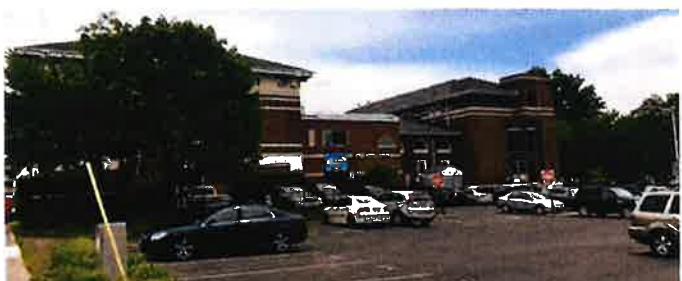
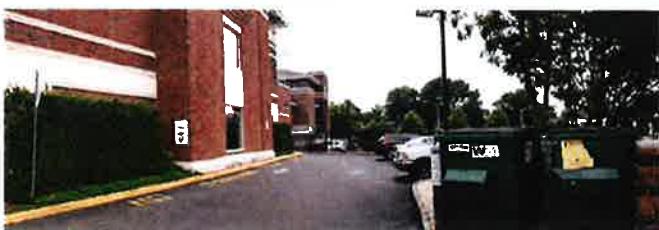
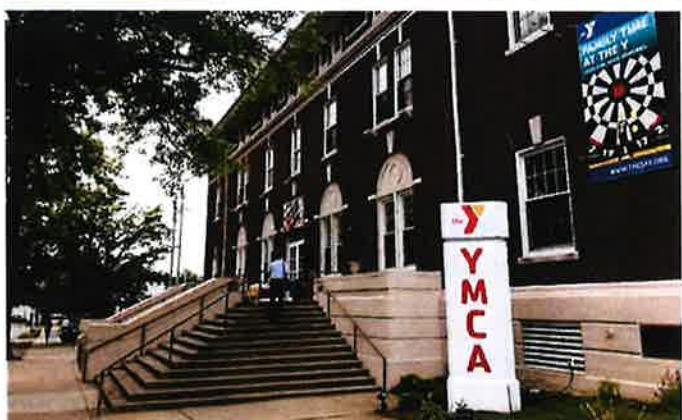
### Block 2705, Lot 1 - (YMCA)

Block 2705, Lot 1 is home to the Summit Area YMCA. The main structure of the facility was built in 1912 and underwent a major renovation, that included the addition of a new wing to the building, in 1998. The facility covers that majority of the 0.74 acre parcel and has only four parking spots on-site. The adjacent municipally owned parking lot offers additional parking to patrons of the YMCA.

The obsolete nature of the structure provides sufficient evidence to designate Lot 3 under "Criterion D."

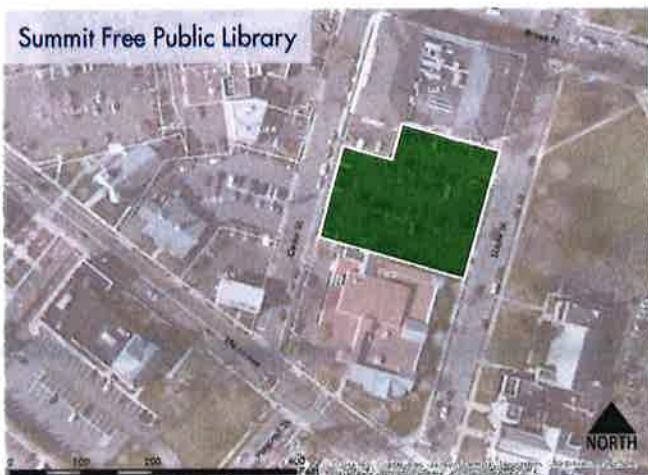
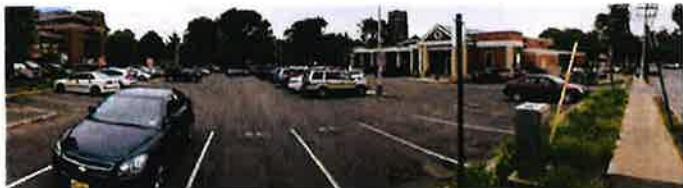
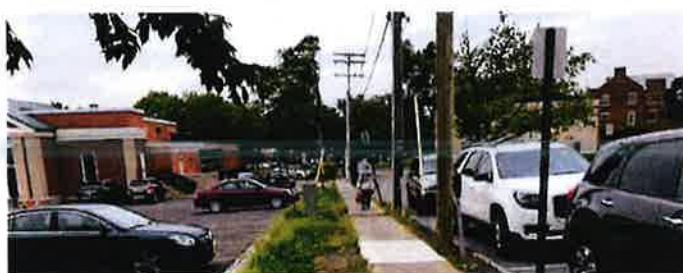
### Block 2705, Lot 2 - Partial (Summit Free Library)

Block 2705, Lot 2 is home to the Summit Free Public Library. The one-story brick building covers approximately half of the 1.8 acre parcel. The other half of the parcel is covered by a publicly accessible surface parking lot. The lot serves both the library's patrons as well as the adjacent YMCA recreation facility.

The building is in generally good condition and was not found to meet criteria under the LRHL. The parking lot, however, does meet the criteria and based upon an inspection of the property, a portion of Block 2705, Lot 2 meets the following criteria under the LRHL:

The use of this lot as a surface parking lot adjacent to a thriving downtown district is, in itself, significant to this analysis, based on the theory advanced under Concerned Citizens, (described above). Sufficient evidence exists to conclude that the current use and conditions upon the parking lot in Block 2705, Lot 2 support designation under 'Criterion D.'

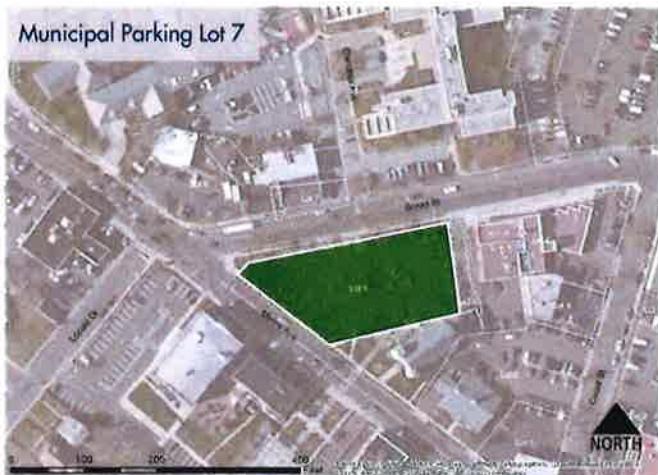
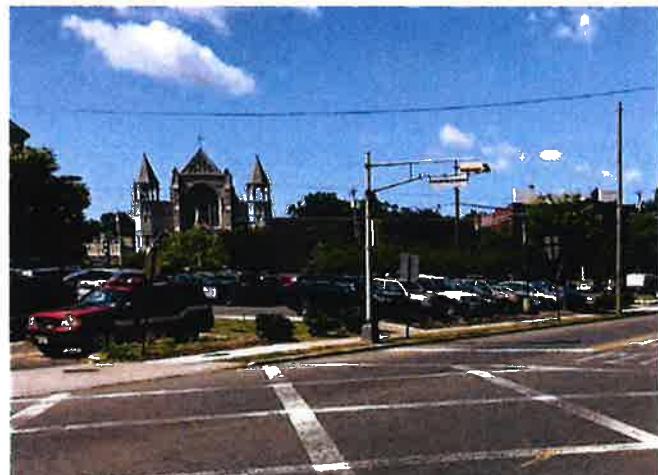
## Block 2706, Lot 1 - (Municipal Parking Lot 7)

Block 2706, Lot 1 contains Municipal Lot 7, also known as the Chestnut Avenue Lot, which has 62 parking spaces designated for residents and employees. It is located at the corner of Broad Street and Morris Avenue. The lot has a single egress point off Broad Street. The lot is paved but provides limited landscaping that includes shrubbery and trees. The municipal lot is marked with pedestrian crossings and has circulation markings throughout the lot.

Improvements on the lot consist almost entirely of surface parking, with limited pedestrian and landscaped area. Impervious coverage, primarily blacktop, occupies nearly the entire area of the parking lot. The condition of the lot is fair, the lot is properly stripped and appears to afford an efficient and safe circulation pattern.

Despite the fair condition, design and circulation, the use of this lot as a surface parking lot adjacent to a thriving downtown district is, in itself, significant to this analysis based on the theory described above relating to Concerned Citizens. As such, sufficient evidence exists to conclude that the current use and conditions of the parking lot in Lot 1 supports designation under 'Criterion D.'

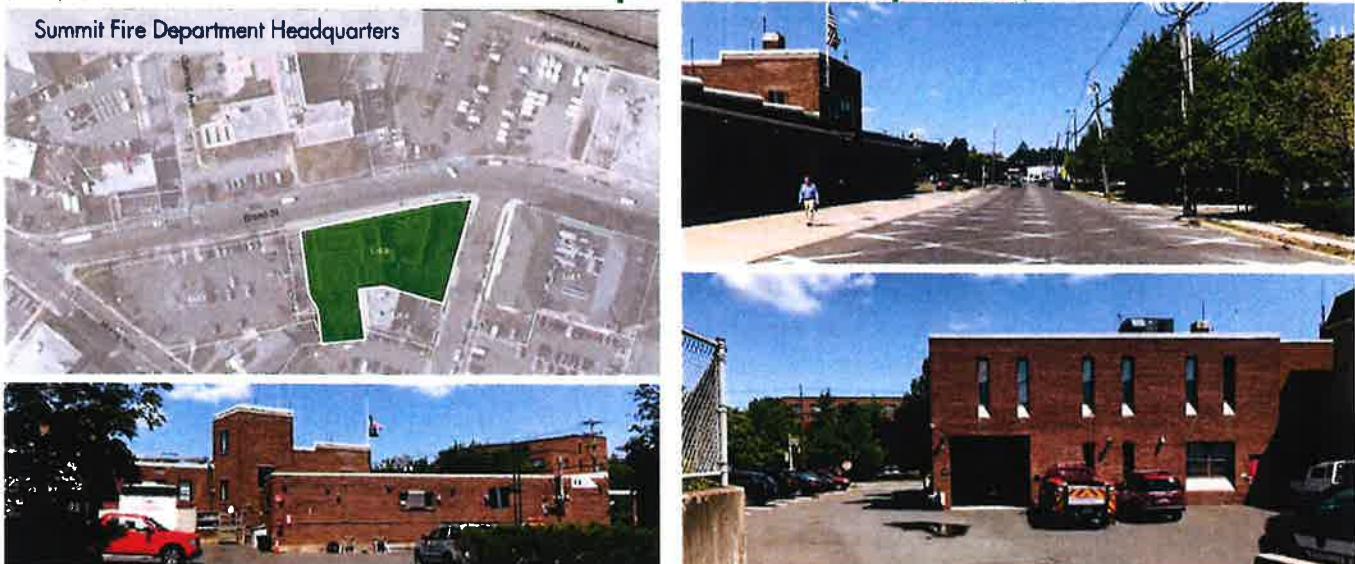
## Block 2706, Lot 3 - (Summit Fire Department Headquarters)

Block 2706, Lot 3 houses the Summit Fire Department Headquarters. The 16,298 s.f. two-story structure is located at 396 Broad Street. The center, two-story portion of the existing building was built in 1901. In 1948 four back-in bays were added in a saw-tooth arrangement to the structure. The two-story addition on the west side of the building was constructed in 1968, when three more back-in bays were added. In 1996, an exterior courtyard area was enclosed and interior office spaces were renovated.

In 2014, the City of Summit Fire Department commissioned a facility assessment of Fire Department Headquarters' building. The assessment report, completed by LeMay Erickson Willcox Architects and Brinjac Engineering, found that the building does not meet current station design standards. The Headquarters building was given a score of 12% based on criteria that included life safety code, accessibility, station alerting, emergency response paths, gender equality, and bunk facilities, among other criteria. Similarly, the site design was evaluated and found to not meet design standards. The site design was given a score of 22% based on criteria that included vehicle circulation, paving conditions, training features, outdoor amenities, trash/dumpster location, among other criteria.

The adjacent Lot 2 of the same Block provides the only point of entry to the back of the Firehouse building. The back of the building has one bay for emergency vehicles and several parking spots used by the Fire Department. Access to the back of the building is crucial to the function of this site and emergency response dispatch station. The City of Summit enjoys an easement on Lot 2, without which no access to the back of the building would exist. This condition of title impedes land assemblage and discourages the undertaking of improvements and results in a stagnant condition of the land.

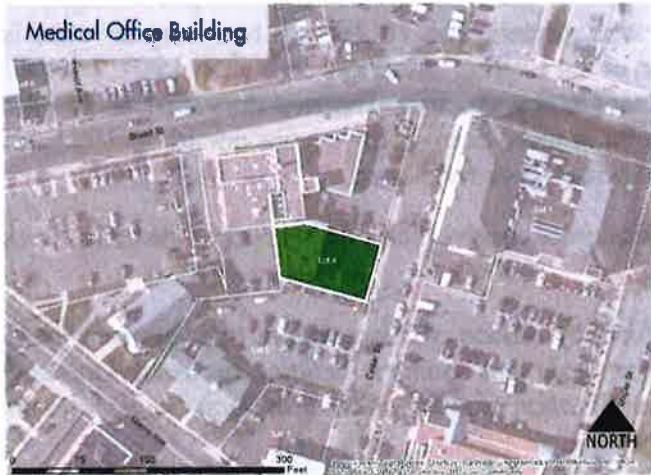
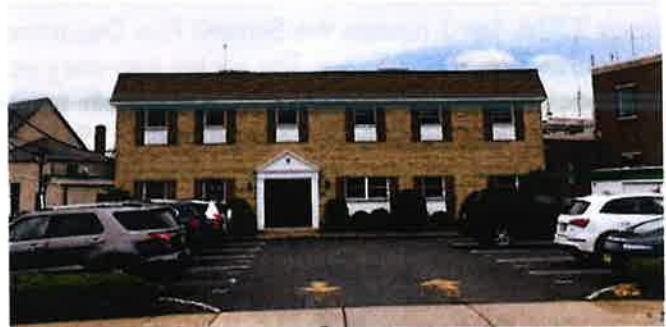
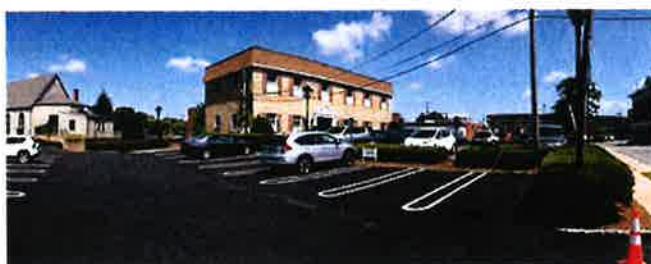
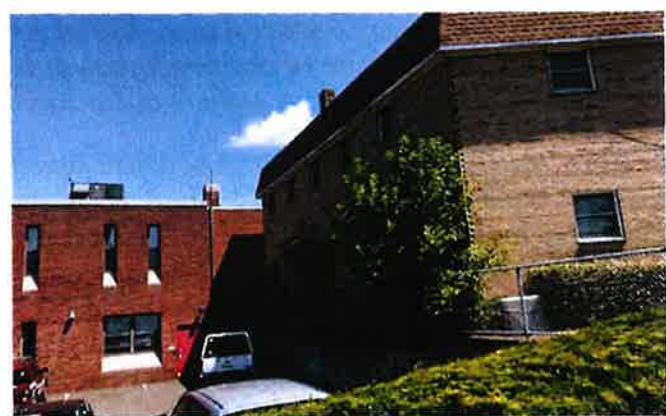
## Block 2706, Lot 4 - (Medical Office Building)

Block 2706, Lot 4 contains a two-story office building located on Cedar Street that abuts both the Summit Fire Department Headquarters building and the Bradley, Brough & Dangler Funeral Home parking lot. The 6,000 s.f. office building is a fully leased Class-B office building that houses multiple medical-office tenants. The office building is set back from Cedar Street and has a 12-car parking lot in front of the building.

The 6,000 s.f. office building is currently in fair condition and is fully leased. The arrangement and design of the site, however, is faulty due to the placement and amount of parking available to the facility which is entirely leased by dental and medical offices. Per the City of Summit's Development Regulation Ordinance, medical and dental offices shall have one parking space per 150 gross square feet of building area. This provision is in place in order to ensure that patients visiting medical or dental offices, who may have limited mobility due to disability, injury, or age, are able to safely access the offices. This site offers only twelve parking spaces for visitors to the office building. Per the aforementioned code, a 6,000 s.f. building that houses dental and medical uses should have forty spaces. The number of spaces provided (12) is twenty-eight spaces short of what would typically be deemed appropriate for such a use.

The faulty arrangement on the site and obsolete design are sufficient evidence to designate Lot 4 under "Criterion D."

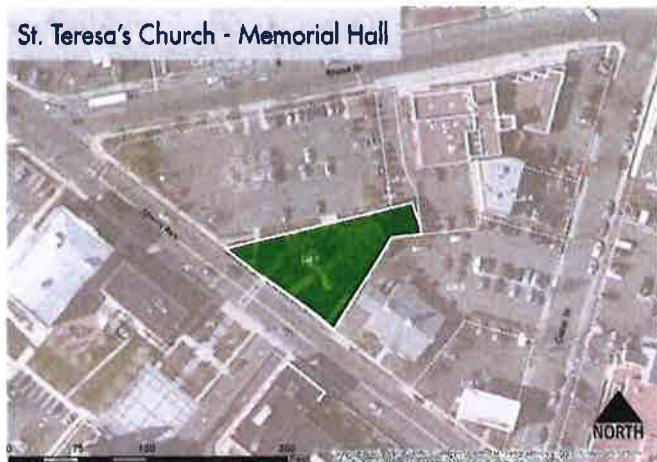
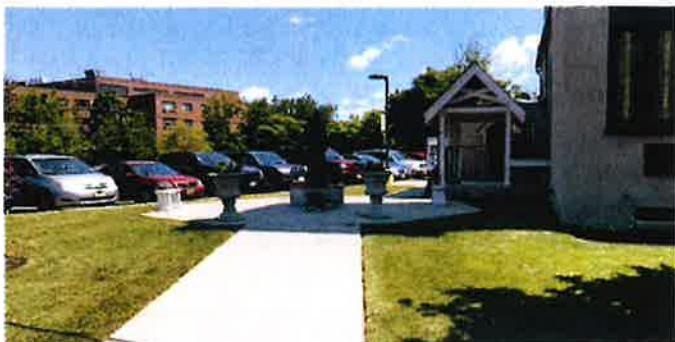
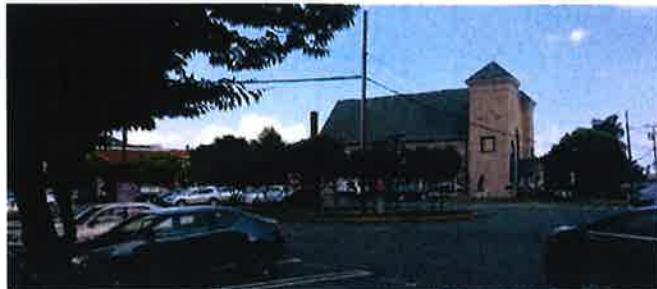
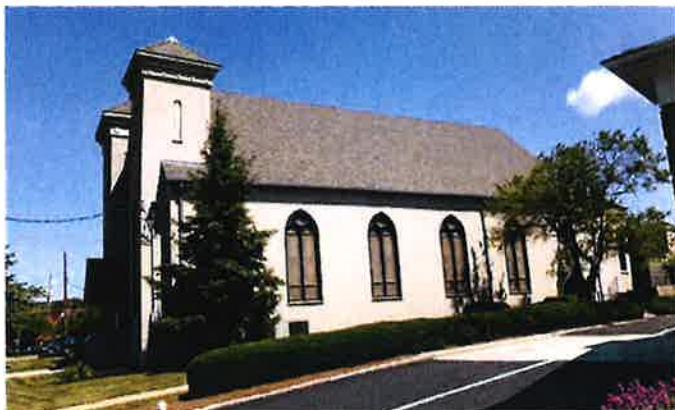
## Block 2706, Lot 7 - (St. Teresa's Church – Memorial Hall)

Memorial Hall is owned by the St. Teresa's Roman Catholic Church which also owns a much larger church across the street from this location on Morris Avenue. This smaller structure was moved here from its original location across the street around 1905, when the new place of worship was constructed. The church is in generally good condition and the site is well-maintained, with few signs of deterioration to its facade and windows. The facility does not have any dedicated parking adjacent to the premises.

Based upon an inspection of the property and an examination of construction and inspection Block 2706, Lot 7 does not meet any of the criteria under the LRHL. While access was not gained into the building, the exterior of the structure and improvements to the site appear to be in good condition. The church itself does not have any direct parking on-site as it shares parking with the much larger St. Teresa's Church across the street. The only adjacent ADA accessible parking spots are available at Municipal Lot 7 northwest of the building.

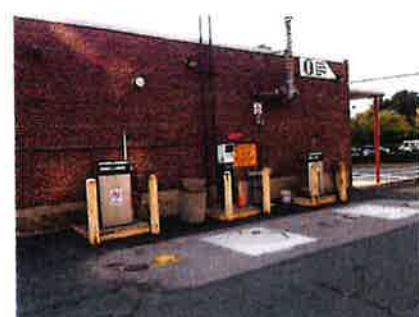
Image 8: Fuel Station

**G. Fuel Station.** An existing City fuel station is located in the east end parking lot at the Fire Headquarters building. The fuel station includes a 6,000 gallon diesel tank and dispenser, and a 4,000 gallon gasoline tank and dispenser. This fuel station is available for use by both the Fire

Department and other City vehicles. Circulation to the fuel station is through the east end parking lot which requires sharp turns on the asphalt surface. (Reference Image 8)

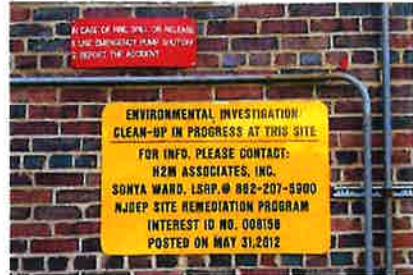
Image 9: Environmental Investigation Sign

The LEWA Team observed a sign posted on the building over the fuel station stating that "Environmental Investigation / Clean-up in Progress at This Site". The sign has a posted date of 5/31/2012. The LEWA Team has requested additional information regarding the environmental investigation from the posted point of contact, but no information has been received as of the preparation of this report. (Reference Image 9)

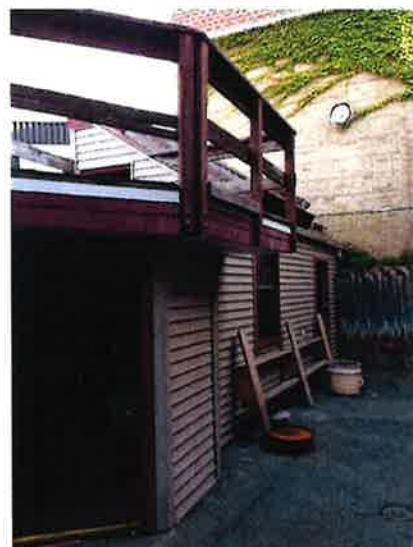
Image 10: Training Prop

At the Fire Headquarters building, the City of Summit Fire Department has incorporated some training opportunities into the facility. At the rear courtyard, the Department has constructed a small wood frame training prop structure with a roof ventilation prop and multiple confined space scenarios. The training scenarios are limited due to the size, scale, and location of the prop, but the prop represents great initiative on the part of the fire department to train and better serve the community. The LEWA Team noted that prop was a wood frame structure and appeared to be non-sprinklered. The prop is in close proximity to the building on the adjacent property as well as to the Fire Headquarters building. (Reference Image 10)

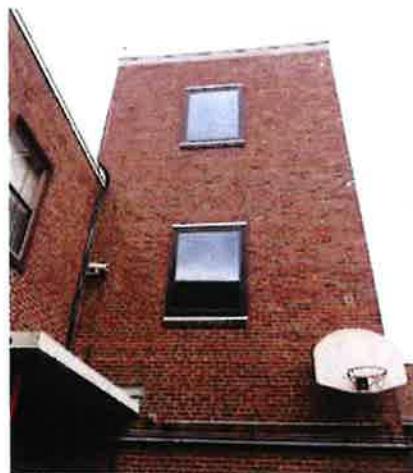
Image 11: Hose Tower

The existing Hose Tower has also been modified to incorporate training opportunities. Two windows have been enlarged on the courtyard side of the hose tower to support window and ladder training. The training scenarios are limited due to the location and the use of the hose tower as the primary circulation and egress for the building. (Reference Images 11)

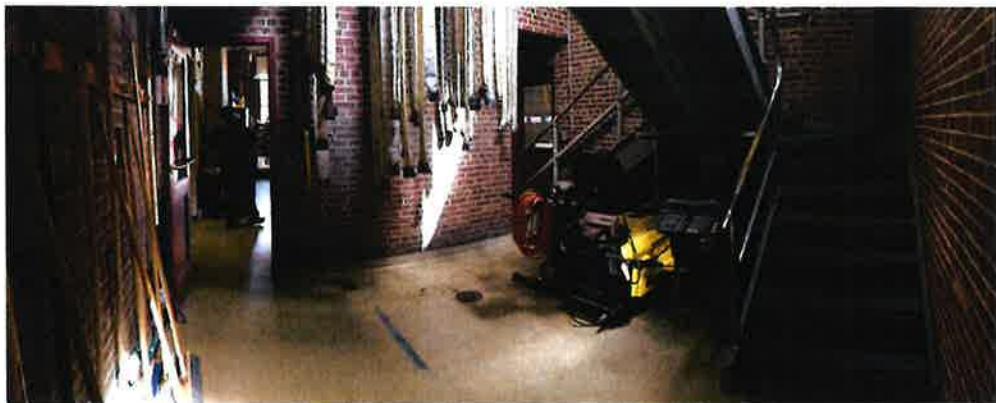
Image 14: Hose Tower

There are three stairs in the Fire Headquarters building. The Hose Tower stair is central in the building and serves as a primary circulation stair. The Hose Tower is also used to hang and dry fire-hoses; for training exercises; and to house several pieces of outdoor equipment such as a gasoline powered snow-blower. This multi-function use for a primary stair is typically not allowed as the other functions could potentially compromise the use of the stair as an egress path in an emergency. Also, the open stair and railings do not meet the design and safety requirements of the current building code. (Reference Image 14)

**Hose Tower.** As noted previously, the Hose Tower is central in the building and serves as a primary circulation stair. The Hose Tower is also used to hang and dry fire-hoses; for training exercises; and to house several pieces of outdoor equipment such as a snow-blower. The stair and railings do not meet the design and safety requirements of the current building code. (Reference Image 14)

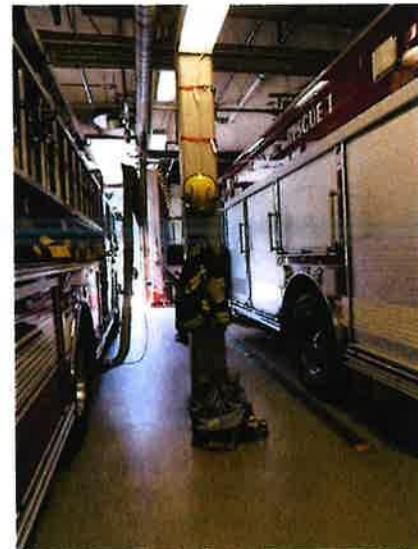
Image 18: Vehicle Exhaust System

Exhaust extraction systems serve to remove vehicle exhaust contaminants from spaces like Apparatus Bays. The Fire Headquarters building utilizes a direct capture system that connects directly to the vehicle exhaust pipes. When used correctly, this system can be very effective in minimizing personnel exposure to the vehicle exhaust inside the building. (Reference Images 16 and 18)

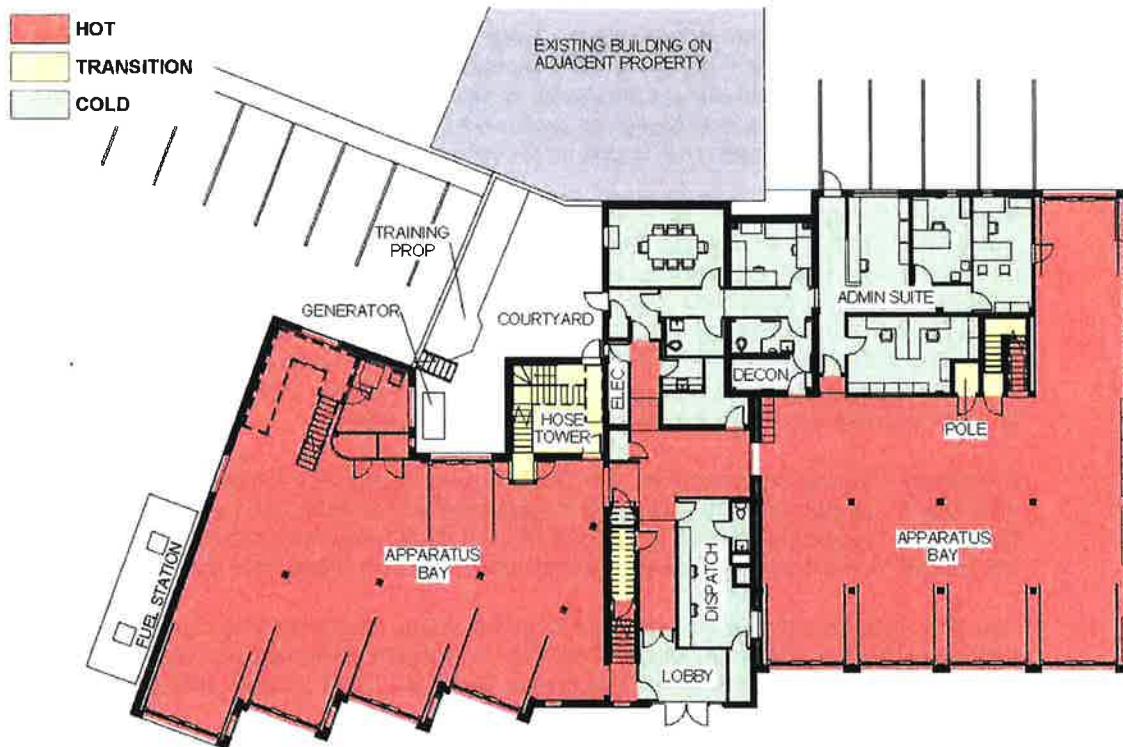
Image 19: First Floor Plan with Hot and Cold Zones

**Contaminant Control.** In fire station design, control and mitigation of contaminants is critical to the health and safety of the personnel that live and work in the facility. During fire and rescue response operations, emergency personnel, their gear, and their vehicles can be exposed to a wide variety of contaminants such as smoke, ash, chemicals, and bodily fluids. In a fire station, the term "Hot Zone" refers to those areas such as the Apparatus Bays and Bay support spaces that are commonly exposed to contaminated materials. The term "Cold Zone" refers to areas such as offices and living spaces that should not be exposed to contamination under normal operations. (*Reference Images 19 and 20*)

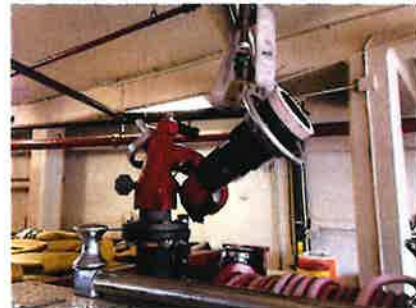
The clear height in the Bays is notably low. At one location, the LEWA Team observed that a water spray nozzle on top of one fire engineer was inches from the piping running across the ceiling. Preferably, the clear height should be 18' or more to allow the fire engine cab to be tilted forward and opened inside the Bays. (Reference Image 23)

Image 23: Apparatus Bay Clearance Problems

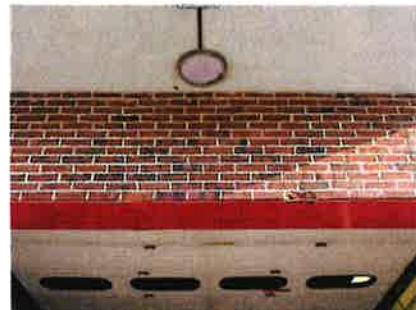
The Bay doors are small relative to current design standards and to the dimensions of the current vehicles. The doors in Bays 1-4 are 12' 2" wide and 11' 2" high. The doors in Bays 5-7 are 12' 0" wide and 11' 3" high, and the door in Bay 8 is 13' 2" wide and 13' 0" high. Current Apparatus Bay doors are often 14' 0" high and 14' 0" wide. Fire Department staff noted that the Apparatus Bay door height restricts the Fire Department's options when purchasing new apparatus as only select manufacturers make vehicles that will fit through the current Bay doors. The current aerial ladder truck has modified axles to help lower the overall truck height to allow it to fit into the Bays. The Bay door size has also caused problems with visiting or Mutual Aid vehicle from other fire stations which are too tall for the Bay doors. There are visible marks in the brick above Bay 1 where a vehicle from another station attempted to back in to the Bays. (Reference Image 24)

Image 24: Apparatus Bay Door Clearance Problems

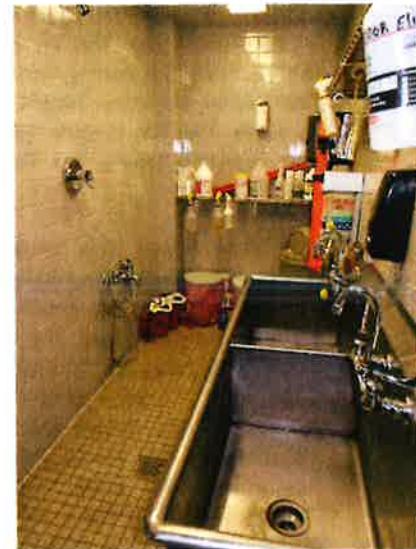
Image 25: Decontamination Room

The Decontamination Room is a cleaning room that is typically located adjacent to the Apparatus Bays for cleaning gear or equipment after a response event. This room often includes a long stainless steel wash sink and may include an emergency eye wash and shower. The Fire Headquarters building has a Decontamination Room at the rear of the Apparatus Bays. The contaminant control aspect of this room is potentially compromised by a second door that connects to the Administrative Office men's restroom. (*Reference Image 25*)

**Decontamination Room.** The Decontamination Room is located at the rear of the Apparatus Bays, and includes a long stainless steel wash sink, an emergency eye wash station, and standard shower. A bio-hazard trash receptacle is located in the room, and there is no closed storage. The contaminant control aspect of this room is compromised by a second door that connects to the Administrative Office men's restroom. (Reference Image 25)

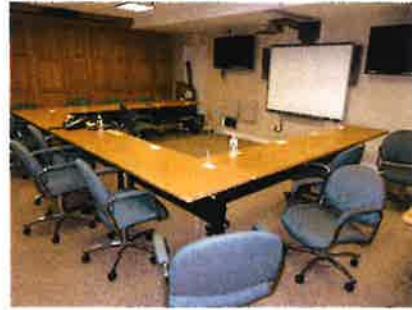
Image 26: Training Room

**Training/EOC Room.** There is one Training Room in the Fire Headquarters building. This has table set up in a "U" shape around a smart board with video projection. Two additional flat panel monitors are mounted to the right and left of the smart board. A side table has three computer work stations that can be used for training purposes and can be connected to the smart board system. The current furniture configuration seats 15 at the "U" shape table and 4 at the side table.

The Training Room also serves as the City of Summit's Emergency Operations Center (EOC). This function brings key City leaders and staff to the Fire Headquarters building during City emergency situations, and depending on the nature of the event, may require 24/7 EOC operations for extended periods of time. Fire Department staff indicated that there are 20 people on the City's EOC Team, and that there may be up to 30 people in the Training Room during EOC operations. *(Reference Image 26)*

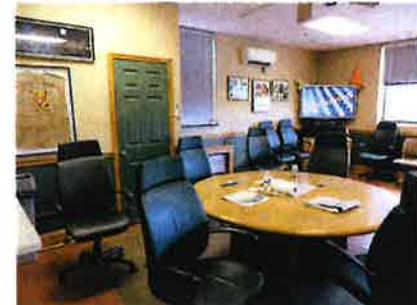
Image 27: Dining/Living Area

The Living/Dining Room serves as the only communal living space for the firefighters to gather while on duty. This room includes a round dining table for meals and a flat panel TV. The space is small relative to the combined Dining Room and Living Room functions, and there is not sufficient space in the room to define a Living Room seating group area. *(Reference Image 27)*

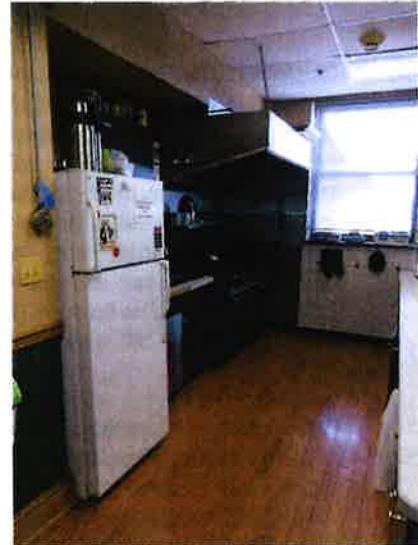
Image 28: Kitchen

The Kitchen is adjacent to the Living/Dining Room and includes one residential refrigerator, a 6-burner commercial stove, and two microwaves. The Kitchen is small with minimal counter space and storage space. In fire stations such as this with rotating shift schedules, it is common to have dedicated refrigerators and dedicated pantry storage space for each shift. *(Reference Image 28)*

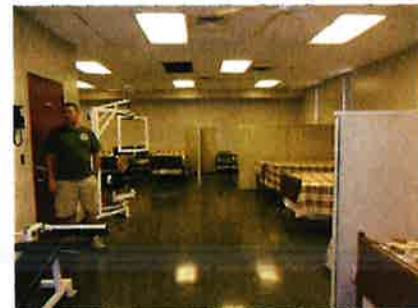
Image 29: Main Bunk Room

There are two Bunk Rooms, or dormitories, in the Fire Headquarters building. The majority of the firefighter personnel sleep in the large 10-person Bunk Room, and the officers on duty sleep in a separate 4-person Bunk Room. Large, open bunk rooms such as these are common in older fire stations, but current station design trends are shifting towards smaller Bunk Rooms for 1, 2 or 4 people. The smaller rooms minimize noise disturbances to sleeping firefighters and can allow flexibility for gender accommodations. The rooms can also be individually managed for station alerting such that only designated rooms receive alerts and other rooms can remain undisturbed. (Reference Image 29)

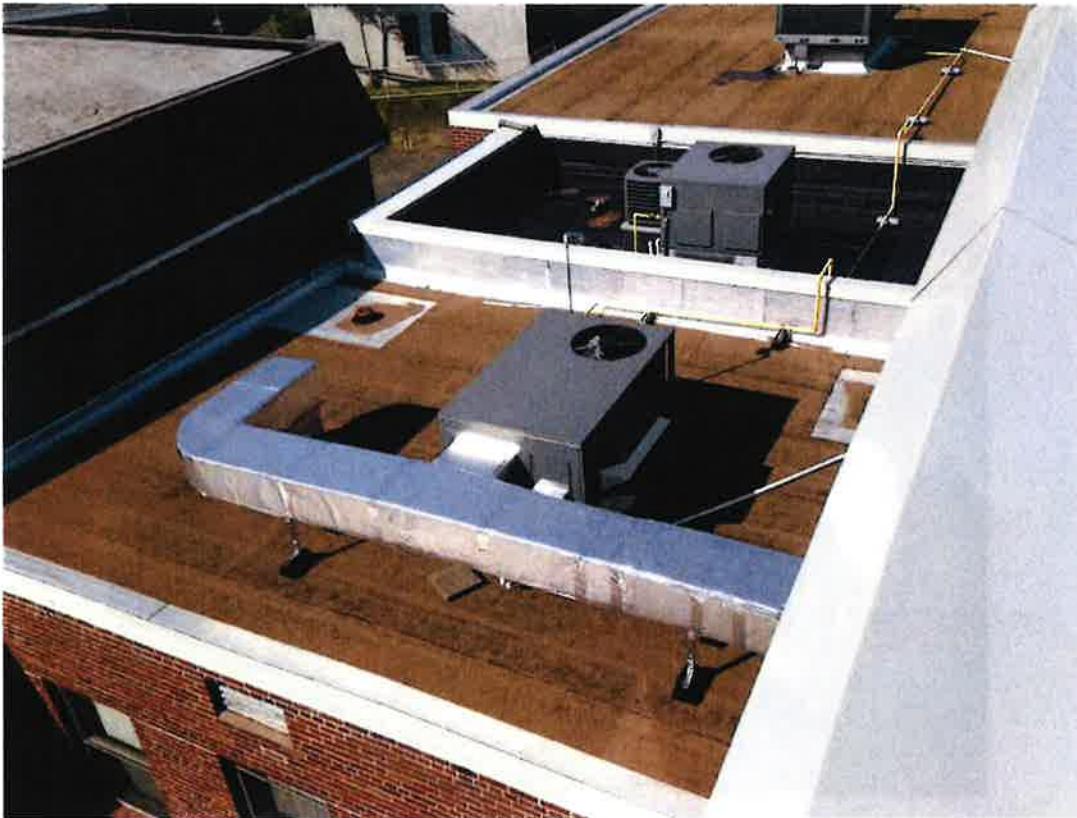
RTU-1: 10 tons cooling capacity, 168,000 BTUh heating capacity serves the Dormitory areas.  
 RTU-2: 2.5 tons cooling capacity, 69,000 BTUh heating capacity serves office spaces on the 1<sup>st</sup> floor.  
 RTU-3: 3 tons cooling capacity, 73,600 BTUh heating capacity serves the 2<sup>nd</sup> floor Training Room.  
 AC-1: A split system with condensing unit on roof and indoor unit above the first floor ceiling is a 3 ton system serving the Chief's office, the Deputy Chief's office and the adjacent administrative area.

*Packaged Rooftop Units and Condensing Unit on Roof*

The roof top equipment is fairly new (2011) and thus in generally good condition. The rooftop units installed in 1996 lasted for 15 years – typical for this type of equipment, and what can be expected for the current equipment due to its exposure to the weather. The indoor unit serving the Chiefs' offices is in a difficult location for maintenance and has already had condensate leakage issues that have stained the ceiling tiles.
