# **PRELIMINARY INVESTIGATION**

## **BROAD STREET WEST, SUMMIT, NJ**

### **DATE: September 15, 2017**

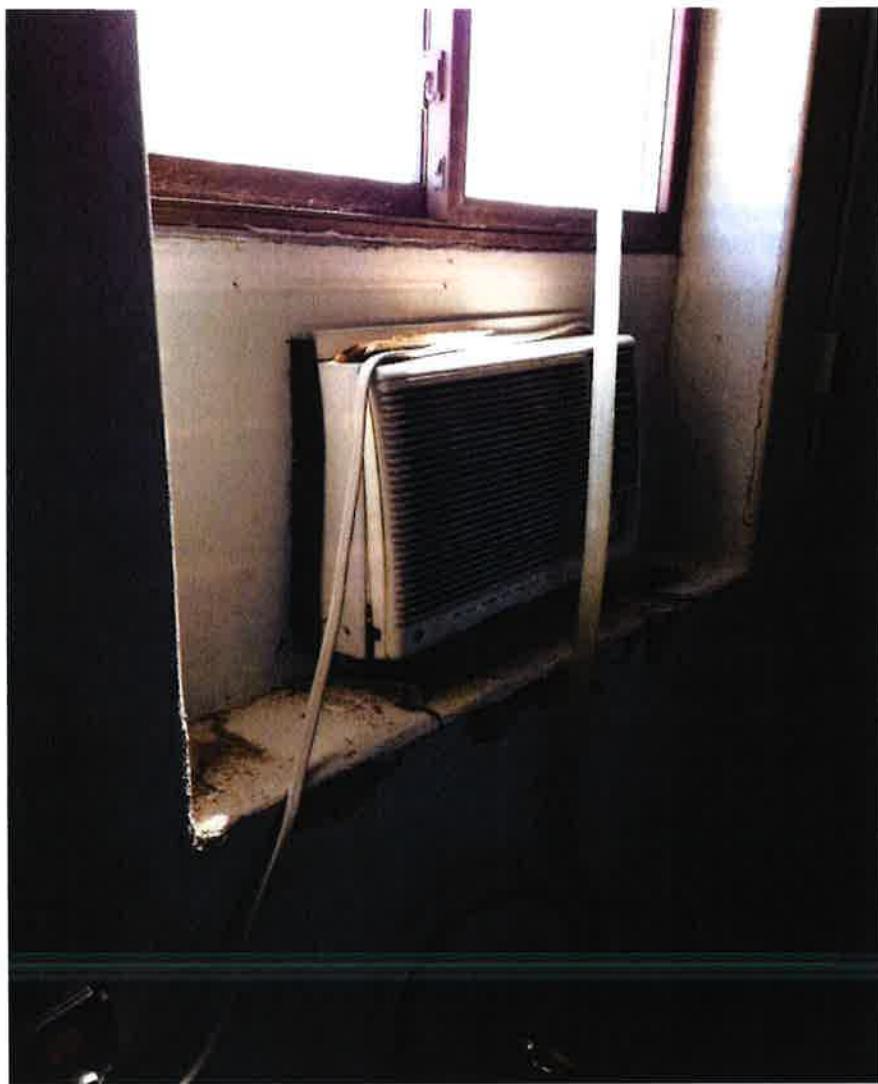
The Recreation Area utilizes a split system Mitsubishi unit with condensing unit located on the low roof above the west Apparatus bay and indoor unit wall mounted. Additionally a small window type air conditioning unit provides cooling to the storage room on the east side of the recreation room.

*Window AC Unit in Storage Room*

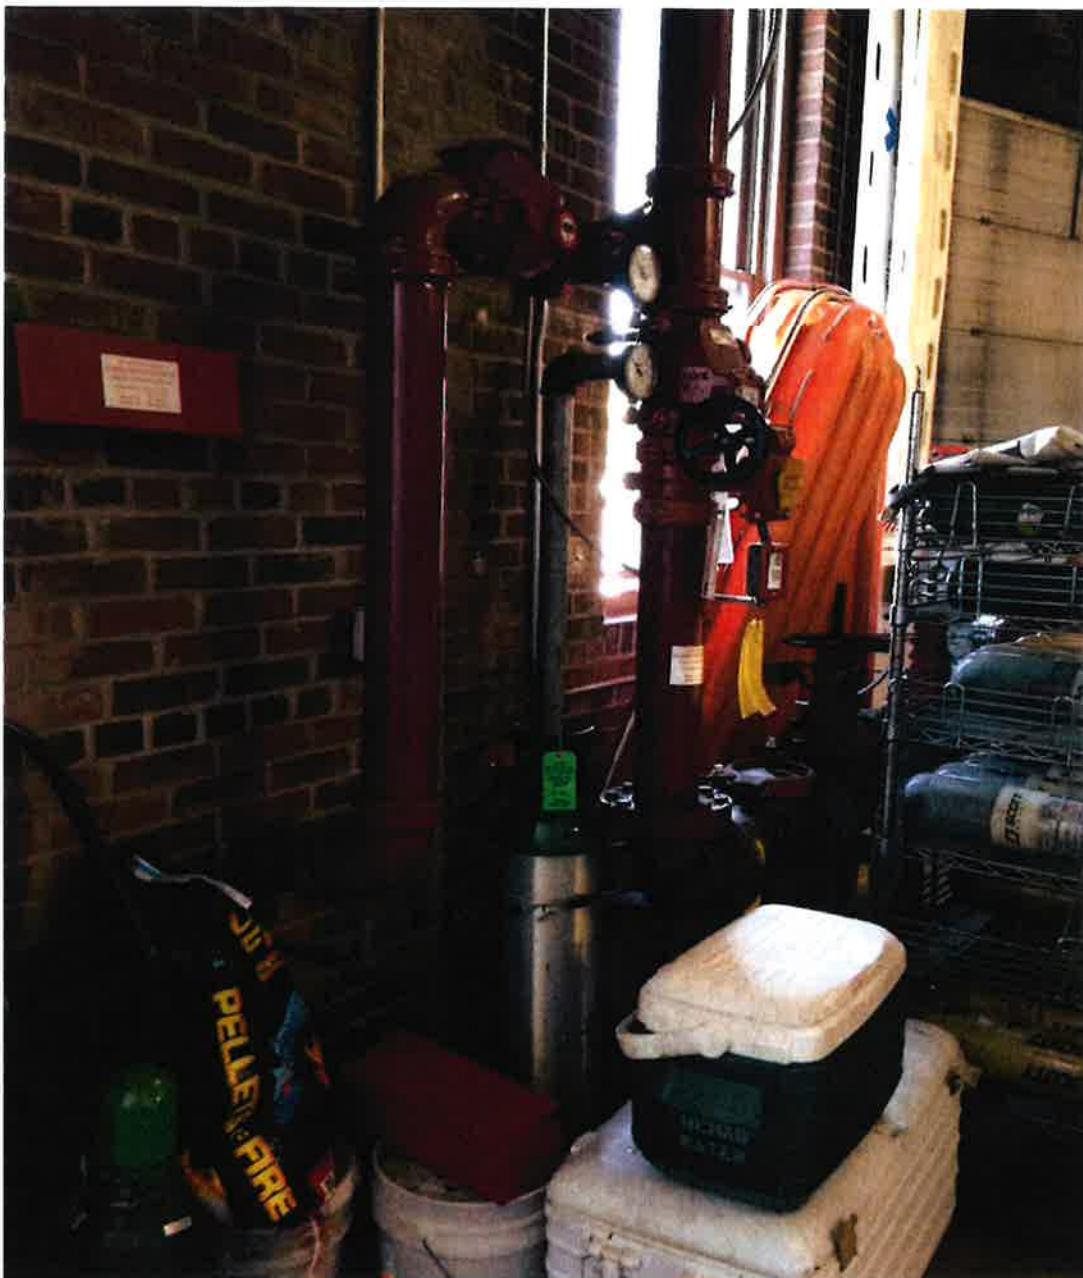
The building is fully sprinkled with a relatively new dedicated 4" fire service that enters the building in the east Apparatus Room. No fire pump is required.

*Building Fire Service*
