**EXISTING FACILITY ASSESSMENT**  
**City of Summit Fire Headquarters**

September 30, 2014

**Purpose.** LeMay Erickson Willcox Architects (LEWA), under contract with the City of Summit, conducted an Existing Facility Assessment (EFA) for the City of Summit Fire Headquarters building located at 396 Broad Street in Summit, NJ. The Existing Facility Assessment was completed by a multi-disciplinary team conducting visual inspections of the existing building, systems, and equipment; review of existing building drawings, and interviews with Fire Department staff.

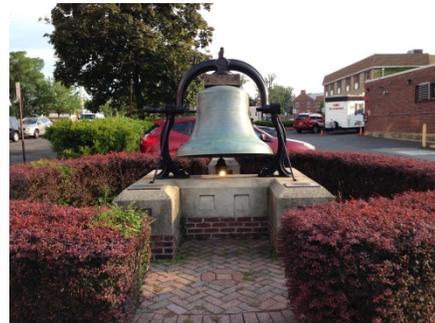
Image 7: Memorial Garden

There is a small memorial garden area at the corner of Broad Street and Cedar Street. The memorial incorporates a ring of low bushes around a historic bell. The memorial and surrounding lawn provide a pleasant corner green-space on an otherwise impervious site. (Reference Image 7)

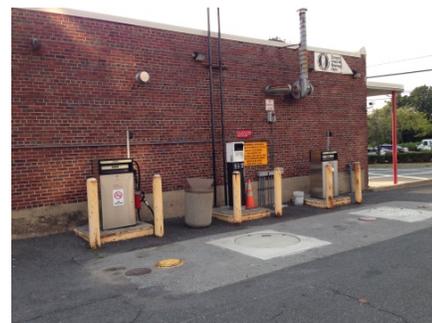
Image 8: Fuel Station

**G. Fuel Station.** An existing City fuel station is located in the east end parking lot at the Fire Headquarters building. The fuel station includes a 6,000 gallon diesel tank and dispenser, and a 4,000 gallon gasoline tank and dispenser. This fuel station is available for use by both the Fire

Department and other City vehicles. Circulation to the fuel station is through the east end parking lot which requires sharp turns on the asphalt surface. (Reference Image 8)

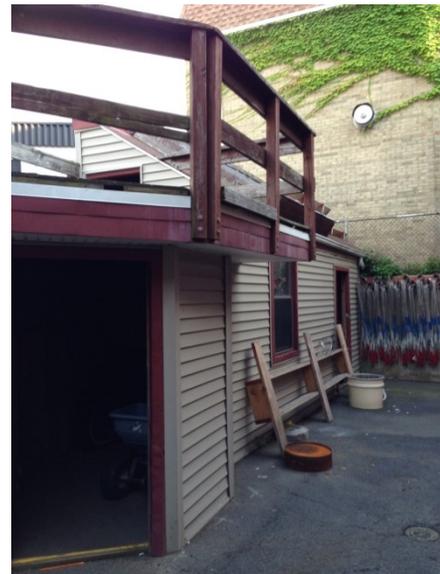
Image 10: Training Prop

At the Fire Headquarters building, the City of Summit Fire Department has incorporated some training opportunities into the facility. At the rear courtyard, the Department has constructed a small wood frame training prop structure with a roof ventilation prop and multiple confined space scenarios. The training scenarios are limited due to the size, scale, and location of the prop, but the prop represents great initiative on the part of the fire department to train and better serve the community. The LEWA Team noted that prop was a wood frame structure and appeared to be non-sprinklered. The prop is in close proximity to the building on the adjacent property as well as to the Fire Headquarters building. (Reference Image 10)

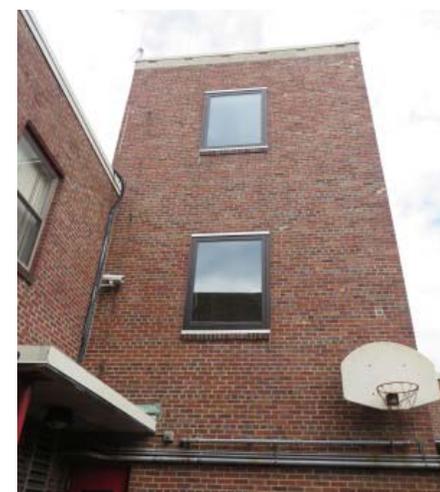
Image 11: Hose Tower

The existing Hose Tower has also been modified to incorporate training opportunities. Two windows have been enlarged on the courtyard side of the hose tower to support window and ladder training. The training scenarios are limited due to the location and the use of the hose tower as the primary circulation and egress for the building. (Reference Images 11)

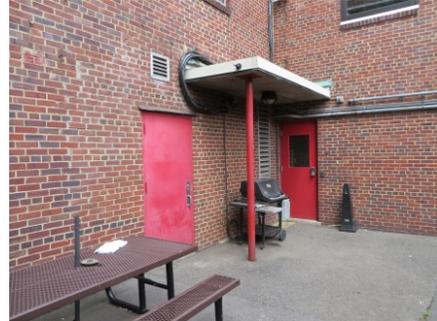
Image 12: Gas Grill and Outdoor Courtyard

- I. Outdoor Amenities.** Because fire stations are continuously operational buildings, many departments incorporate a small patio or outdoor space for the personnel. At the Fire Headquarters building, the only outdoor space available to the personnel is the fully paved rear courtyard which also hosts the training prop and the emergency generator. The Fire Department has made the best of the minimal courtyard space by providing a table, a residential gas grill, and a basketball hoop installed on the hose tower. (Reference Images 12 and 13)

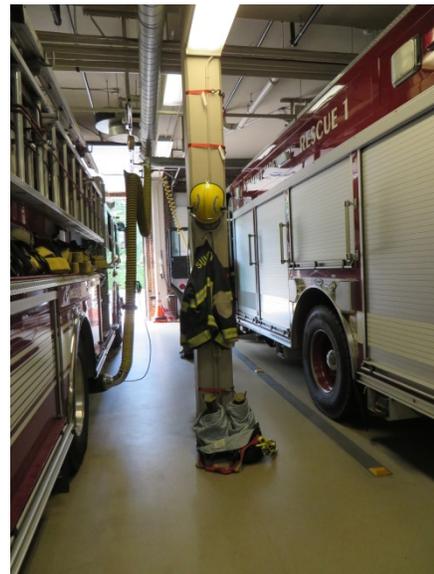
Image 18: Vehicle Exhaust System

Exhaust extraction systems serve to remove vehicle exhaust contaminants from spaces like Apparatus Bays. The Fire Headquarters building utilizes a direct capture system that connects directly to the vehicle exhaust pipes. When used correctly, this system can be very effective in minimizing personnel exposure to the vehicle exhaust inside the building. (Reference Images 16 and 18)

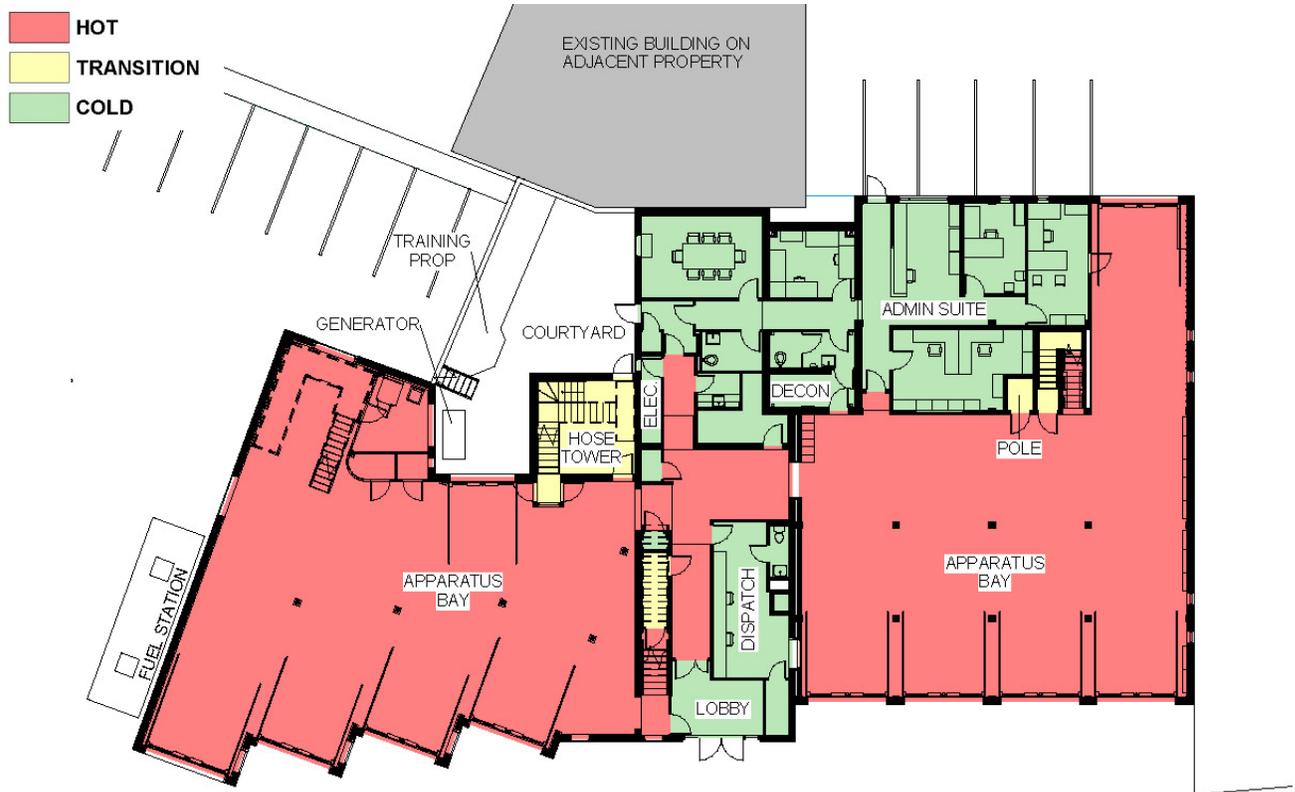
Image 19: First Floor Plan with Hot and Cold Zones

**Contaminant Control.** In fire station design, control and mitigation of contaminants is critical to the health and safety of the personnel that live and work in the facility. During fire and rescue response operations, emergency personnel, their gear, and their vehicles can be exposed to a wide variety of contaminants such as smoke, ash, chemicals, and bodily fluids. In a fire station, the term "Hot Zone" refers to those areas such as the Apparatus Bays and Bay support spaces that are commonly exposed to contaminated materials. The term "Cold Zone" refers to areas such as offices and living spaces that should not be exposed to contamination under normal operations. (*Reference Images 19 and 20*)

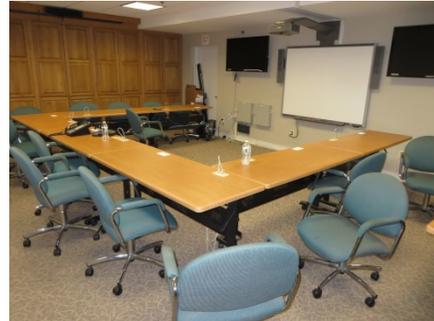
Image 26: Training Room

**Training/EOC Room.** There is one Training Room in the Fire Headquarters building. This has table set up in a “U” shape around a smart board with video projection. Two additional flat panel monitors are mounted to the right and left of the smart board. A side table has three computer work stations that can be used for training purposes and can be connected to the smart board system. The current furniture configuration seats 15 at the “U” shape table and 4 at the side table.

The Training Room also serves as the City of Summit’s Emergency Operations Center (EOC). This function brings key City leaders and staff to the Fire Headquarters building during City emergency situations, and depending on the nature of the event, may require 24/7 EOC operations for extended periods of time. Fire Department staff indicated that there are 20 people on the City’s EOC Team, and that there may be up to 30 people in the Training Room during EOC operations. (*Reference Image 26*)

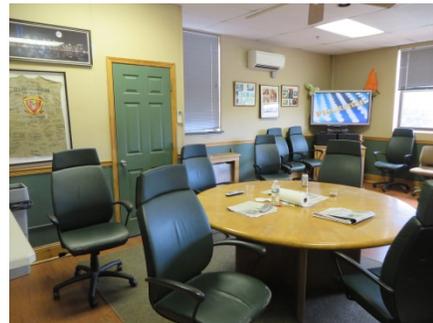
Image 27: Dining/Living Area

The Living/Dining Room serves as the only communal living space for the firefighters to gather while on duty. This room includes a round dining table for meals and a flat panel TV. The space is small relative to the combined Dining Room and Living Room functions, and there is not sufficient space in the room to define a Living Room seating group area. (*Reference Image 27*)

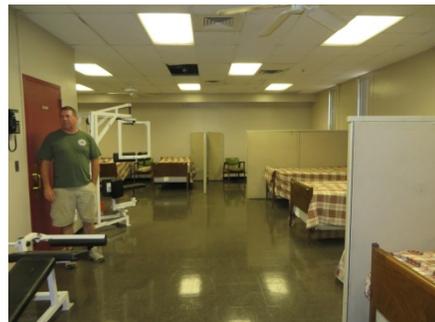
Image 29: Main Bunk Room

There are two Bunk Rooms, or dormitories, in the Fire Headquarters building. The majority of the firefighter personnel sleep in the large 10-person Bunk Room, and the officers on duty sleep in a separate 4-person Bunk Room. Large, open bunk rooms such as these are common in older fire stations, but current station design trends are shifting towards smaller Bunk Rooms for 1, 2 or 4 people. The smaller rooms minimize noise disturbances to sleeping firefighters and can allow flexibility for gender accommodations. The rooms can also be individually managed for station alerting such that only designated rooms receive alerts and other rooms can remain undisturbed. (Reference Image 29)
